IN THE MATTER of an application to Auckland Council by Watercare Services Limited ("**Watercare**") for a resource consent to construct, commission, operate and maintain a wastewater tunnel and associated activities in Herne Bay, Auckland ("**Project**")

**STATEMENT OF EVIDENCE OF ANDREW NATHAN CLARKE ON BEHALF OF
WATERCARE SERVICES LIMITED**

(STRUCTURAL ENGINEERING)

2 FEBRUARY 2024

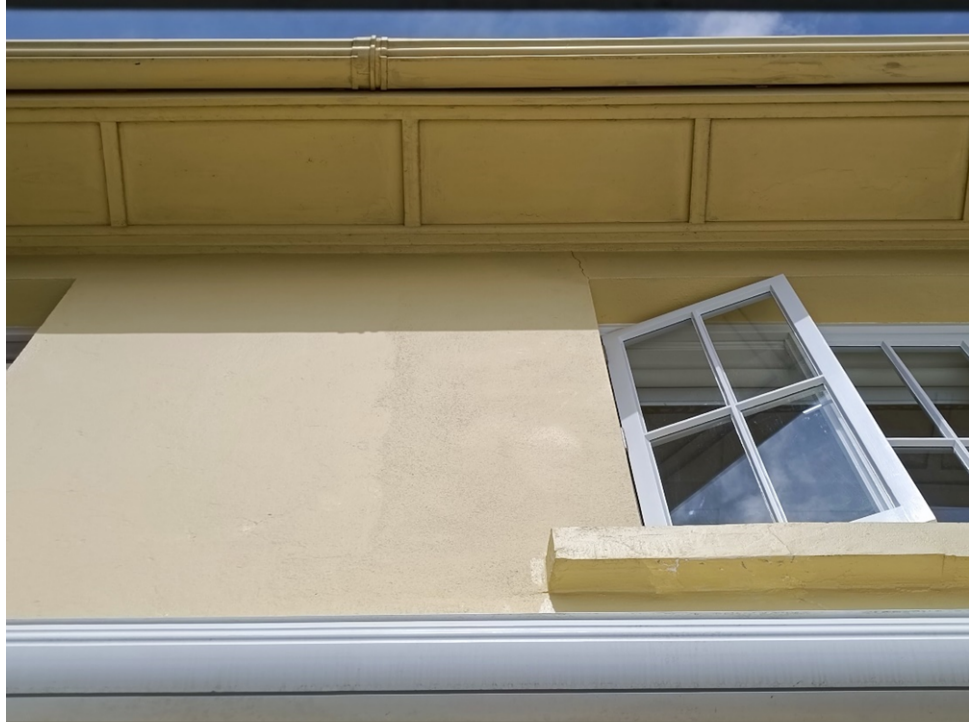
- (a) Cracking around windows (Photo 1). Likely caused by historic shrinkage or seasonal expansion/contraction in URM walls.
 - (b) Cracking observed at interface/joints between URM and timber walls (Photo 2). Likely caused by differential movement between the different construction materials.

Photo 1 - Example of cracking around windows

- 5.4 Cosmetic cracking of this nature can be easily remediated. If required, small cracks can be plastered and painted, while larger cracks may also require grout injection. ¹Further, I note that Watercare is offering pre and post condition surveys to the owners of the Townhouses. I support this approach as it will ensure any cosmetic damage is identified and will also enable easy remediation to occur should that be required.

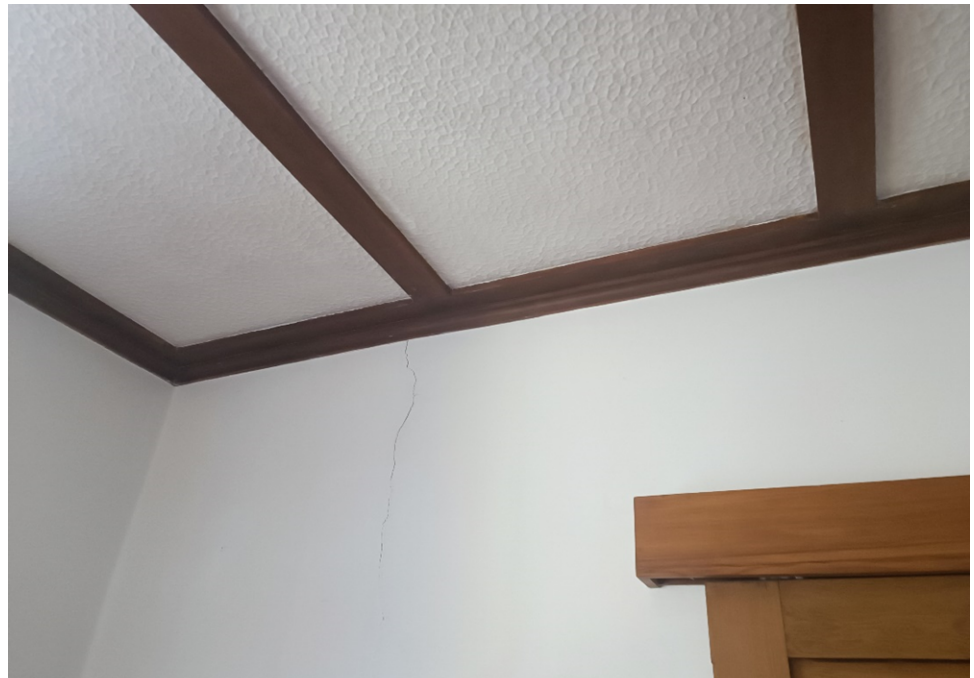
Photo 2 - Example of cracking at interface between URM and timber walls

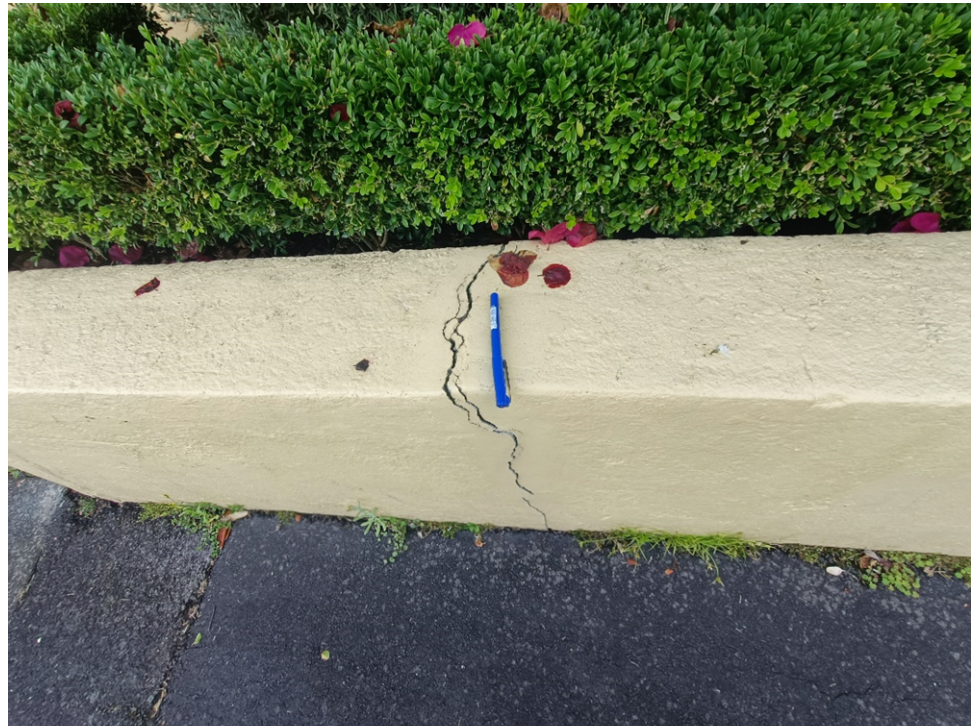
- (c) Cracking observed in or between landscaping URM walls (Photo 3). Likely caused by seasonal expansion/contraction of the ground and with potentially shallower foundations than the main building.

Photo 3 - Example of cracking in landscaping URM walls
