# Arboricultural Assessment of Effects

of  
**Extension of the Central Interceptor wastewater tunnel into Point Erin Park, resulting in the removal of reserve trees.**

**Date** 25 January 2023  
**Job ref #** 2499  
**Reviewed by** Tracey Funnell

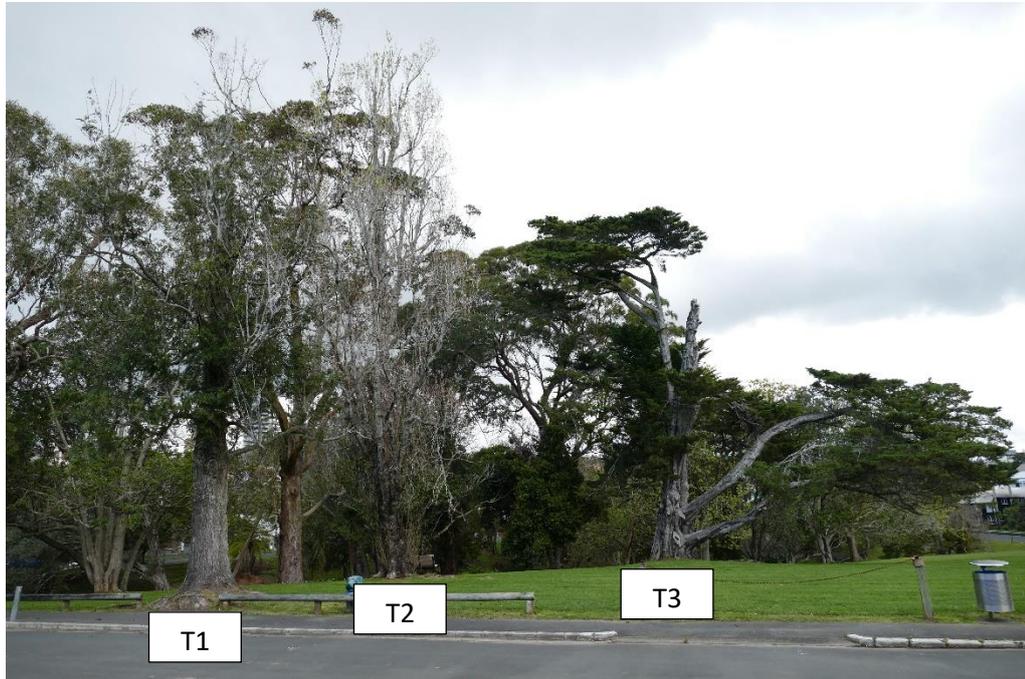
- 4.2 The macrocarpa tree located near the southeastern corner of the grassed area was exhibiting an active branch failure, with the second lowest branch opening and closing during a high wind event. Council's tree maintenance contractors (via council's online reporting function) have been notified of the works. The tree also shows signs of numerous historical live branch failures with torn stubs and tear wounds throughout the crown. Although the tree exhibits an obvious tree risk feature with an active failure occurring and has a clear history of previous live branch failure, it is a substantial tree within the park. For this reason, it should be managed as a veteran specimen, and allowed to naturally reduce in size with intervention that is only necessary for public safety. Figure 2 depicts the macrocarpa tree.

Figure 2 - Tree 1 (silky oak), Tree 2 (Lombardy poplar) and Tree 3 (macrocarpa)

- 4.3 A mature silky oak and Lombardy poplar tree (Figure 2) are located adjacent to the accessway and near the park maintenance access route through bollards. The silky oak is in poor health and of fair form with canopy retrenchment occurring and the main leader previously being removed. It also has basal trunk damage. The Lombardy poplar also has dieback occurring and visible decay within basal roots and near the base. Sounding the trunk with a nylon mallet revealed the decay is almost certainly extensive within the trunk. The species is also known to respond and compartmentalise poorly to wood decay.

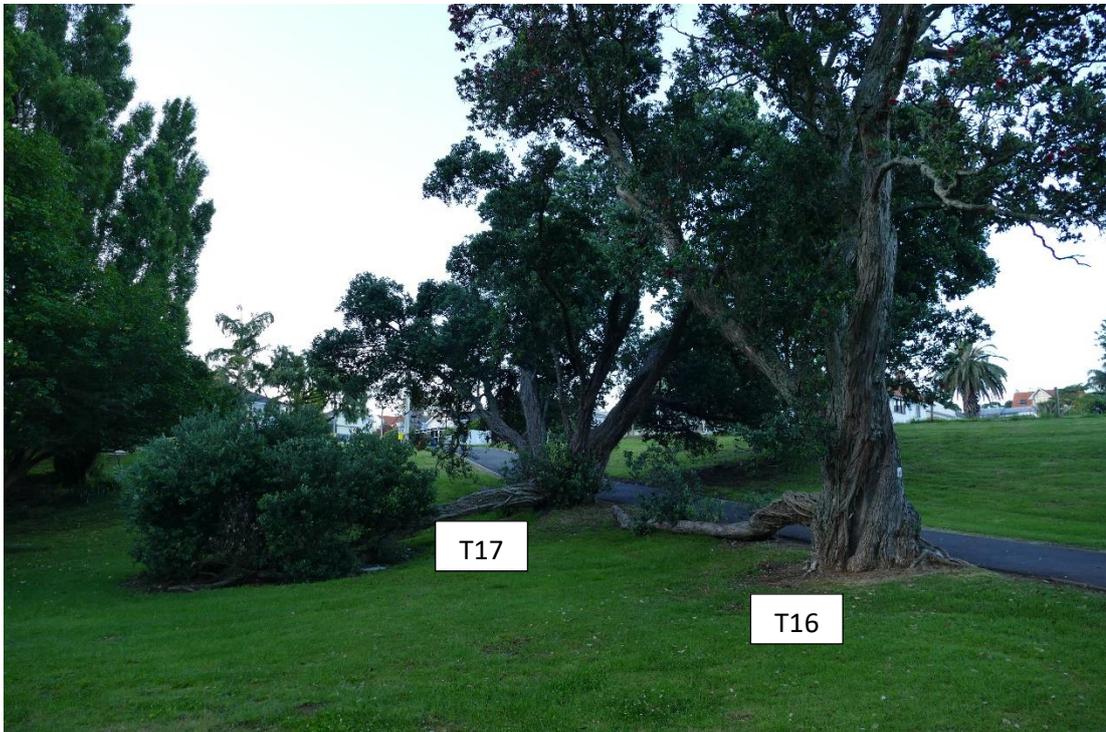
- 4.4 Two mature pōhutukawa trees (Figure 3) are present, along with a semi-mature lime tree along the southwestern boundary edge boarding the Curran Street motorway on-ramp. The pōhutukawa is commencing the 'walking' stage, where lateral limbs fail or settle to the ground, where they can continue to grow. Both of these trees have a single limb that has failed at or near the union. The more southern of the two pōhutukawa has a low-hanging limb that forms an archway over an adjacent footpath that runs beneath.

Figure 3 – Trees 16 and 17 (pōhutukawa)

- 5.8 Trees 16 and 17 are mature pōhutukawa trees that stand at approximately 13 m in height. Tree 16 has quite an upright form, with the exception of one limb on the southern side that has failed in the past. Sections of the failed limb are touching the ground, where it is almost certain new roots have developed, resulting in the ability for the branch to continue to grow. This is a common occurrence with mature pōhutukawa and is referred to as the walking stage of its lifecycle.

- 5.9 Tree 16 is on the eastern edge of the southwestern construction area (Figure 5, yellow area), where a retaining wall is expected to be constructed to form a level platform for construction works. Cumulatively, the wall construction, disturbance to roots through severance and the changes in soil levels, and pruning to provide clearance for the work area are expected to compromise the health and longevity of the tree.

- 5.10 Tree 17 is the second and more southern mature pōhutukawa tree of the two. It also has a scaffold branch that has failed to the ground and continued to grow. The branch is on the eastern canopy side and is not impacted by the proposed works. The tree is, however, some 18m from the Curran Street boundary and on the periphery of the extent of the works boundary. Given the nature of the chamber earthworks and overall construction, significant root disturbance will occur, to a point where retention of the tree is not viable. Additional impacts will also occur due to the requirement for significant pruning to cut the canopy back to allow for machinery access and use (i.e. crane to lift materials for construction).

- 5.11 I have been advised by Watercare that although consent will be sought for the removal of trees 16 and 17, every effort practicable will be made to seek retention during construction. A suitably qualified and experienced supervisory arborist will be engaged for the construction works and guide the principal contractor through working around the trees as much as practicably possible. While it is recommended that all efforts be made to prune the tree so that it can be retained, the overall disturbance to the trees means retention is untenable, and removal is required.

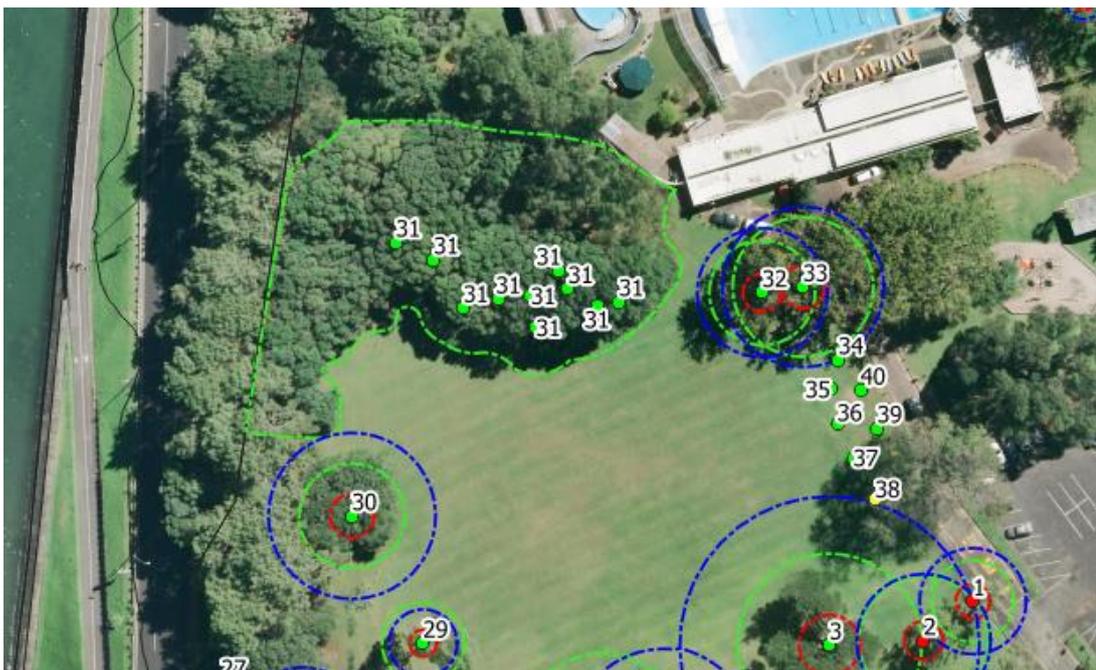
- 4.6 To the north of the grass area in Point Erin Park, is a band of pōhutukawa trees of approximately 10m in height (Trees 31 in Figure 4). They form a contiguous group with an area of approximately 2500 m<sup>2</sup>. Due to the pōhutukawa being formed of a large group, trees closest to the area of works have been plotted (ten trees in total), with the largest tree having the trunk measured. By measuring the largest trunk diameter, the protected root zone area will include all remaining trees as well, ensuring a sufficient protection zone is plotted.

Figure 4 – Aerial showing Tree group 31, Trees 32 and 33.

- 4.7 Two mature English oak trees (Trees 32 and 33) are situated in the northeastern corner of the grassed area, adjacent to an access road for the pools. Both trees are in fair condition, with a moderate amount of twiggy deadwood present throughout the crown. There is also clear evidence of previous live branch failure and areas of cambial dieback. The condition of the trees suggests they are in a life stage of senescence, and for this, they should be maintained as veteran specimens. With the deadwood, tear wounds and pockets of decay present, they will be providing benefits outside of direct arboricultural (such as ecological and biodiversity).

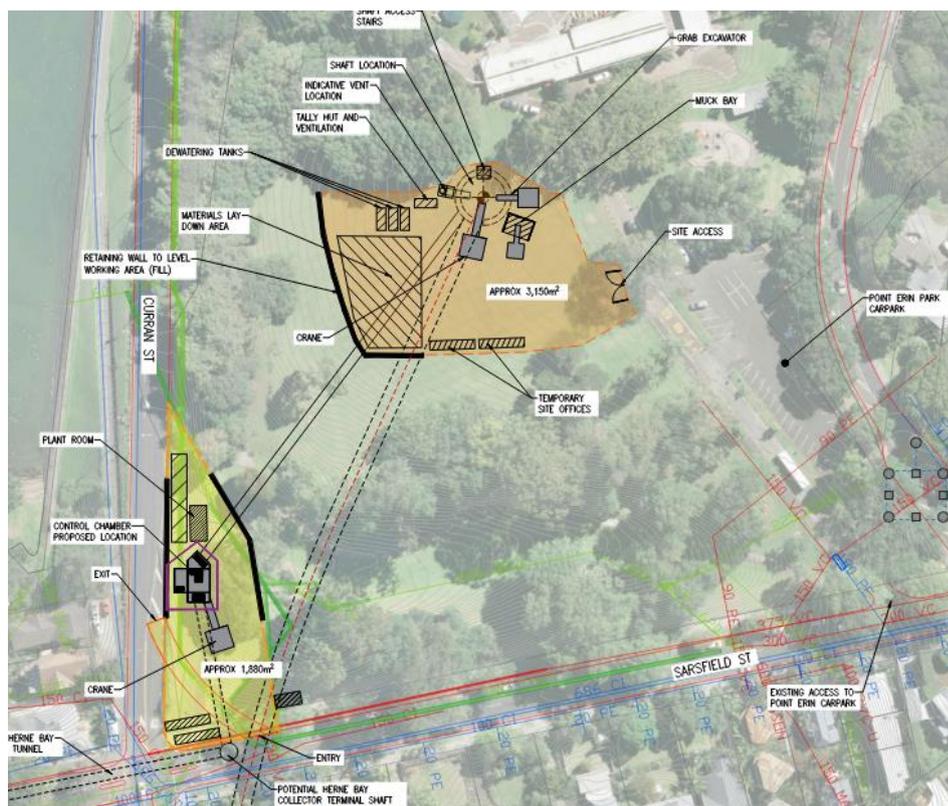
- 5.1 The main construction area in the large grassed area of Point Erin Park is mainly situated outside of both the Auckland Unitary Plan defined root zone and Tree Protection Zone (a measurement calculated to be 12 times the trunk diameter at 1.4 m above ground level). This is with the exception of tree 3 (large macrocarpa), several of the pōhutukawa trees to the north of the extent of the work (referenced as tree 31), and the two oak trees to the northeast of the shaft location (trees 32 and 33). Figure 5 shows the two construction areas, with the main site being the area in orange.

Figure 5 – Construction areas

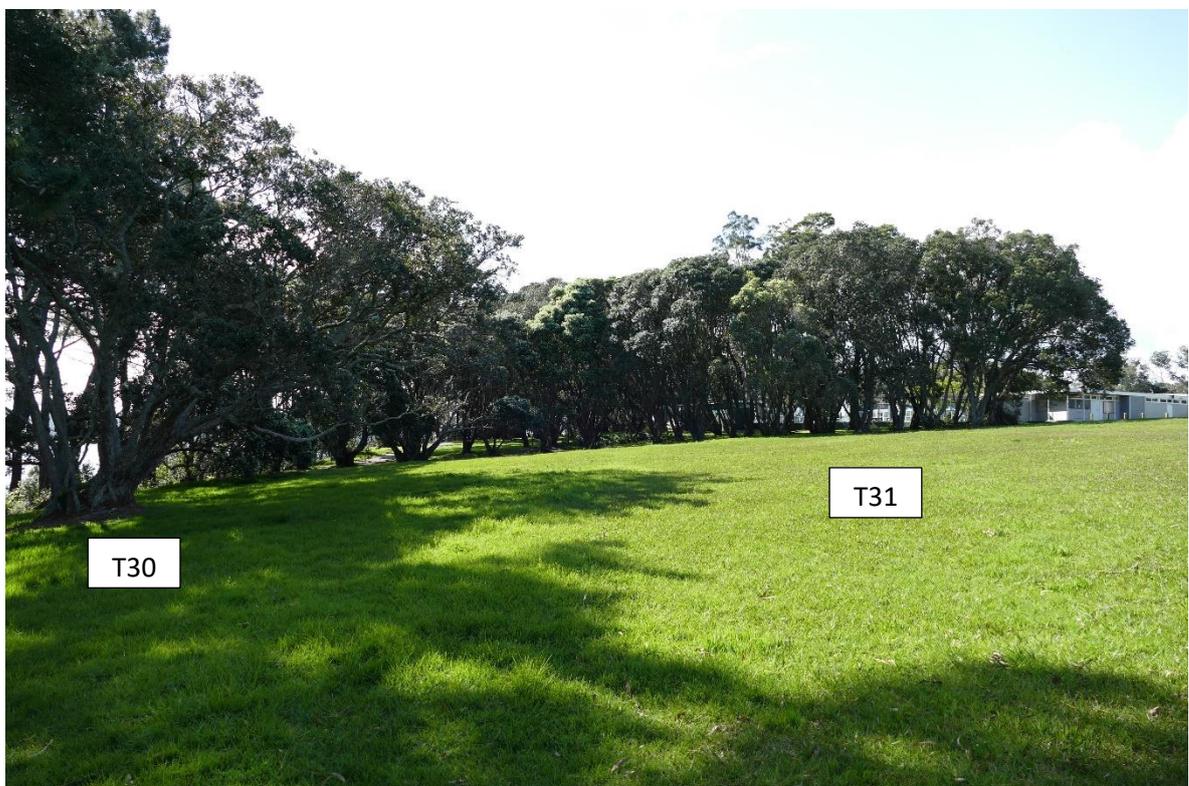
- 5.4 The proposed contractor's yard will occupy a small area of the macrocarpa (Tree 3), pōhutukawa tree group (Tree group 31, Figure 6) and the two oak trees' (Trees 32 and 33) root zone area, and this could be utilised for temporary site offices, dewatering tanks and the Tally Hut and ventilation extraction. Filling or excavation may occur within this area to create a level construction yard. The shaft will be constructed outside of the root zone of this tree group. The area of the root zone, which may be impacted by the establishment of the temporary construction yard, is very small in comparison to the overall root zone area that is within a wide and expansive grassed area. Given the large undisturbed root zone area outside of the contractor's yard and the small proportion of the tree roots that will be disturbed, even with no controls on root loss in the contractor's yard to construct the shaft and other works for establishment, biological effects on tree health associated with the construction area's establishment and shaft construction are expected to be minimal, or perhaps negligible.

Figure 6 – Trees 30 and 31

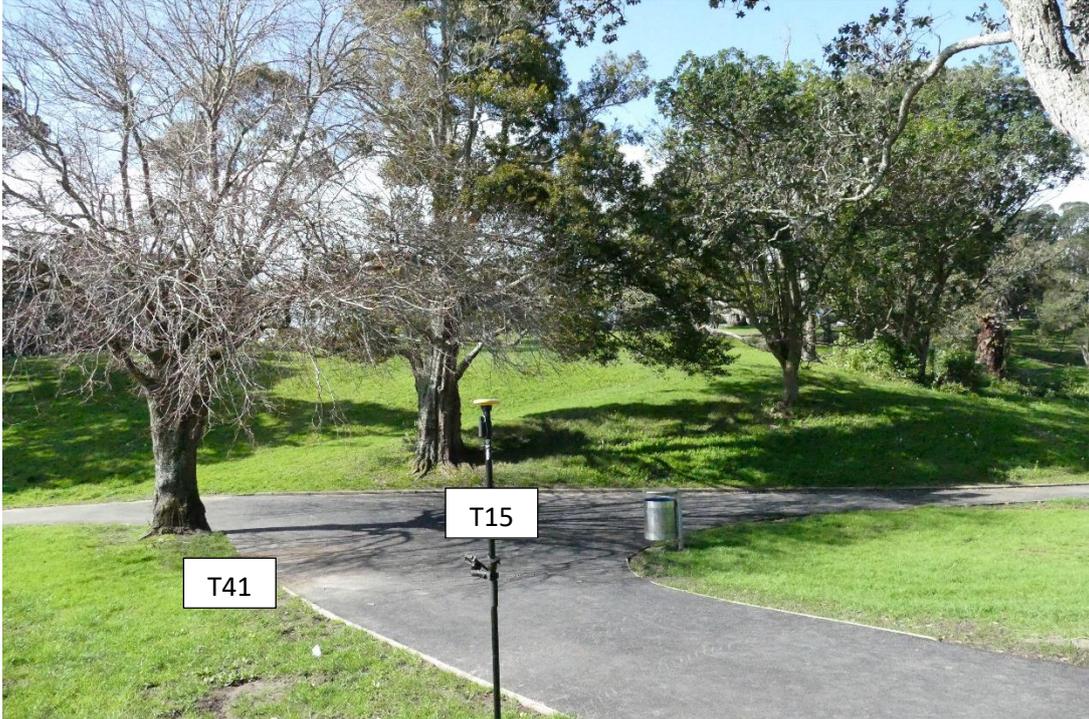
- 5.15 Other tree removal is proposed for the Project, and this comprises tree 12 (tulip tree), and trees 15 and 18 (both Syzygium). Trees 12 and 15 are not directly impacted by the works however they are in sufficiently poor condition, and in the case of the Syzygium trees, are structurally poor due to the presence of fungal fruiting bodies and other tree risk features. Tree 18 is within the footprint of the

works. Their removal is proposed as part of the project, as there is an opportunity to undertake replacement planting of better quality trees, that have a better long-term future.

Figure 7 - Tree 15 (for removal) and 41 (for retention)
