**Huia Water Treatment Plant
Replacement Project**

**Addendum to the Preliminary Land
Stability Assessment Report**

Prepared for
Watercare Services Limited

Prepared by
Tonkin & Taylor Ltd

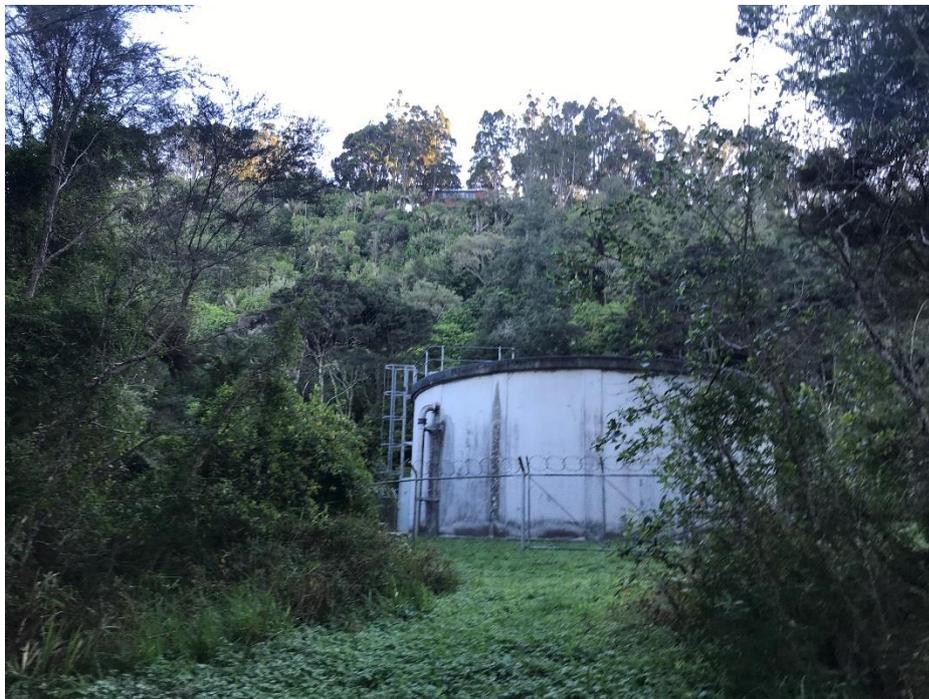
The escarpment behind Reservoir No. 1 and the tunnel shaft is steep and formed within weak to moderately strong volcanoclastic sandstone⁵. The steep nature of the escarpment can be seen in Figures 3.1 and 3.2. The rock forming the escarpment is exposed within the cutting used to form the track known as Exhibition Drive (Figure 3.3).

Figure 3.1: View of the escarpment from the existing tank north of Woodlands Park Road.

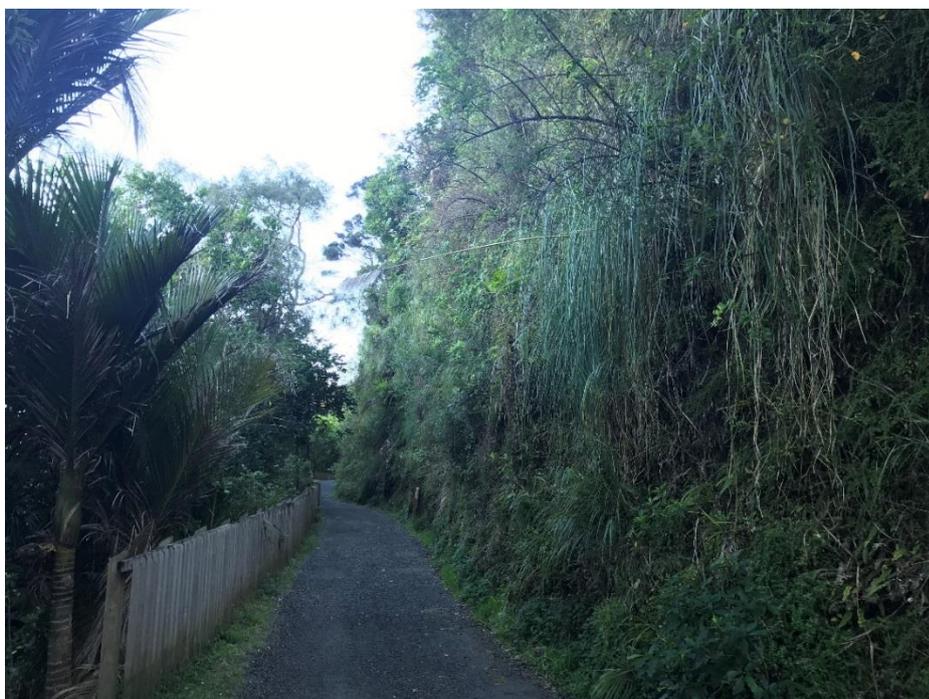
Figure 3.2: Steep cutting upslope of Exhibition Drive behind Reservoir No. 1 location

The stability of the rock escarpment is entirely independent of the proposed development in terms of the proposed development affecting the escarpment. There is however potential for rock falls to send boulders down into the reservoir site. This has happened relatively recently at the nearby abandoned filter station where a security fence was damaged. This is an issue of asset protection that should be accounted for in detailed design.

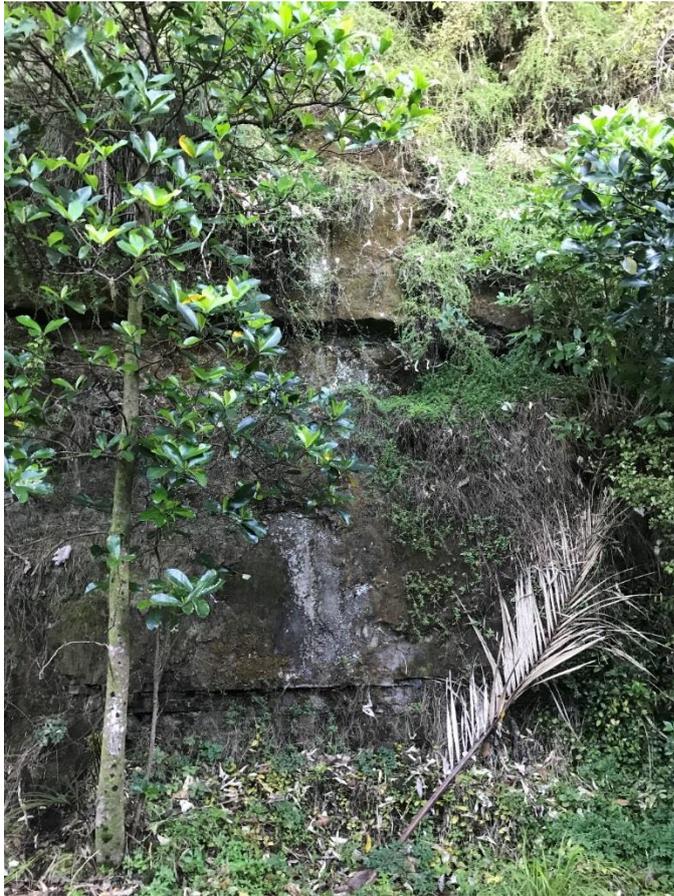
Figure 3.3: Thickly and horizontally bedded volcaniclastic sandstone seen on the inside of the Exhibition Drive cutting immediately upslope of Reservoir No. 1.

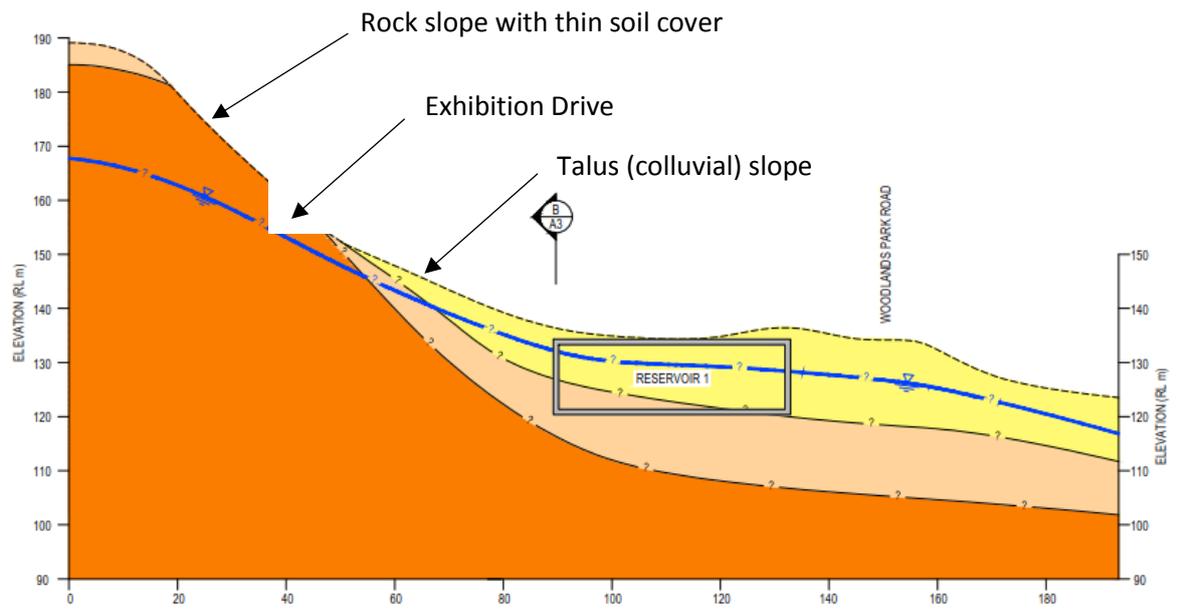
The geological section of the escarpment presented in the AEE and reproduced in Figure 3.4 below reflects the description presented above.

Figure 3.4: Geological section showing the escarpment located north of the Reservoir No. 1 site

The talus slope has formed from the deposition of soil and rock that have either naturally fallen from the escarpment and/or come from the excavation of exhibition drive. Being deposited in this fashion, the talus slope can be considered to be at its angle of repose and therefore marginally stable. That being said, the slope is fully vegetated and site examination did not identify any slope instability other than minor surface soil creep.

There is potential for earthworks undertaken without appropriate controls to initiate slips within the talus slope. It will be necessary as part of the project design and construction that the talus slope be left unaltered or retained where material is removed from its toe.

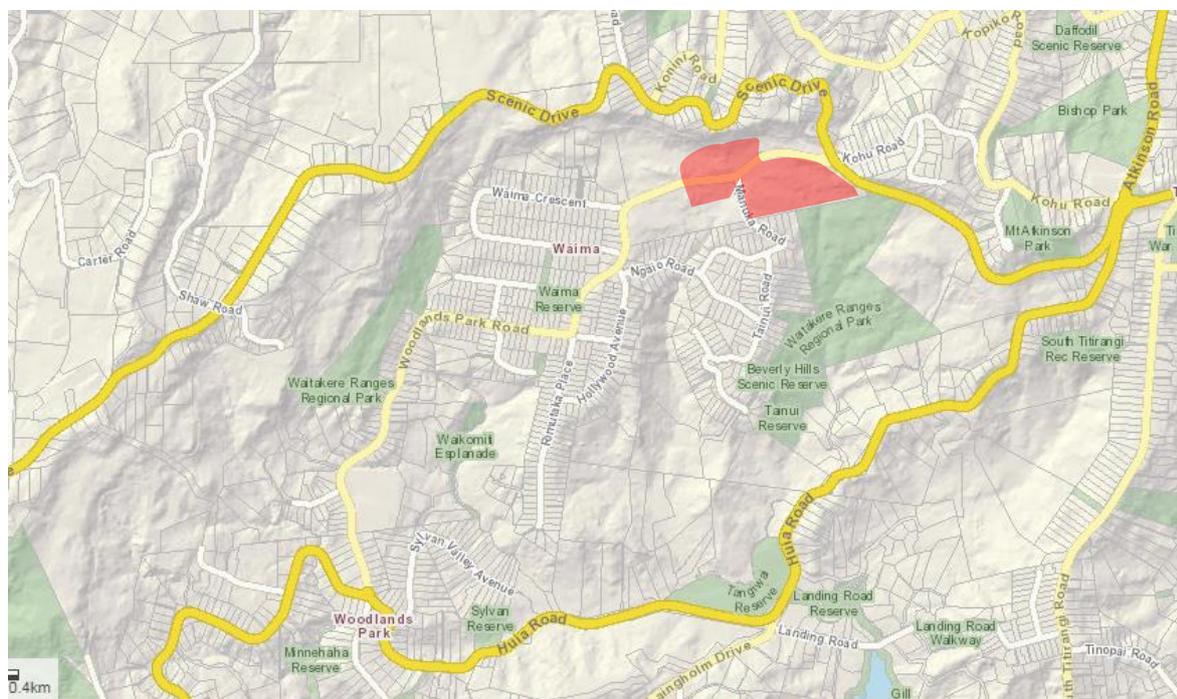
The Groundwater and Settlement Report (Appendix H of the AEE) described the potential presence of a large regional-scaled landslide that had been discussed in a number of previous reports. The escarpment below Scenic Drive can be inferred from the topographic map presented in Figure 4.1 to be the headscarp of a very large landslide approximately 3 km² in area. The proposed WTP site is located at the extreme eastern end of the headscarp. The vast majority of the landslide is located to the west, with the most significant portion being located in the Waitakere Ranges Regional Park.

Figures 4.1: Topographic map showing the likely presence of a very large ancient landslide covering the area between Scenic Drive and Huia Road. The approximate location of the Huia WTP replacement project is indicated in red.

A number of boreholes were drilled into the landslide by Opus as part of their 2013 investigation. None of these boreholes encountered evidence of landsliding, although they were only 15 m deep. A future site investigation could potentially gain information of the location and nature of the landslide through the drilling of one or more deep boreholes.

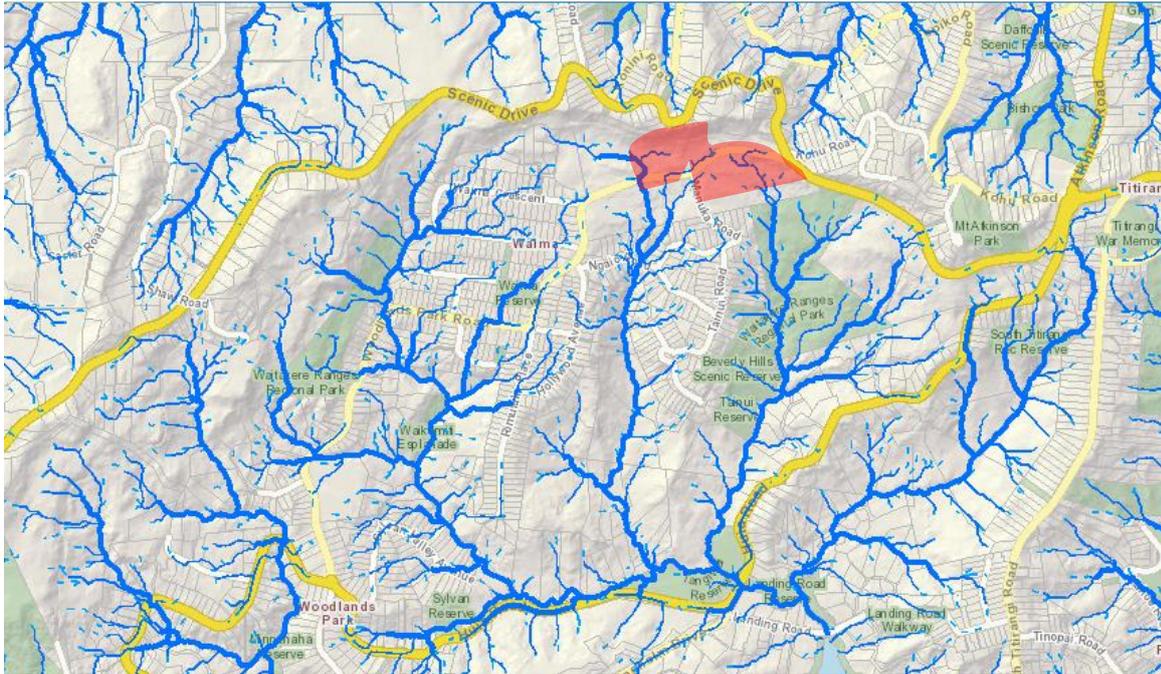
The landslide is considered to be an ancient (dormant) feature that does not represent a realistic hazard to the proposed WTP. Evidence for stability includes the pattern of drainage channels cross the surface of the landslide (Figure 4.2). The fact that such a well-established drainage pattern has developed is indicative of a landslide that is probably many thousands of years old. Furthermore, there are no offsets to the pattern that would indicate any movement of the landslide since its initial formation. The landslide is not actively being eroded at its toe by a river, a common source of ongoing instability within ancient landslides.

Figure 4.2: Drainage patterns developed over the surface of the ancient landslide.

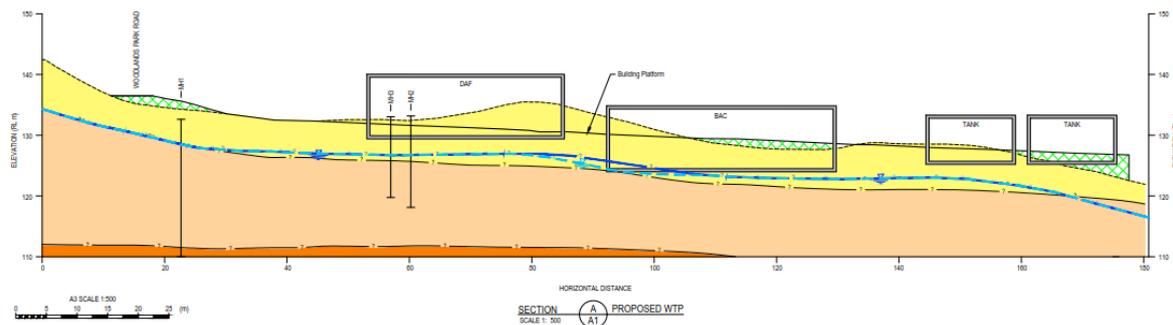
The replacement WTP is located on a gently sloping site (Figure 4.3). Other than temporary cut slope stability, we consider that there are no slope stability issues that require assessment at this stage, although detailed design will need to account for the long term stability of the slopes below Woodlands Park Road (presumably by retaining walls) and the stability of the fill platform at the southern end of the site. The analysis of very similar geology at the existing WTP demonstrates that such development is possible without inducing slope instability (see Section 4.4)

Figure 4.3: Replacement WTP profile.

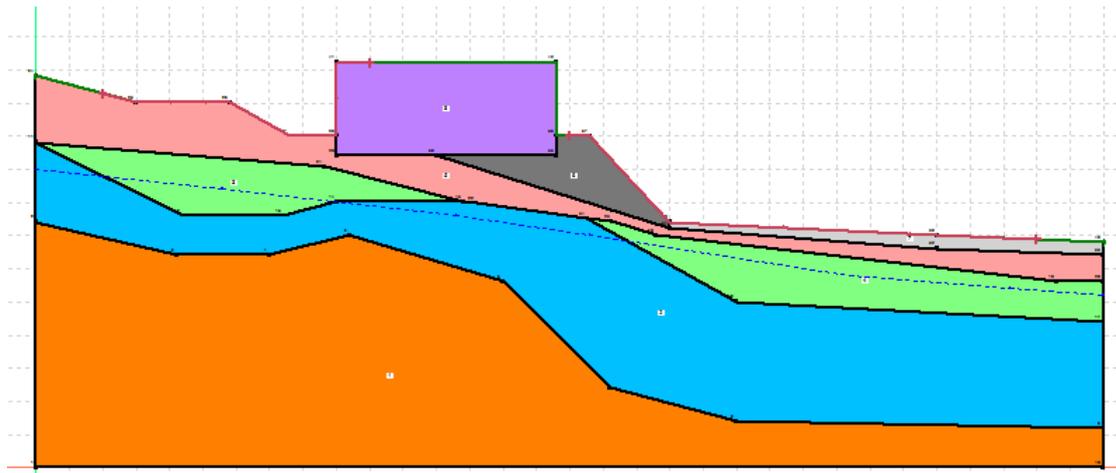
Indicative stability analyses have been undertaken for the same geological section modified to include Reservoir No. 2 and the proposed fill embankment (Figure 4.4). The results of the analyses (Figures 4.5 to 4.9) returned similar results as the 2010 analyses and therefore confirm the suitability of the site for the proposed development. The removal of the underlying colluvium and/or the use of higher strength reinforcement could readily increase the stability of the fill should this be required/desired.

These results are considered conservative as they do not take into account the presence of any deep foundations constructed to support Reservoir No. 2 nor the removal of colluvium from beneath the fill embankment.

Figure 4.4: 2D slope stability model of Reservoir No. 2. See Figure A2 for geological units

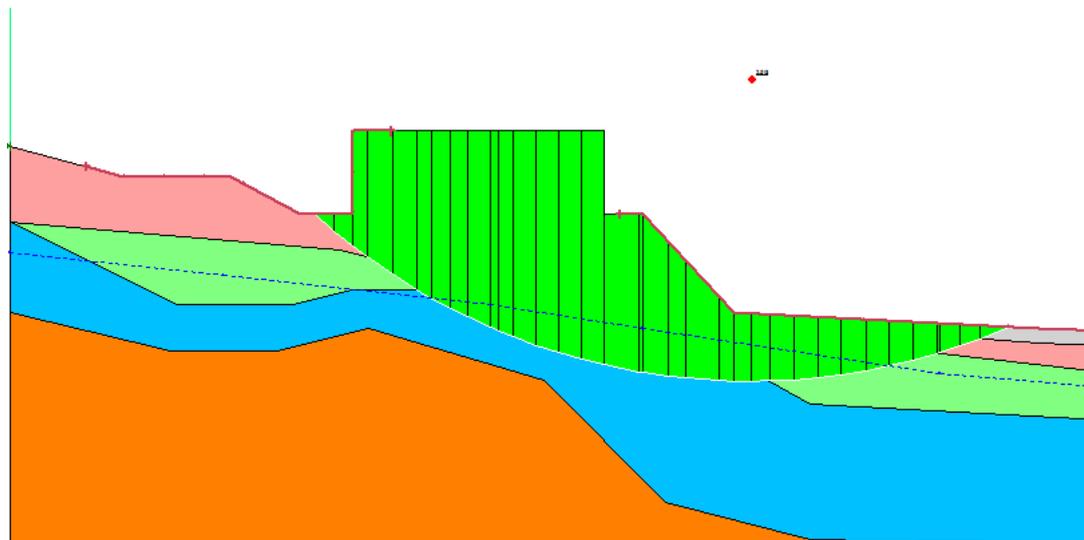
The then-proposed development was broadly similar to that currently proposed with Reservoir No. 2. Slope stability assessments undertaken in 2010 showed that the Reservoir No. 2 site had a static Factor of Safety of 2.4, well above the typically required minimum of 1.5. Under the design earthquake loading of 0.31g, the site's FoS reduced to 1.1. Typically, a FoS of 1.0 to 1.1 is adequate under seismic loading, depending upon the magnitude of induced displacement. The slope was also reported to have a high FoS under elevated groundwater conditions.

Figure 4.5: 2D static slope stability analysis for Reservoir No. 2 (FoS=2.4)

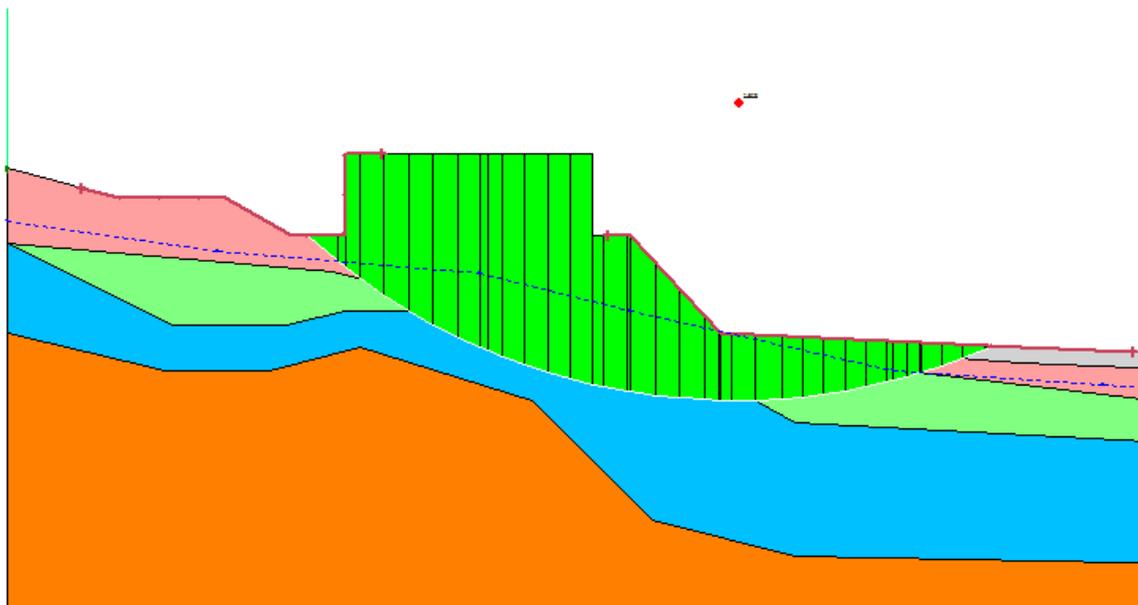
Figure 4.6: 2D static slope stability analysis with elevated groundwater conditions (FoS = 2.0)

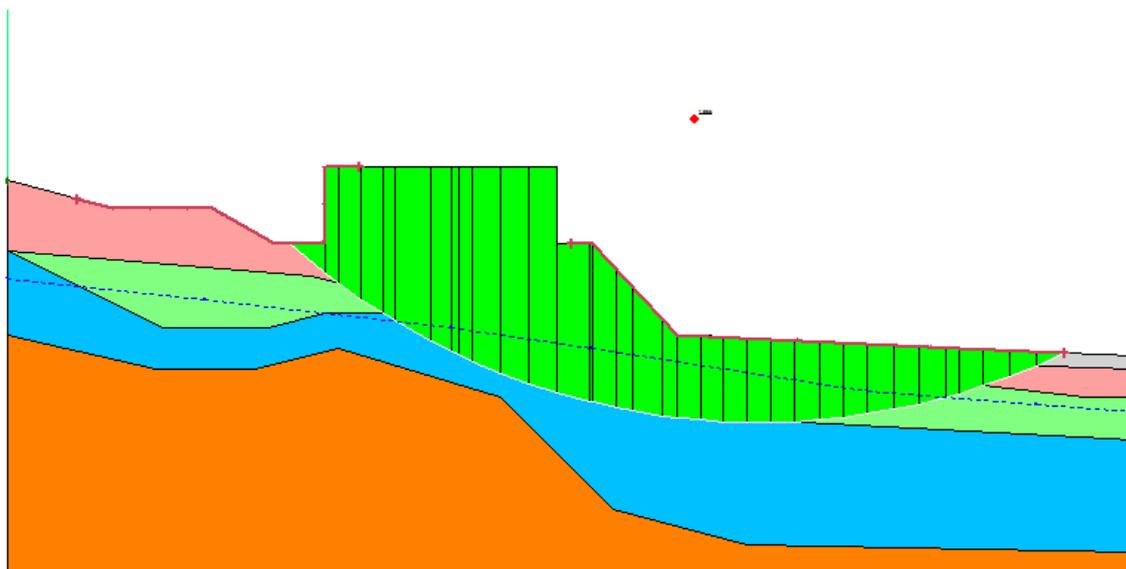
Figure 4.7: 2D seismic slope stability analysis for Reservoir No. 2 (FoS=1.1)

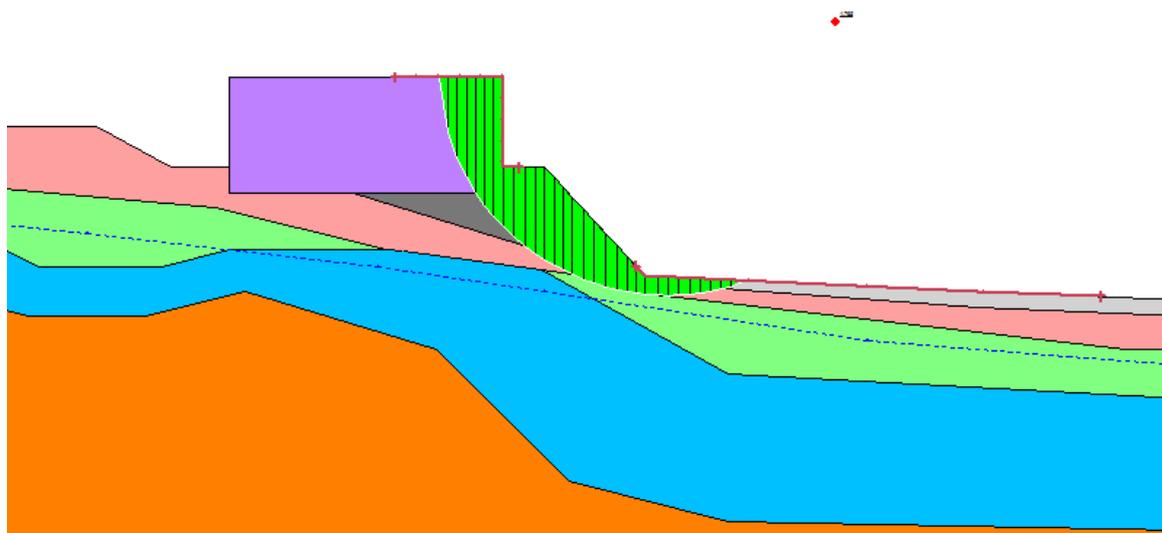
Figure 4.8: 2D static slope stability analysis for the fill in front of Reservoir No. 2 (FoS = 1.77)

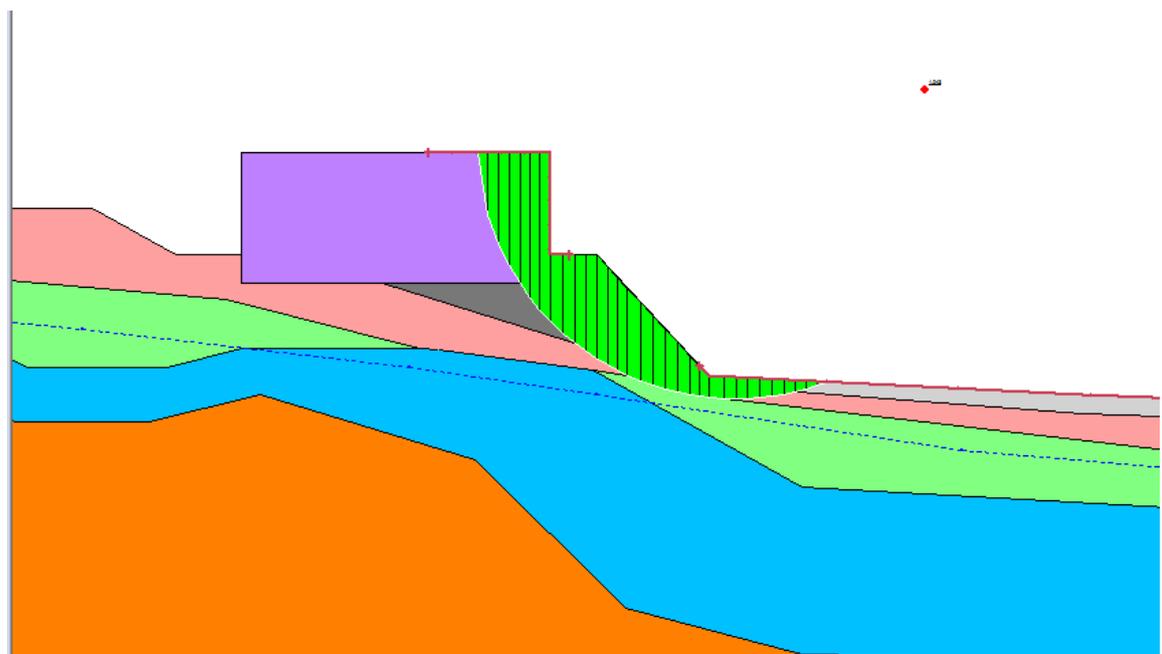
Figure 4.9: 2D seismic slope stability analysis for the fill in front of Reservoir No. 2 (FoS = 1.04)

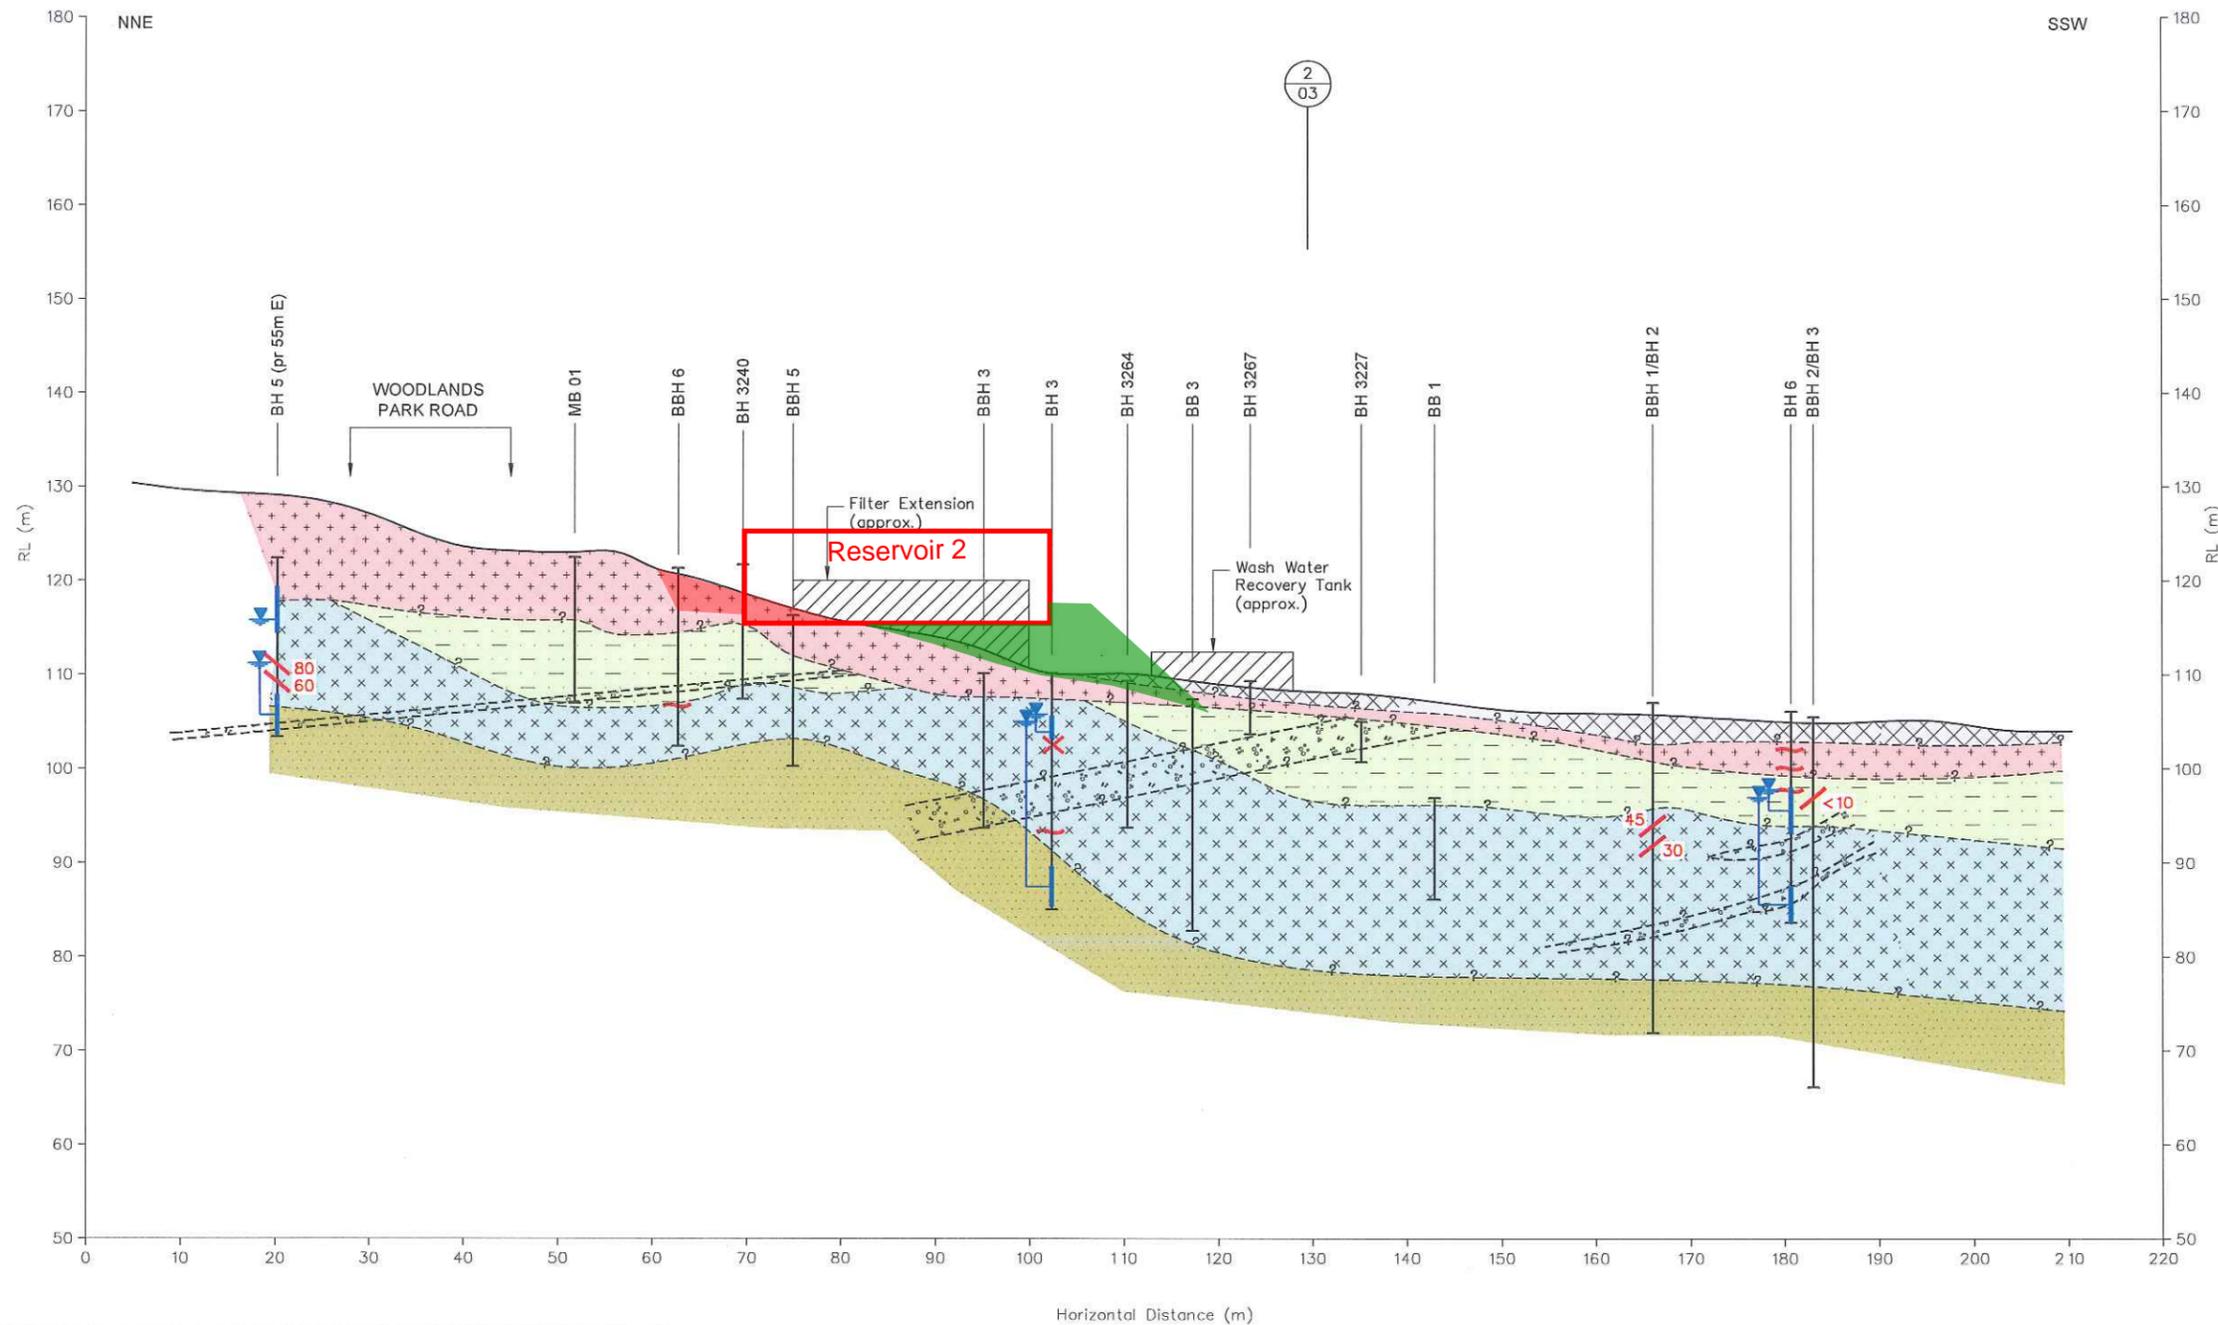
A geological long section was constructed through what is now the proposed Reservoir No. 2 site in 2010. This is presented as Figure A2 (Appendix A). This figure has been modified to show the proposed location of Reservoir No. 2 and the fill embankment proposed to form part of the building platform.

Figure A2 show the same fundamental stratigraphy presented in T+T (2010) with up to 5 m of fill and colluvium overlying variably weathered Cornwallis Formation volcanoclastic sandstones and conglomerates. Slightly weathered rock is encountered at a depth of approximately 15 m below ground level. The contacts between the geological/weathering units dips to the south approximately parallel to the ground surface.

Standard elastic compression calculations show that under a 10 m thickness of engineered fill, 50 mm of consolidation can be expected for each metre of colluvium and 20 mm for each metre of completely weathered to highly weathered Cornwallis Formation. Adopting the geological profile used in the stability analyses (2 m of colluvium and 2 m of Cornwallis Formation soil), 10 m of fill is expected to result in a settlement of 150mm.

Settlement of the indicated magnitude is in excess of what would be acceptable for a structure such as Reservoir No. 2. This can be addressed by either removing the colluvium prior to construction or the installation of pile foundations that penetrate to rock. Preloading the site is also a possibility depending on the available construction programme, although potentially detrimental effects on the stability of the slope will likely preclude this as a ground improvement option.
