REPORT 7534

Watercare Services Ltd

Huia Water Treatment Plant Rebuild
Preliminary Geotechnical Assessment

January 2010

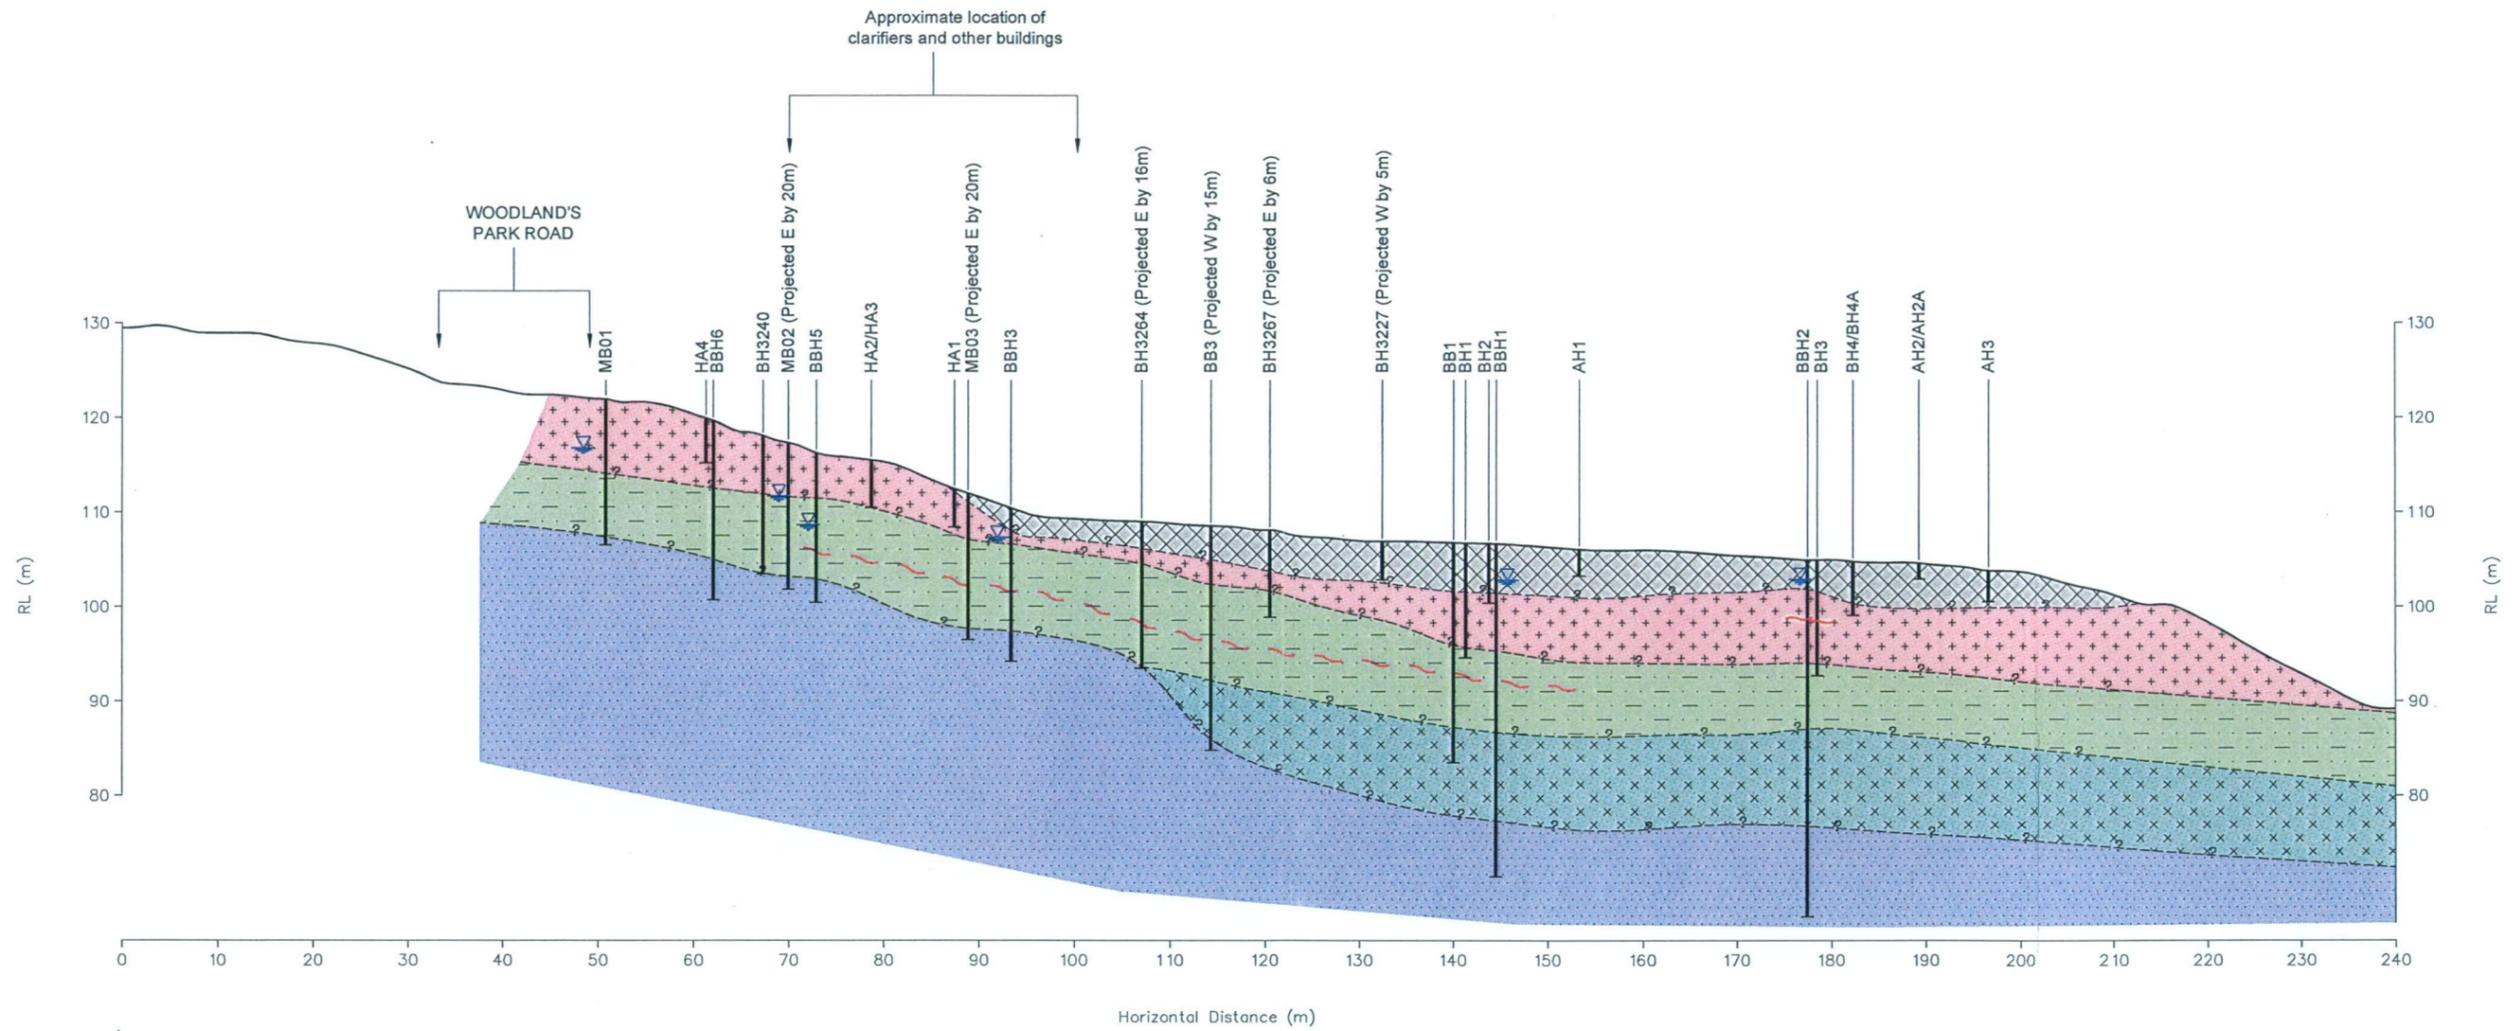
Geological Section - Drawing 27064-01

These logged zones of potential historical movement have been noted on the cross section developed in drawing 27064-01. The potential for a continuous shear surface made up of these intersections in borehole core is a key risk to the site and is addressed further in Section 4 below.

Our geological model for the site is illustrated in drawing 27064-01. The site is covered by a upper layer of colluvium between 5 and 7m thick, overlain on the lower slopes by placed fill, which is up to 5m thick.

- Case A: No continuous shear surface
- Case B: Continuous shear surface as indicated in drawing 27064-01.

- The geological model outlined in drawing 27064-01 has been developed from the existing data. It comprises fill on the lower slopes, overlying up to 8m of Colluvium, in turn overlying completely to highly weathered Cornwallis Formation which has soil strengths. Depths to the underlying slightly weathered Cornwallis Formation rock mass range between 15m (upper slopes) and 27.5m (lower slopes).
