# Whenuapai Wastewater Servicing Scheme Package 1

## Ecological Impact Assessment

Prepared for Watercare Services Ltd  
Prepared by Beca Limited

5 September 2022

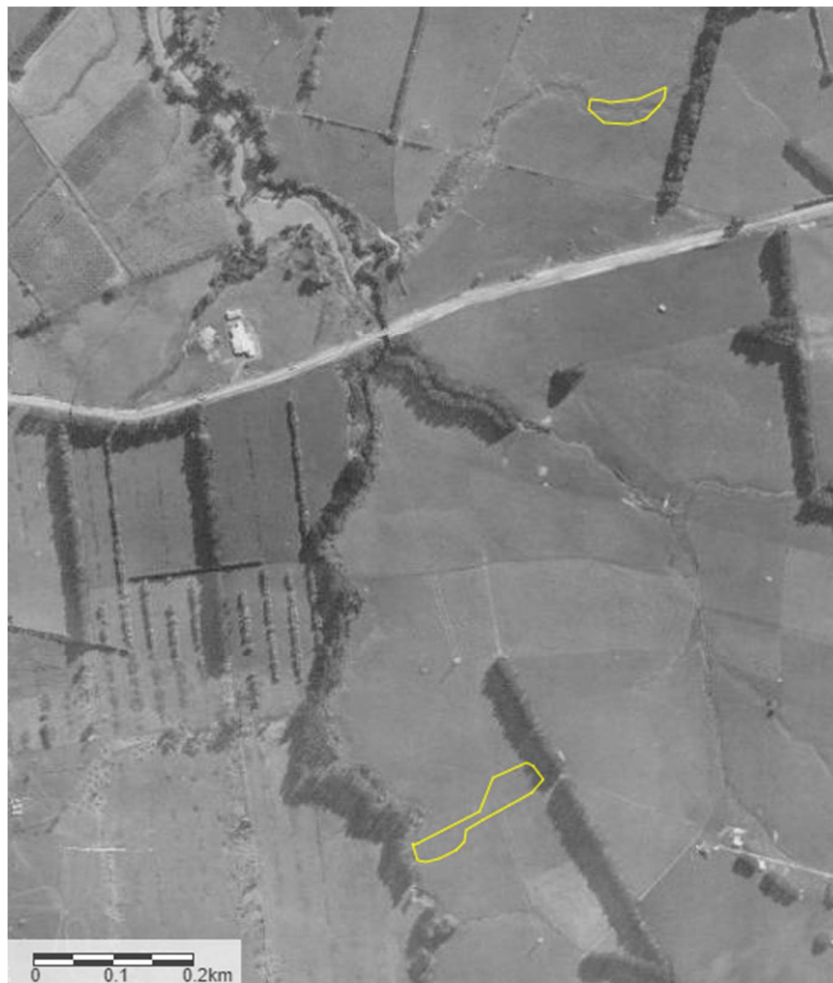
Figure 5. Aerial imagery from 1959 showing approximate locations of potential wetland areas (sourced from Auckland Council Geomaps, accessed 28/7/2022).

Neither of the two areas are modelled as historic wetland (Ausseil et al., 2008; Leathwick et al., 2010). In historic aerial imagery from 1959 (Figure 5), Potential wetland 1 consists of a stream channel and potential adjacent riverine wetland vegetation located within the floodplain. Potential wetland 2 consists solely of pasture in 1959, however since this time the area has been excavated for a silage storage area and drainage channel. This excavation has subsequently formed an area of contour depression.

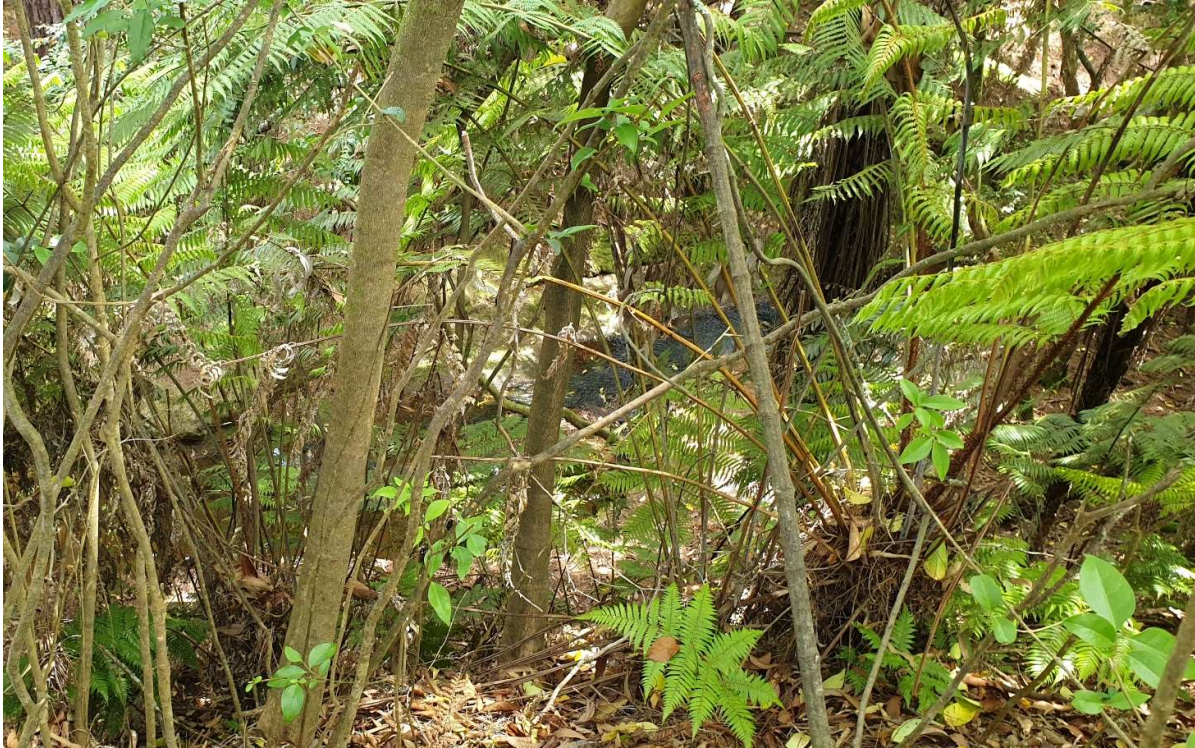
Figure 7: Riparian vegetation at the proposed emergency overflow location at Sinton Stream. Image taken during Beca site visit 3 December 2021.

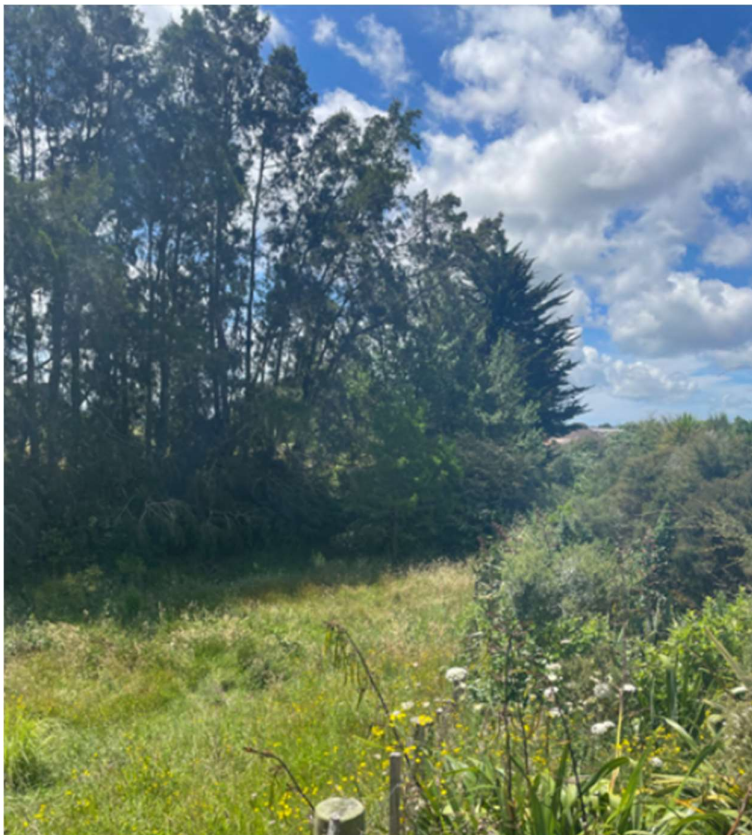
Figure 8: Slaughterhouse Stream riparian area. Image taken during Beca site visit 3 December 2021.

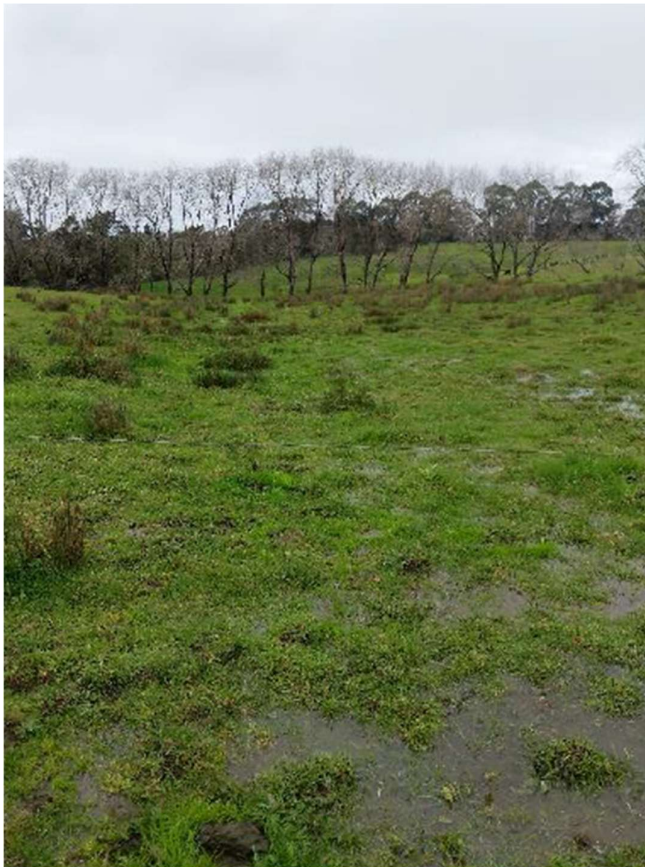
Figure 9: Wetland A surface water observable (Tonkin & Taylor Ltd, 2021).

The wetland is within a slight topographical depression, which may be a historic tributary or flow path to the Sinton stream. The wetland area is highly modified and degraded as it is in a paddock with unrestricted stock access. Exotic pasture grasses form the dominant cover (~88%), *Juncus edgariae* (~10%), and *Ranunculus repens*, *Plantago major*, *Trifolium repens*, and *Rumex obtusifolius* (~2%) (see Figure 2).

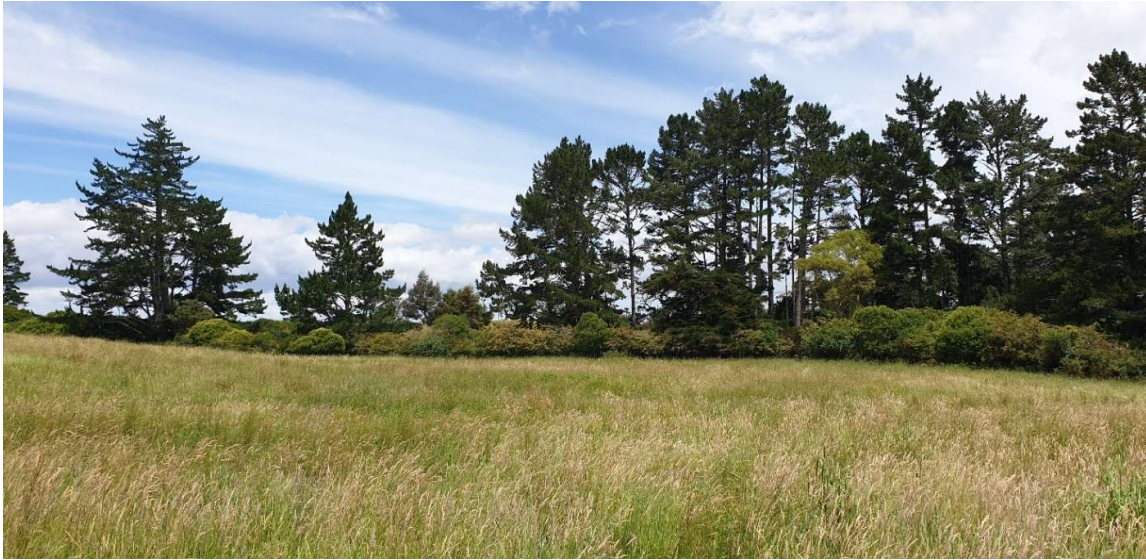
Figure 10: Area surrounding Wetland C looking towards Sinton Stream. Image taken during Beca site visit 3 December 2021.

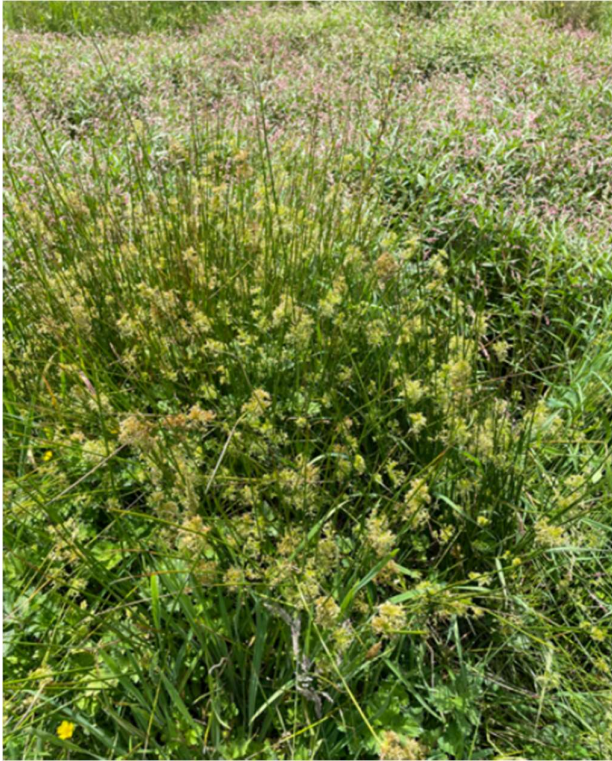
Figure 11: Wetland C vegetation (inclusive of *Juncus edgariae*, *Pericaria decipiens*, *Ranunculus repens*). Image taken during Beca site visit 3 December 2021.

the extent of presence of wetland vegetation Wiwi (*Juncus edgariae*). This wetland is dominated by exotic grasses, *Persicaria decipiens*, and Wiwi. It is ephemeral, in terms of that it expands and contracts in extent seasonally based on hydrological conditions.

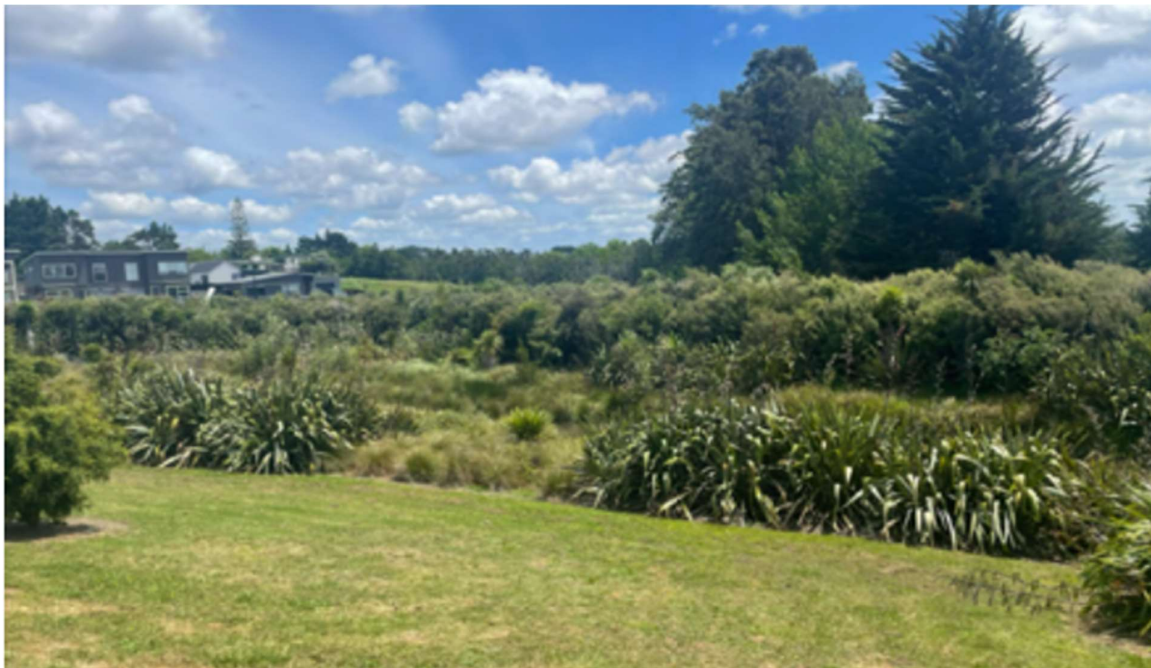
Figure 12: Mixed native vegetation looking south from pump station locality. Image taken during Beca site visit 3 December 2021.

Vegetation present at the Project site comprises indigenous and exotic species (moderate representativeness), common weedy species along with native species with one species having 'At Risk – Declining' conservation status (moderate rarity/distinctiveness, low diversity and pattern). The vegetation present also forms a buffer from surrounding agricultural activities and an ecological corridor for freshwater fauna (moderate ecological context).

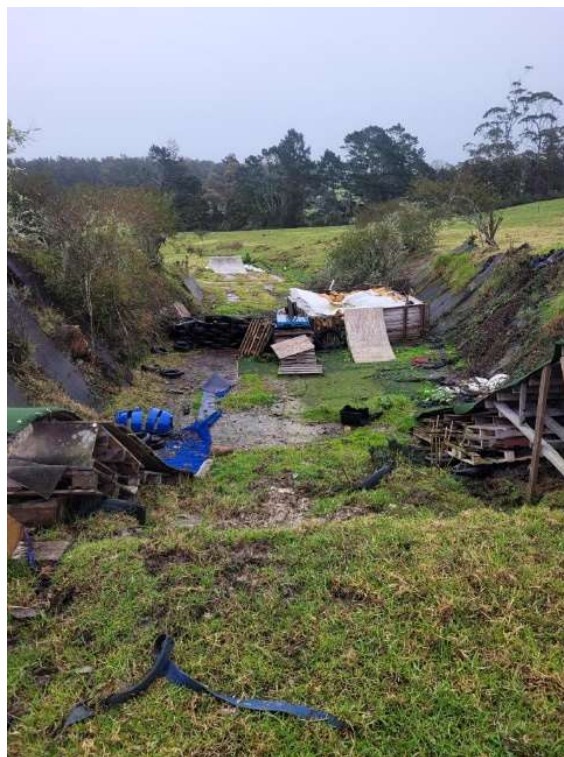
Figure 14; Image of excavated storage area taken during site visit on 5<sup>th</sup> July 2022.

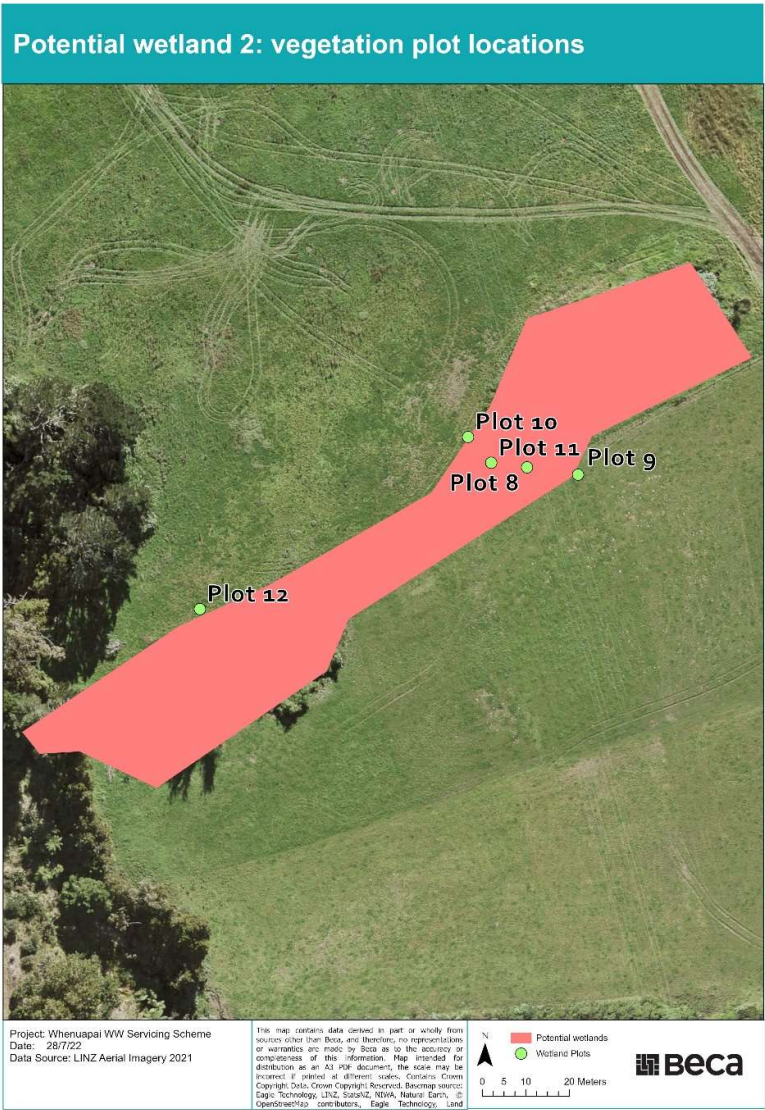
Figure 15: Locations of vegetation plots completed within, and adjacent to, Potential Wetland 2.

Plot 11 was located within a localised depression of pooled water, dominated by Water pepper and Mercer grass (refer Table 14). This plot passes the vegetation tests and has surface water present (primary indicator of hydrology; 1A). As this area is formed within a constructed watercourse it is a localised constructed wetland.

Plot 12 was located further west along the drainage channel, dominated by broad-leaved plantain and creeping buttercup. This plot failed the vegetation test, had had saturated soils (primary indicator of hydrology; 1C) with clay mottling. However, as it is likely that soils were only saturated due to recent rainfall, and no FACW or OBL species were present within the plot or surrounding area, this is assessed as non-wetland.

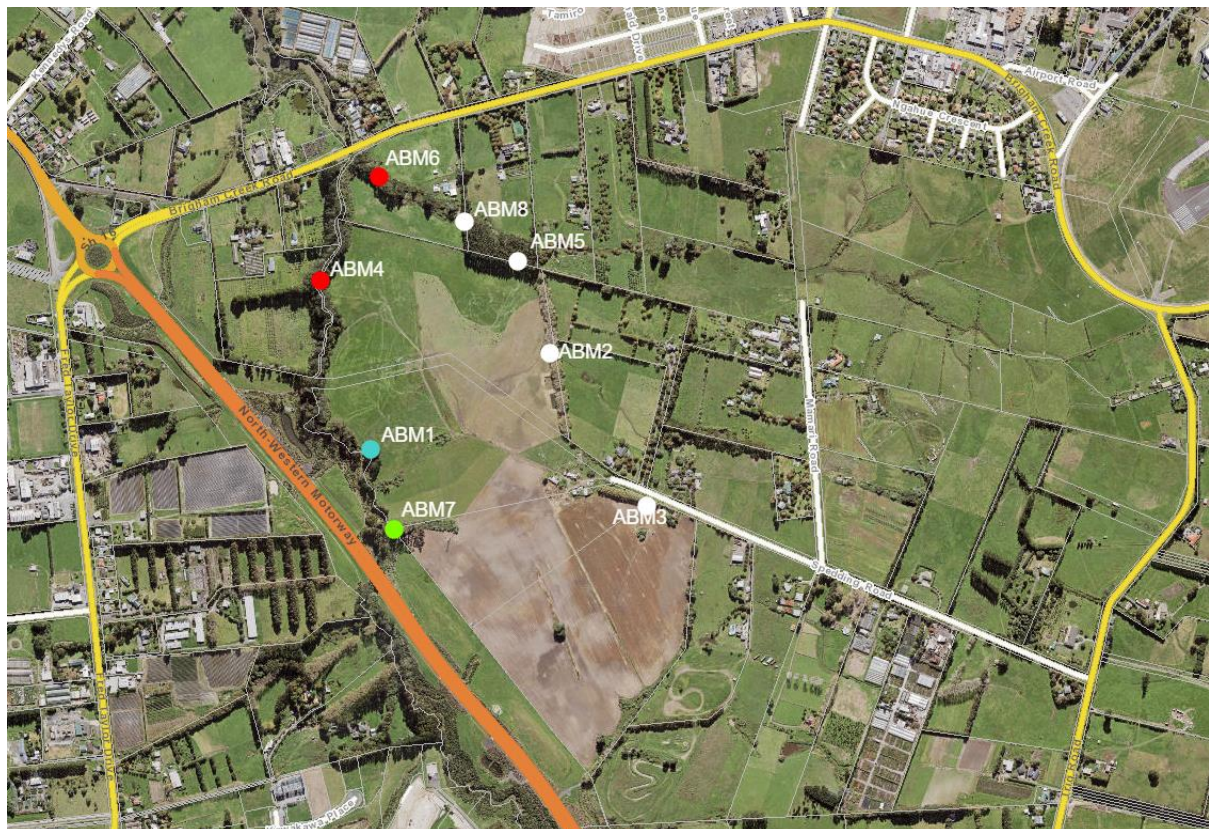
*Figure 3.1: Automatic Bat Monitor deployment locations (dots). Bat activity detection on a valid night indicated in green, bat activity detection on a technically invalid night in blue, no bat activity detected indicated in white, and automatic bat detectors failure and faults indicated in red.*

The recordings were processed using an automated AI-based tool<sup>12</sup> which identified long-tailed bat recordings. Results were then manually checked for quality assurance purposes using the DOC BatSearch 3.11 programme.

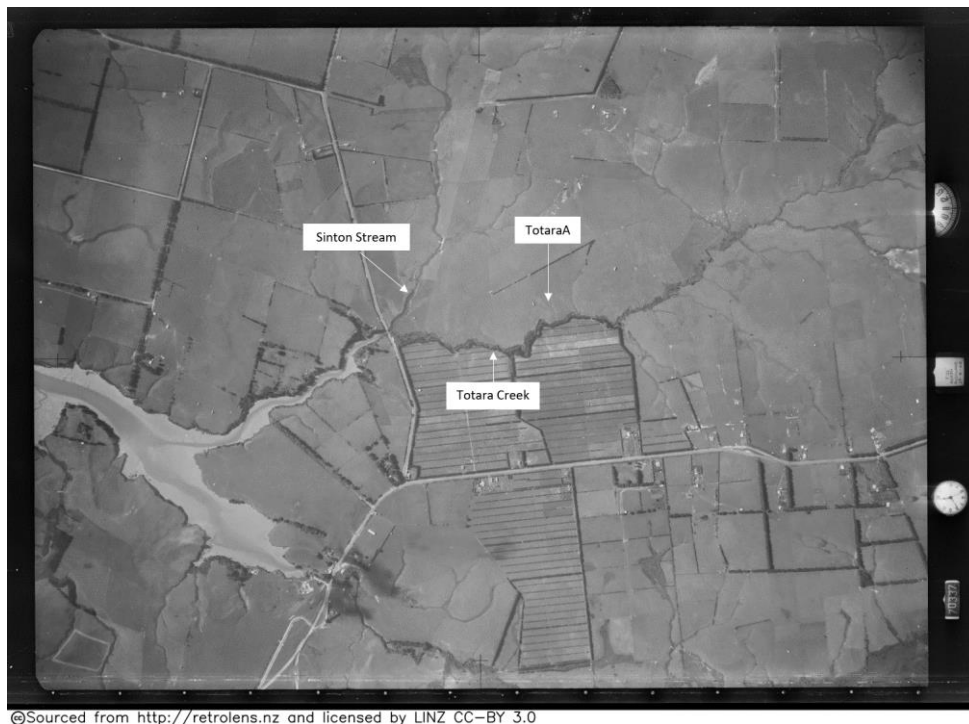
*Photograph Appendix E.1: Spedding Block aerial photograph taken on 23/04/1940. The natural extent of TotaraA prior to artificial modification (Retrolens).*

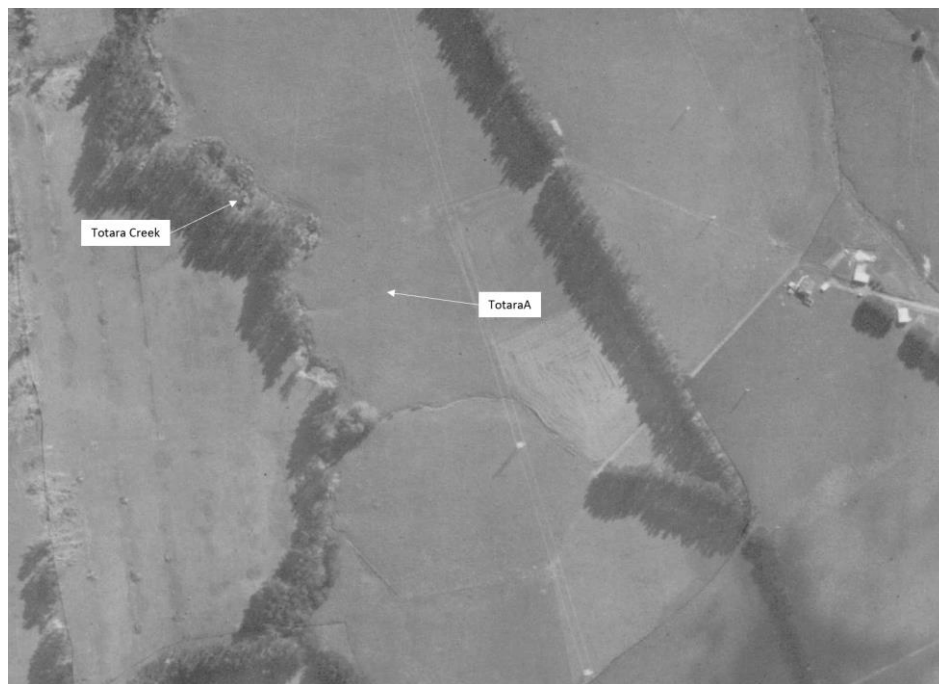
*Photograph Appendix E.2: Spedding Block aerial photograph taken in 1959. The natural extent of TotaraA prior to artificial modification (Auckland Council GeoMaps).<sup>43</sup>*
