# **Watercare Services Limited**

## **Whenuapai Redhills Wastewater Package 1 Geotechnical Interpretive Report**

March 2021

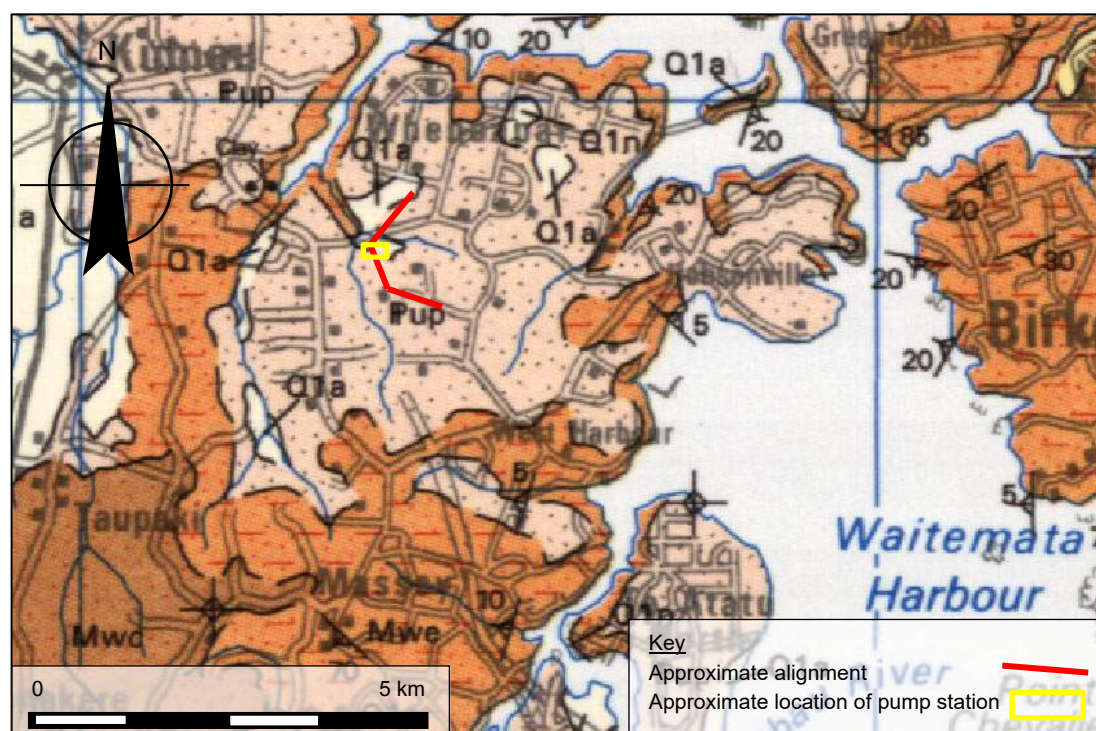
**Figure 3 Extract from 1:250,000 geological map**

The 1:250,000 Geological Map of Auckland (Edbrooke 2001) shows the gravity sewer main to straddle the geological boundary of Tauranga Group Alluvium and Tauranga Group Puketoka Formation. The rising main is shown to be underlain by the Puketoka Formation only. An extract of the geological map is presented as Figure 3 with the units identified with their corresponding map descriptions in Table 1. It is noted that the 1:250,000 map presents the same geology as the 1:50,000 published geological map.

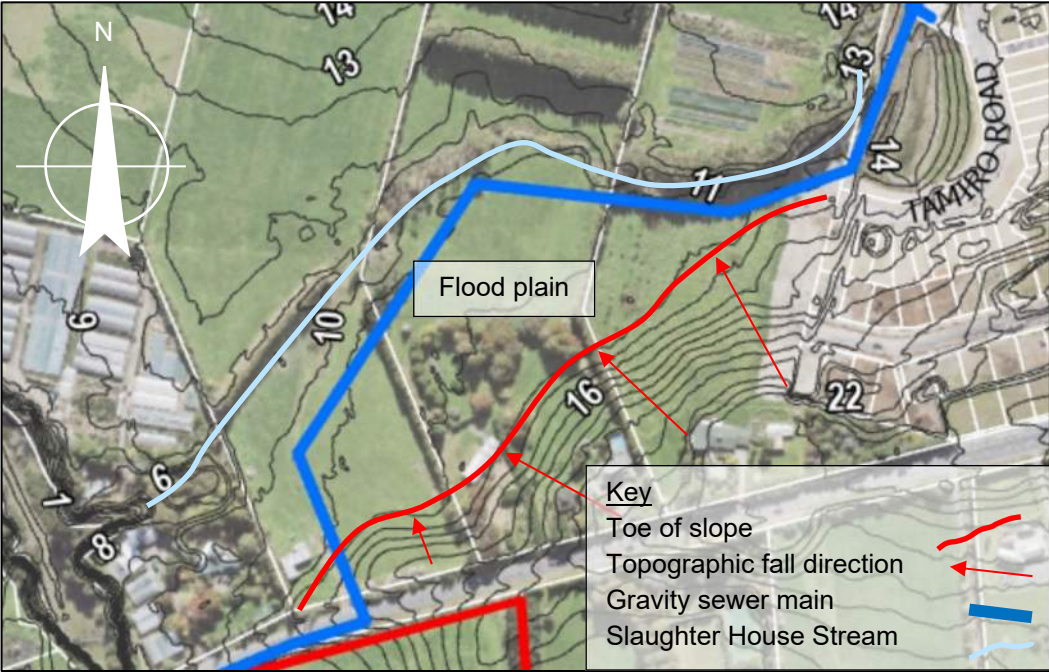
**Figure 5 Gravity sewer main between CH 167 and CH 647 geomorphology**

- Brigham Creek Road is level with the surrounding topography along the northern side of the road. The southern side of the road is however formed by an approximately 30° 1.5 m high batter when compared to the adjacent topography. It is therefore expected that the road is founded on a fill batter approximately 1.5 m deep along the southern edge thinning to ground level along the northern side of the road.

possibly include colluvium from the gentle slope above to the south. The alignment through this area is presented as Figure 5 below. The geology within this area is expected to be highly variable.

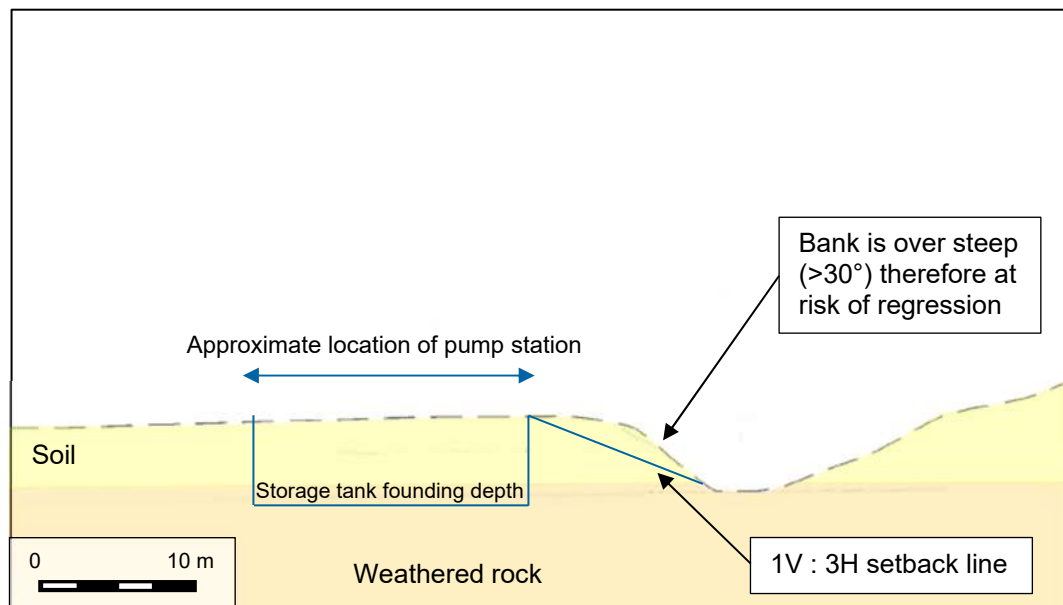
**Figure 6 Cross section through pump station**

The underlying geological profile at the pump station comprises Tauranga Group alluvium to approximately 2.5 m depth followed by residual ECBF soils grading to weathered rock at 4.0 m bgl. The proposed elements of the pumping station are typically founded at depths greater than 4.0 m bgl therefore will be embedded into weathered rock.

Weathered rock poses a small risk of instability. However, it is possible that the crest of the Sinton Stream banks will regress with time possibly exposing the buried tanks. A cross section through the pump station and Sinton River is presented as Figure 6 and shows the stream banks and an assumed 1 V (vertical) to 3 H (horizontal) regression slope angle.

It is recommended that the pump station be set back 6 m from the crest of the slope to allow for the regression of the slope.

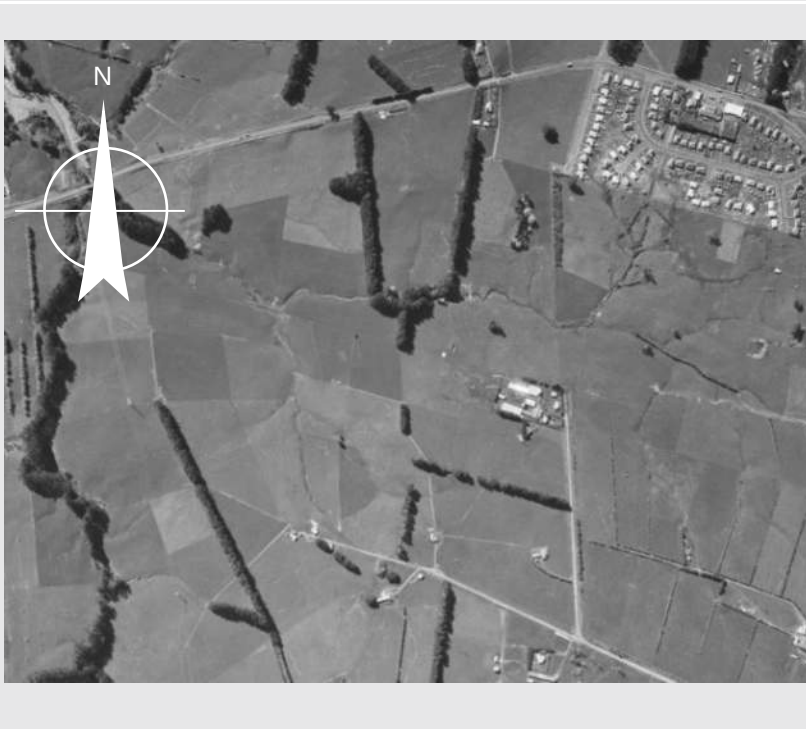
| Historical Aerial Photographs | Comments |
|---|---|
| | <p><b>1961 – Retrolens (unknown SN)</b></p> <p>Housing at NE end. Growth of vegetation (trees). Additional roads down the southern end</p> |

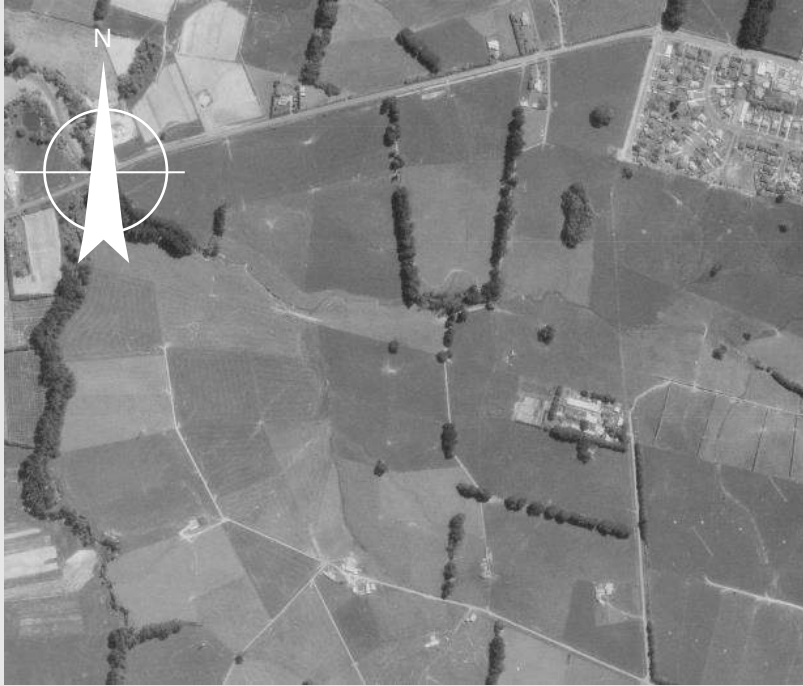
#### 1980 – SN5783 - Retrolens

Removal of vegetation at SW end replaced with extended roads down the southern end

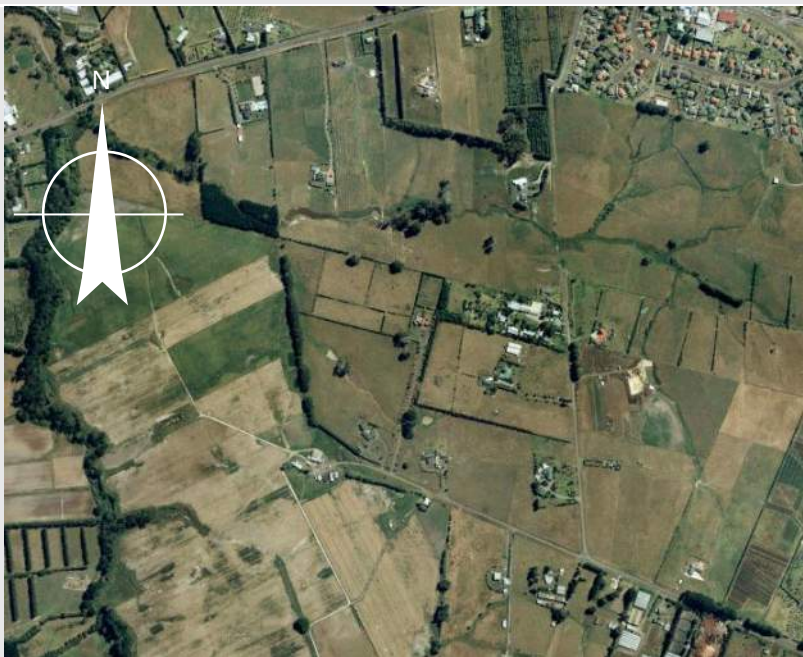
#### 2000– Auckland Council GeoMaps

Clearer distinctions in property of lands through vegetation, fencing, crops, etc. More buildings/houses scattered around the area. New growth and removal of vegetation at the eastern ends

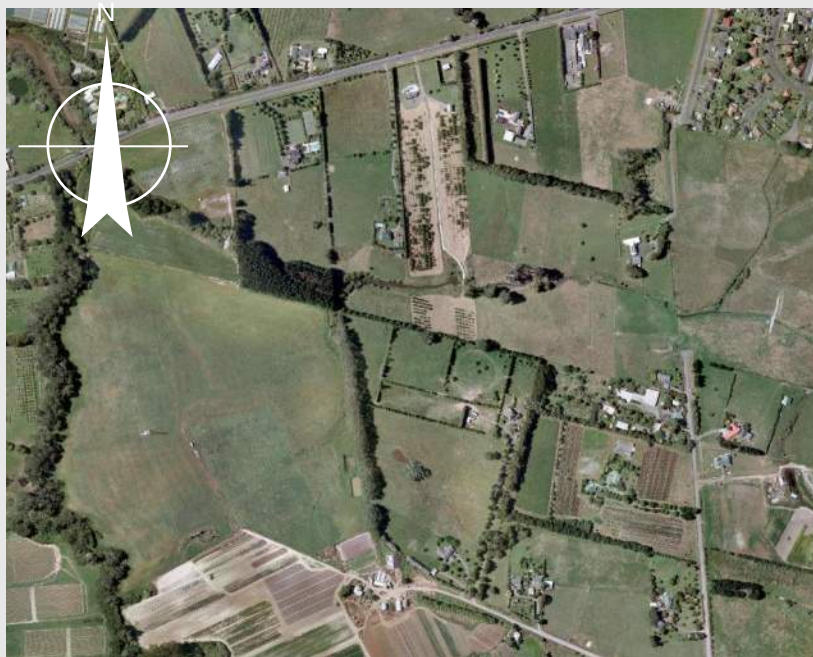
**2008 – Auckland Council  
GeoMaps**

No significant changes

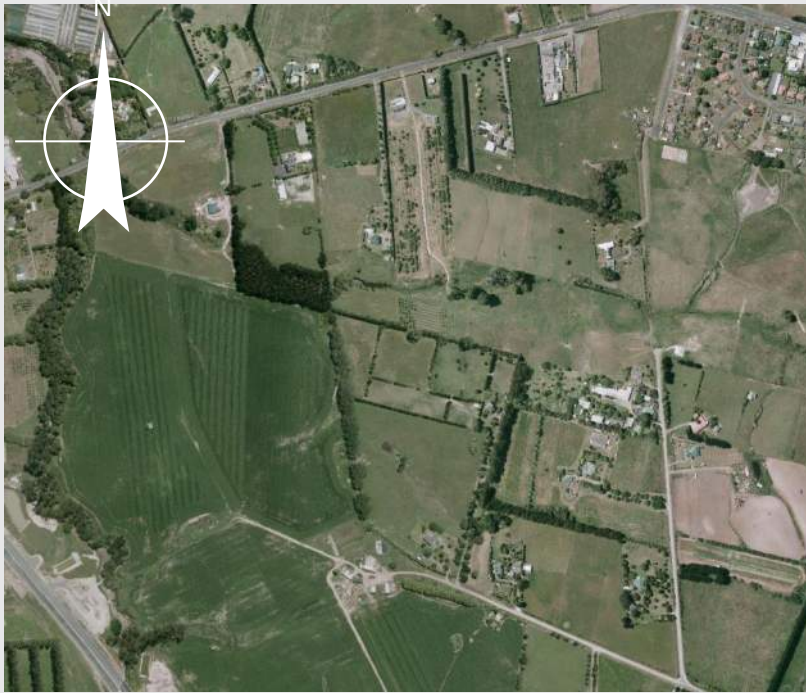
**2010-11 – Auckland  
Council GeoMaps**

No significant changes

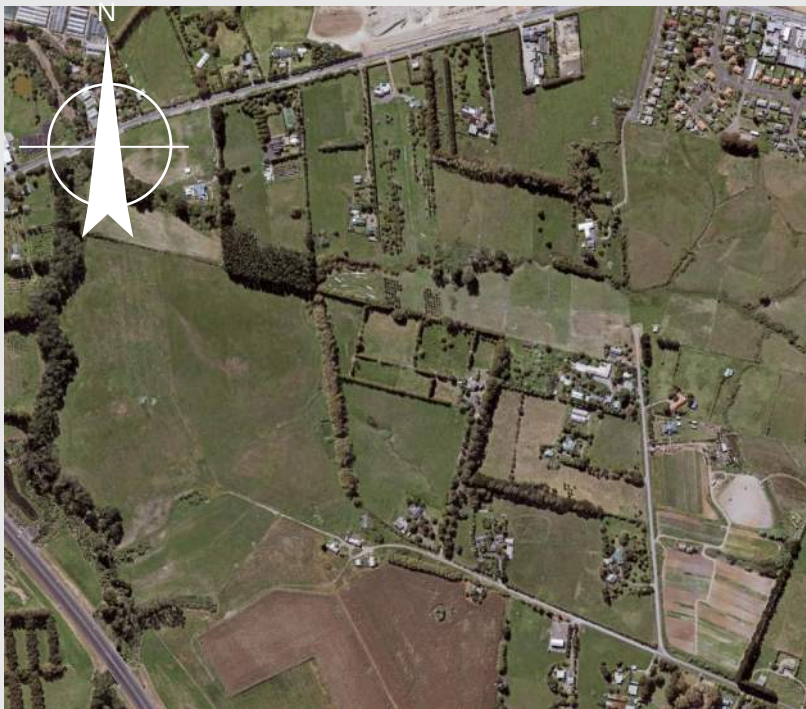
**2015-16 – Auckland  
Council GeoMaps**

No significant changes

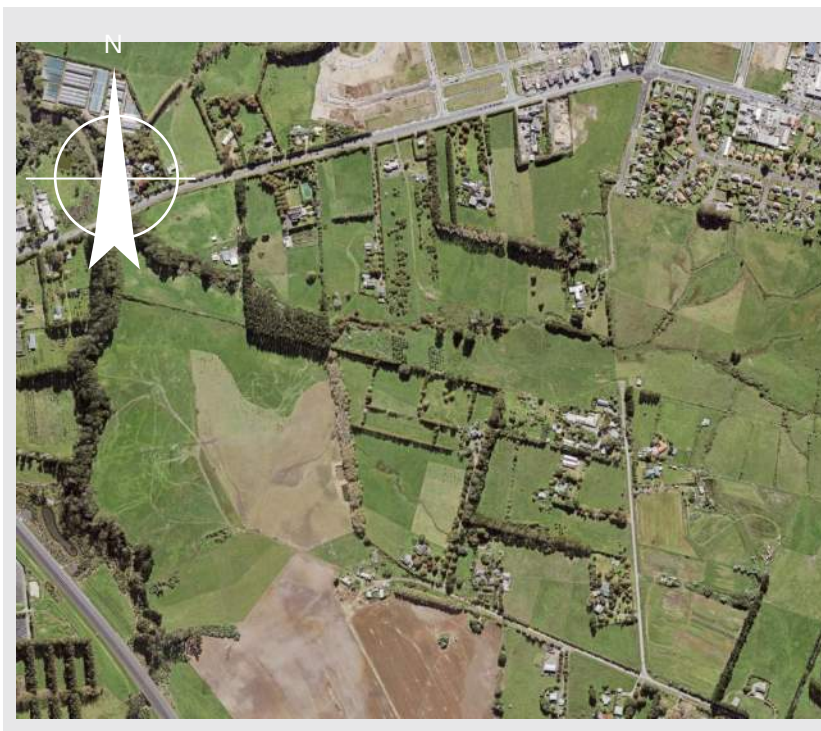
**2017 – Auckland Council  
GeoMaps**

Latest available aerial shot.

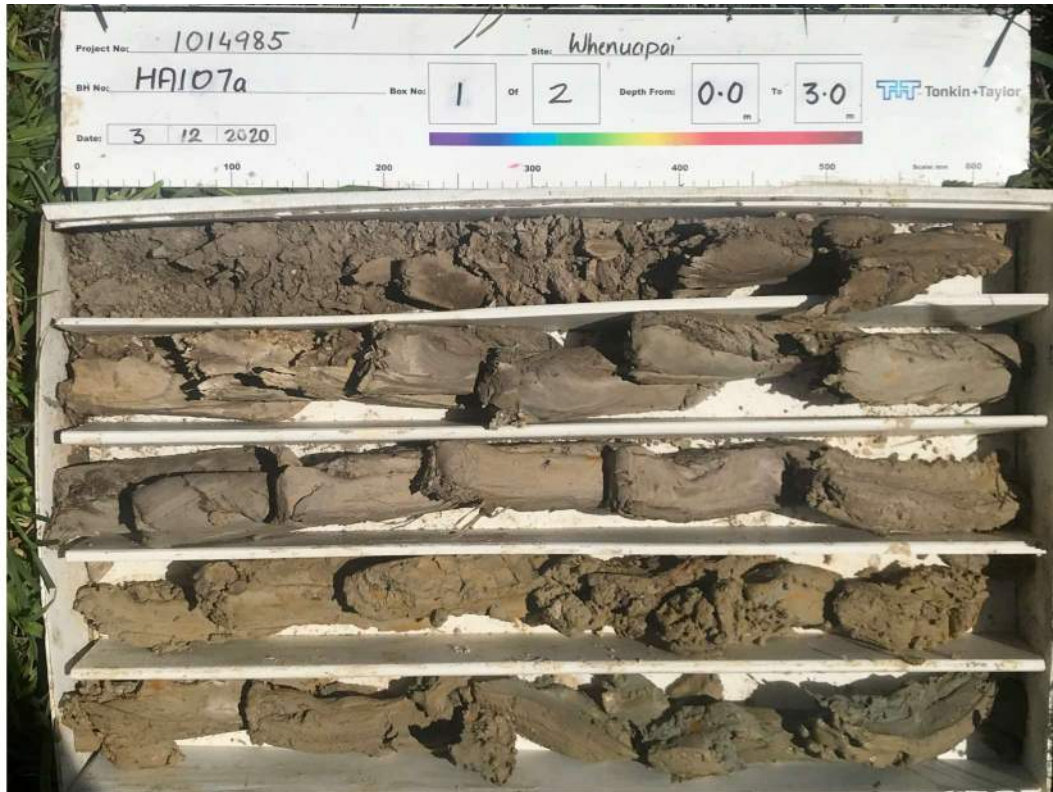
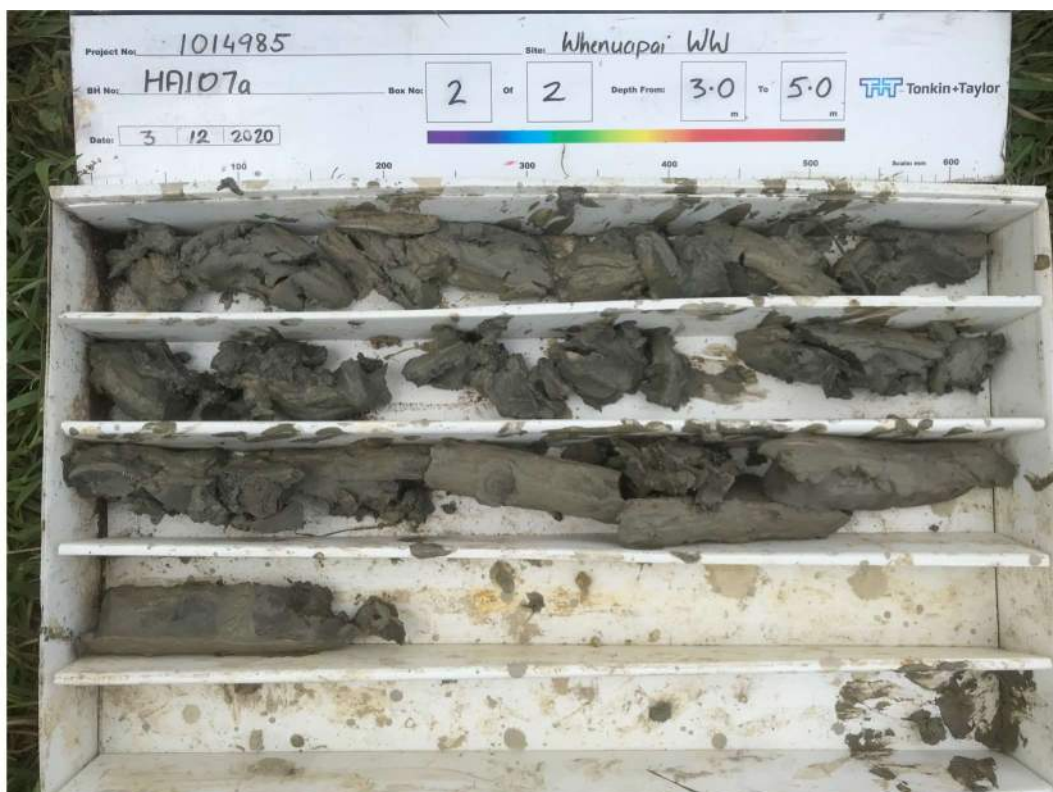
| | | | | | | | | | | ● 152/34 kPa<br>Env @ 1.00m<br>PID 0.1ppm @ 1.01m<br>corrosivity @ 1.20m | | | | 1.0 | | | | | | M | | St | | | | Sandy SILT, trace organics and clay; grey-brown mottled orange speckled white and black. Stiff, moist, low plasticity; sand, fine; organics, rootlets. | | | |
| | | | | | | | | | | corrosivity @ 2.70m | | | | | | | | | | | | | | | | Silty SAND; grey mottled orange speckled white. Very stiff, moist, poorly graded; sand, fine. | | | |
| | | | | | | | | | | ● 45/28 kPa | | | | 4.0 | | | | M-W | | L-MD | | | | Silty SAND, trace organics; grey mottled brown. Loose to medium dense, moist to wet, poorly graded; sand, fine; organics, rootlets. | | | | | |

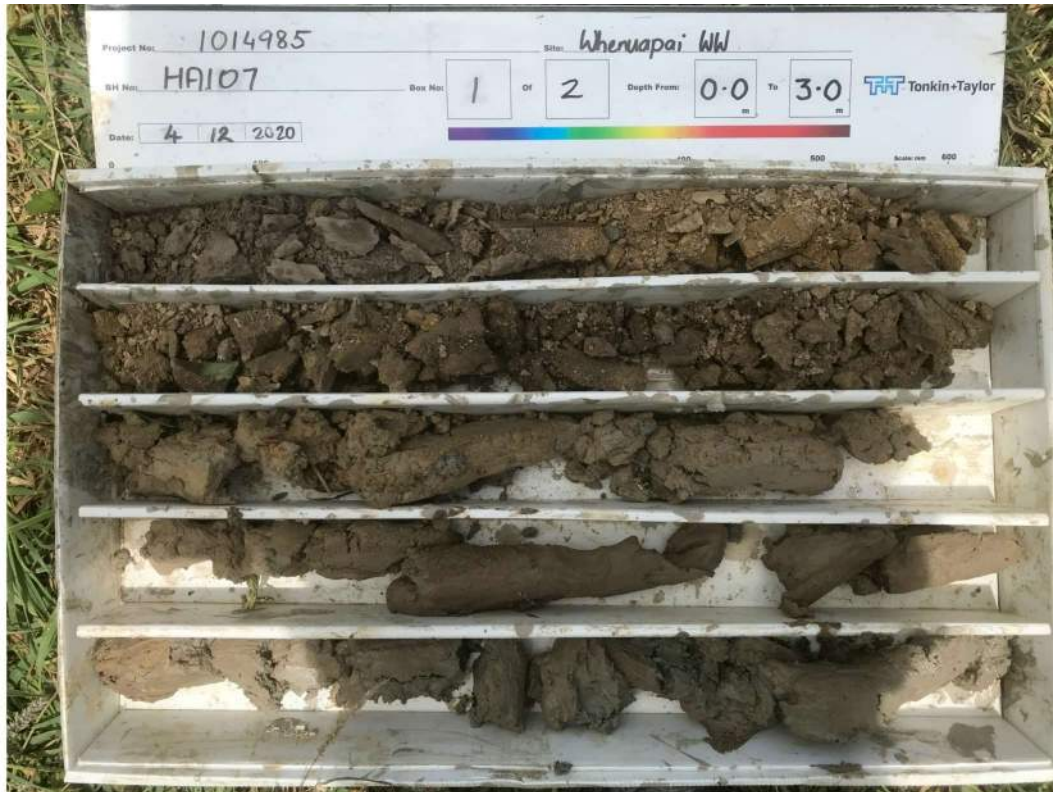
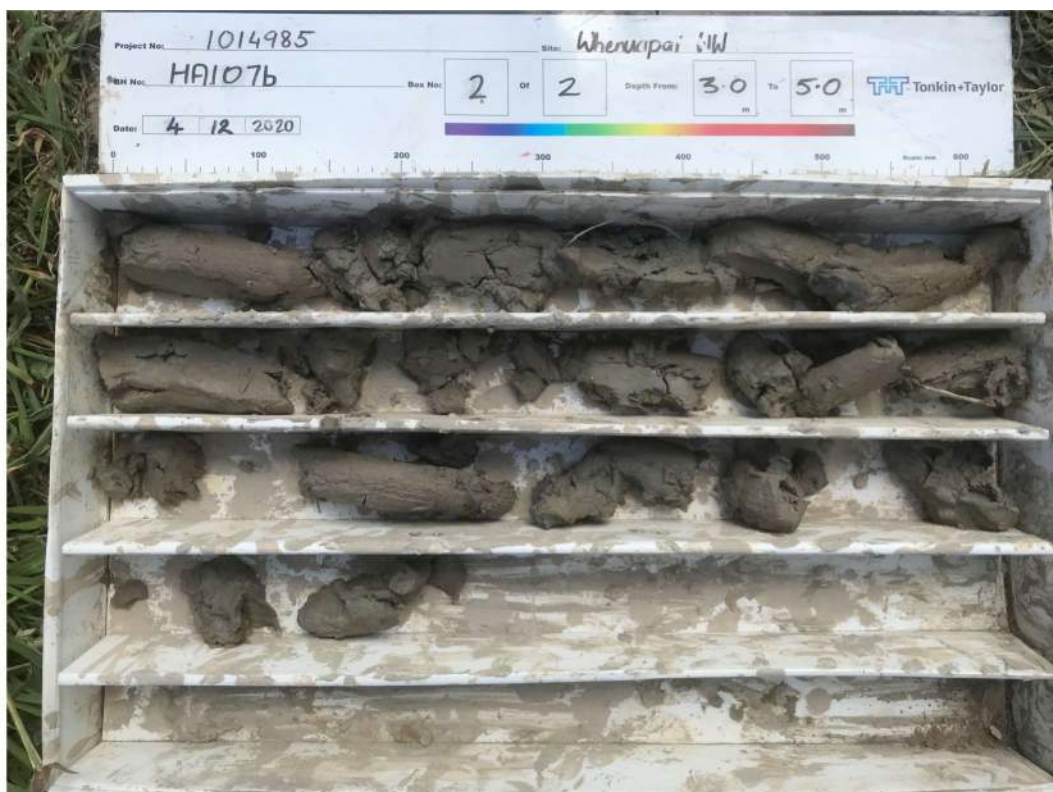
| PROJECT: Watercare Whenuapai-Redhill GI | | | | LOCATION: Whenuapai | | | | JOB No.: 1014985.0000 | | | | | | | |
|---|---|---|---|---|---|---|---|---|---|---|---|---|---|---|---|
| | | | | | ● 73/28 kPa<br>Env @ 1.00m | | | 1.0 | | St | | Sandy SILT, minor clay, trace organics; brown, mottled orange. Stiff, moist, low plasticity; sand, fine; organics, rootlets. | | | |
| | | | | | ● 54/21 kPa | | 10 | 1.5 | | | SILT, minor sand and clay, trace organics; light brown, mottled orange. Stiff, moist, low plasticity; sand, fine; organics, rootlets. | | | | |

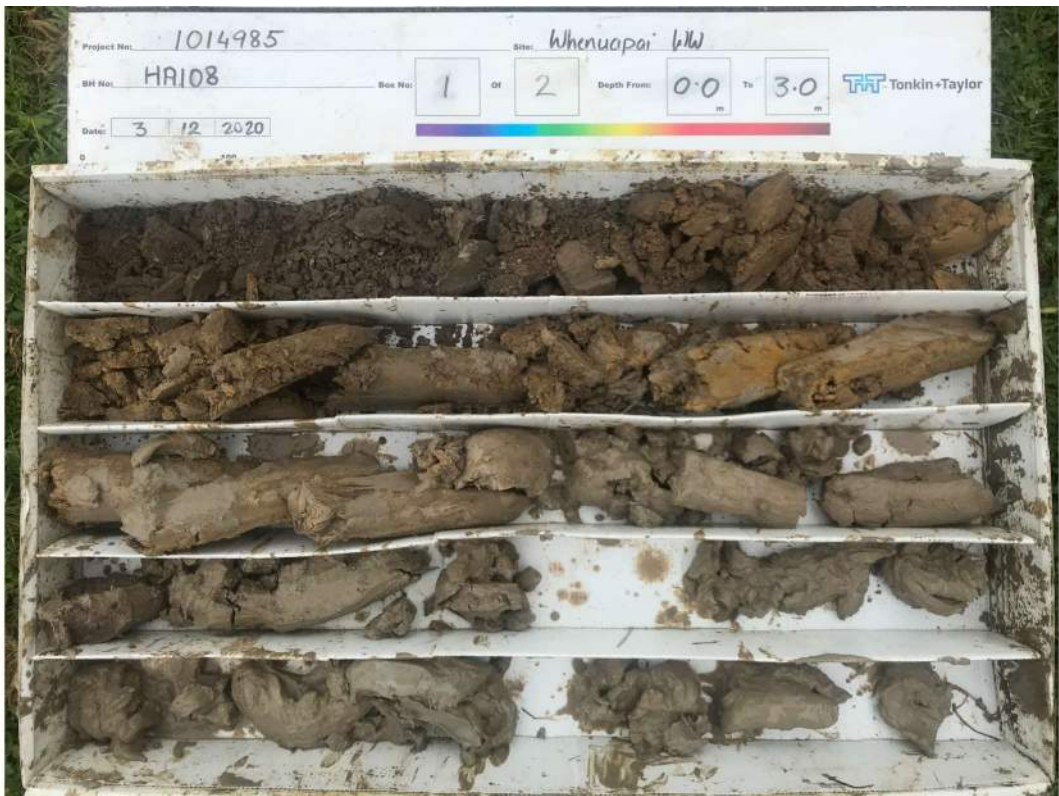
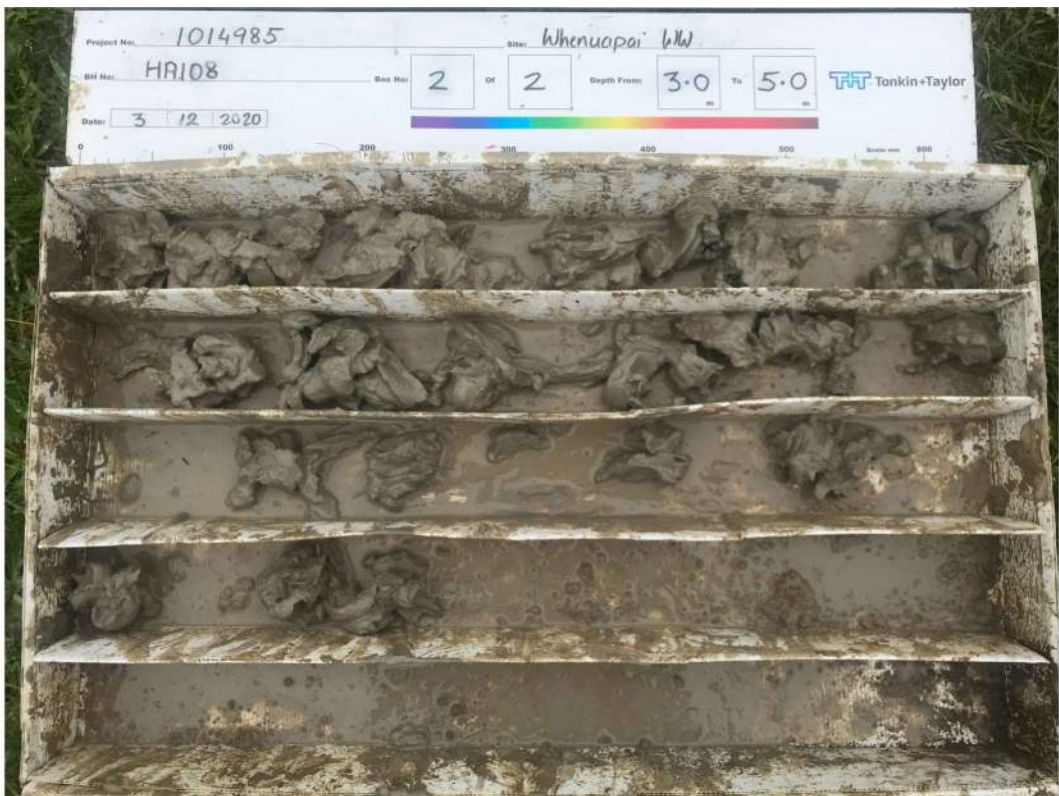
| Topsoil | | | | | | | | | | asb/gl/split @ 0.00m | | | | | | | | TS | | D-M | | | | | | SILT; light brown. Dry to moist, non-plastic. | |
| | | | | | | | | | | ● 122/21 kPa | | | | | | 0.5 | | | | M | | VSt | | | | SILT; yellowish brown. Very stiff, moist, non-plastic. | |
| | | | | | | | | | | asb/gl @ 0.40m | | | | | | | | | | | | | | | | SILT, some clay; light brown mottled yellowish brown. Very stiff, moist; low to no plasticity. | |
| | | | | | | | | | | ● 76/15 kPa | | | | | | | | | | | | St | | | | SILT; light brown. Stiff, moist, non-plastic. | |
| | | | | | | | | | | asb/gl @ 0.90m | | | | | | 1.0 | | | | | | | | F | | Silty CLAY; light brown mottled yellowish brown. Firm, moist, high plasticity. | |
| | | | | | | | | | | ● 48/19 kPa | | | | | | 1.5 | | | | | | | | | | Clayey SILT; light brown. Firm, moist, low plasticity. | |
| | | | | | | | | | | ● 32/8 kPa | | | | | | | | | | | | | | | | Silty CLAY; light brown mottled yellowish brown. Firm, moist, medium plasticity. | |
| | | | | | | | | | | | | | | | | | | | | W | | | | | | Silty CLAY; light brownish grey. Soft, moist, high plasticity. | |
| | | | | | | | | | | asb/gl @ | | | | | | | | | | | | F-St | | | | Clayey SILT; light grey. Firm to stiff, moist, medium plasticity; sandy layers at 4.8m and 5m. | |

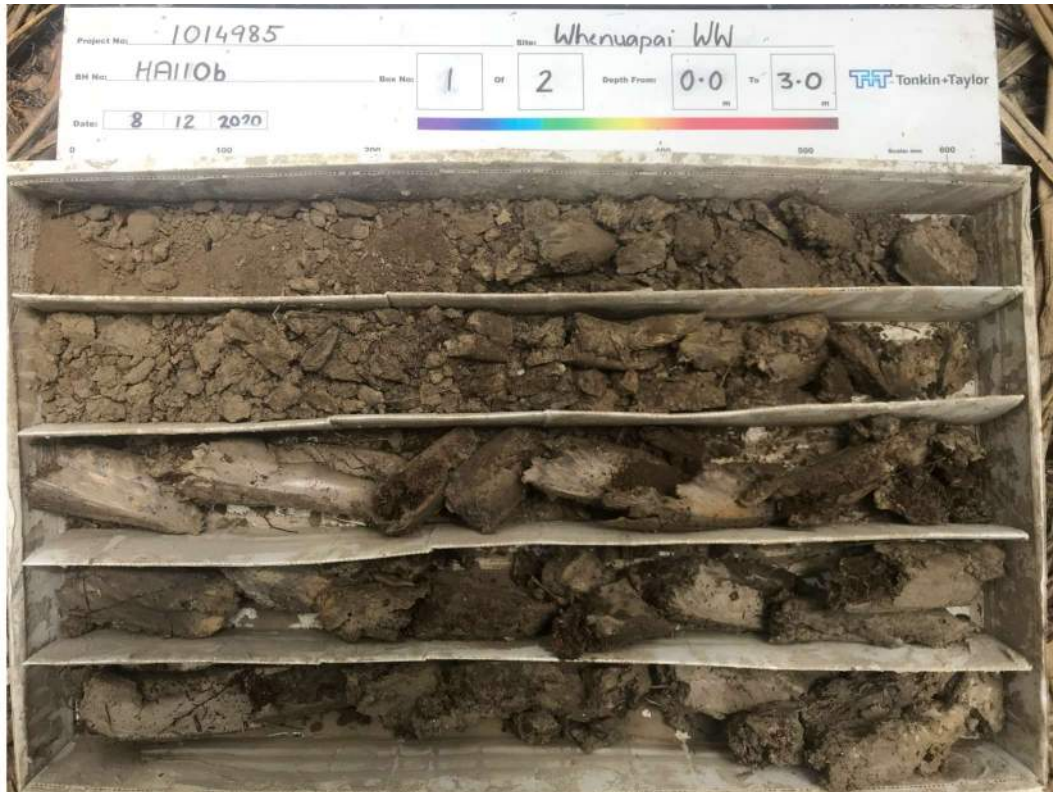
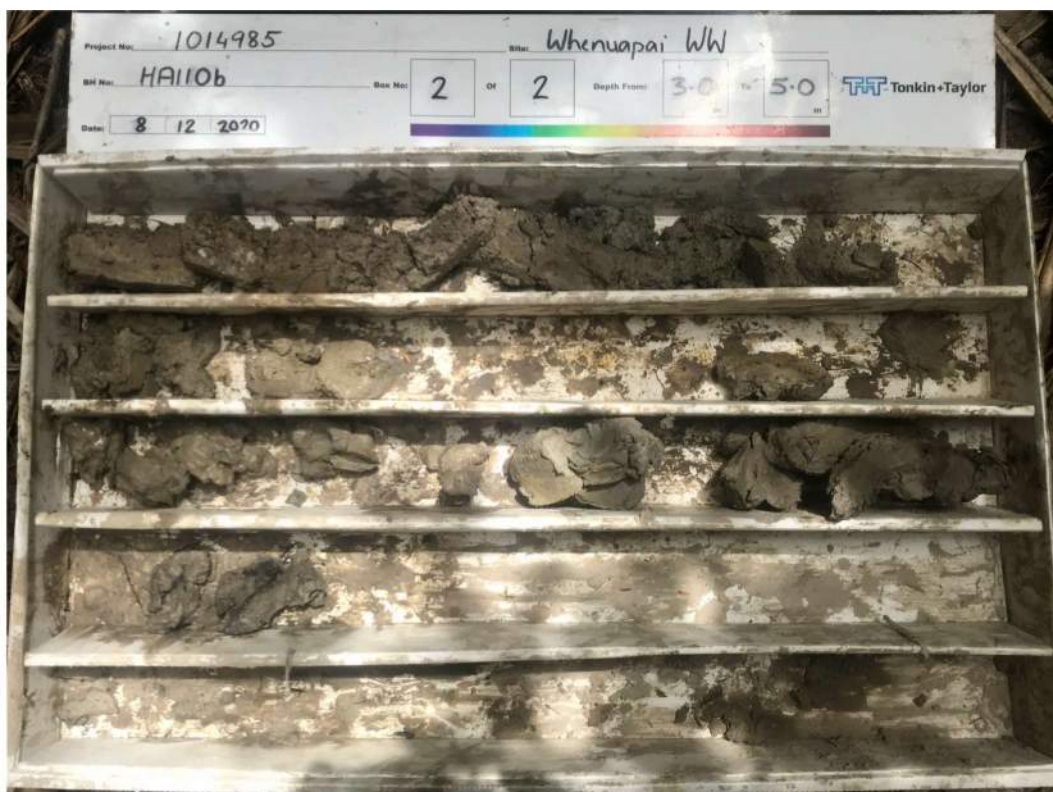
| | | | | | 6 | | Corrosivity @ 1.20m | | 13 | 1.5 | | | M | | | Sandy SILT, some gravel; dark brown. Firm, moist, low plasticity; sand, fine; gravel, fine, angular, sandstone. | | | |
| | | | | | 12 | | Corrosivity @ 2.40m | | 12 | 2.5 | | | | | St | | | SILT, some sand, minor clay and gravel, trace organics; dark brown and black. Stiff, moist, low plasticity; sand, fine; gravel, fine, sub-angular, sandstone; organics, rootlets. | |
