# Central Interceptor Main Project Works Detailed Design

WATERCARE SERVICES LIMITED

## Geotechnical Interpretative Report

PWCIN-DEL-REP-GT-J-100048 | 6

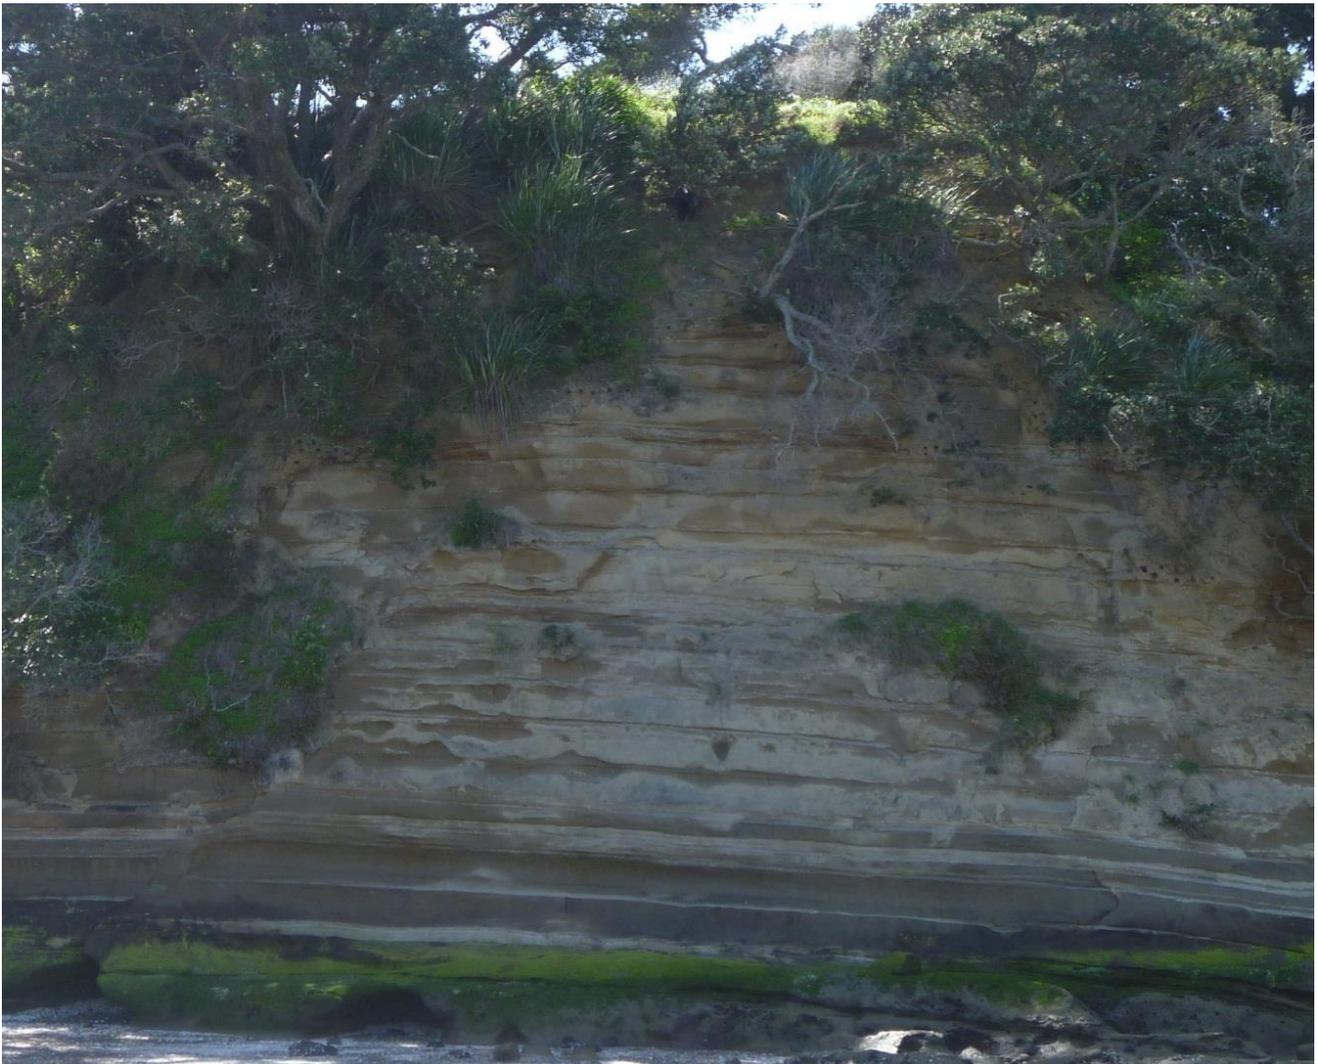
**Figure 3.2 : View of cliffs at Hillsborough showing typical East Coast Bays Formation gently inclined planar mudstone and sandstone beds. This view is part of a larger dome or fold structure ranging approximately 400 m along the cliff. A defect can be seen extending from the lower left corner of the photograph to midway up the cliff face.**

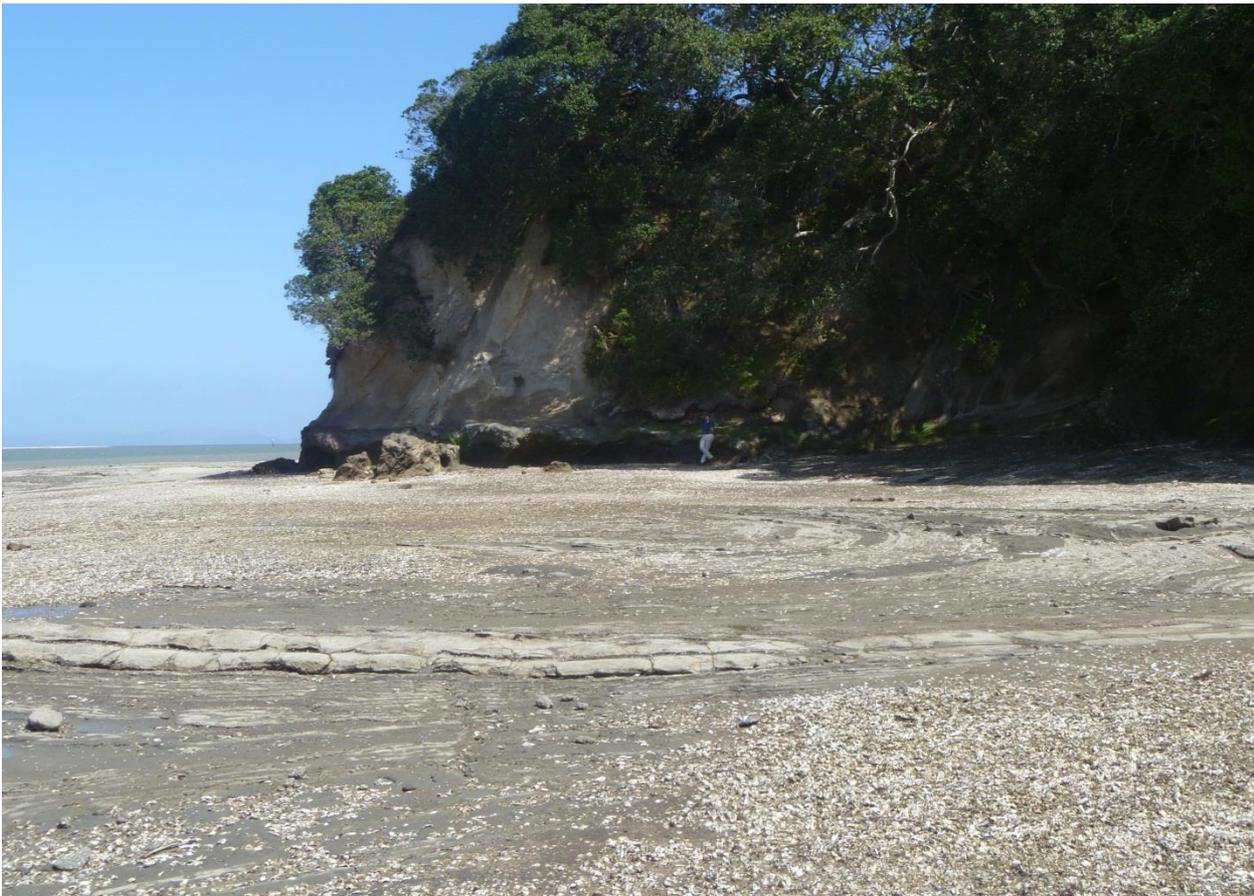
Figure 3.3 : View looking south west at White Bluff. Folded mudstone and sandstone beds of East Coast Bays Formation can be seen in the shore platform with massive sandy siltstone forming White Bluff. Discrete and localised beds of Parnell Volcaniclastic Conglomerate can be seen at the base of the cliffs.

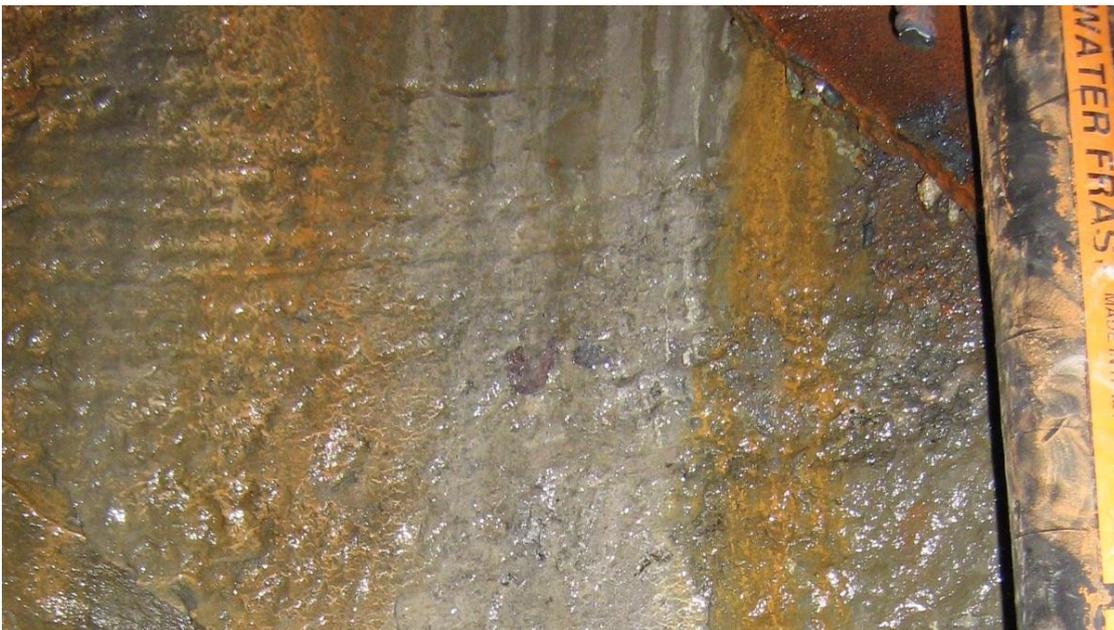
Figure 3.4 : PVC in the face of the Davis Crescent tunnel. This rock was well cemented with calcite and recorded a uniaxial compressive strength in the order of 10-20 MPa. The largest grain (dark red grain near photo centre) is 14 mm across.

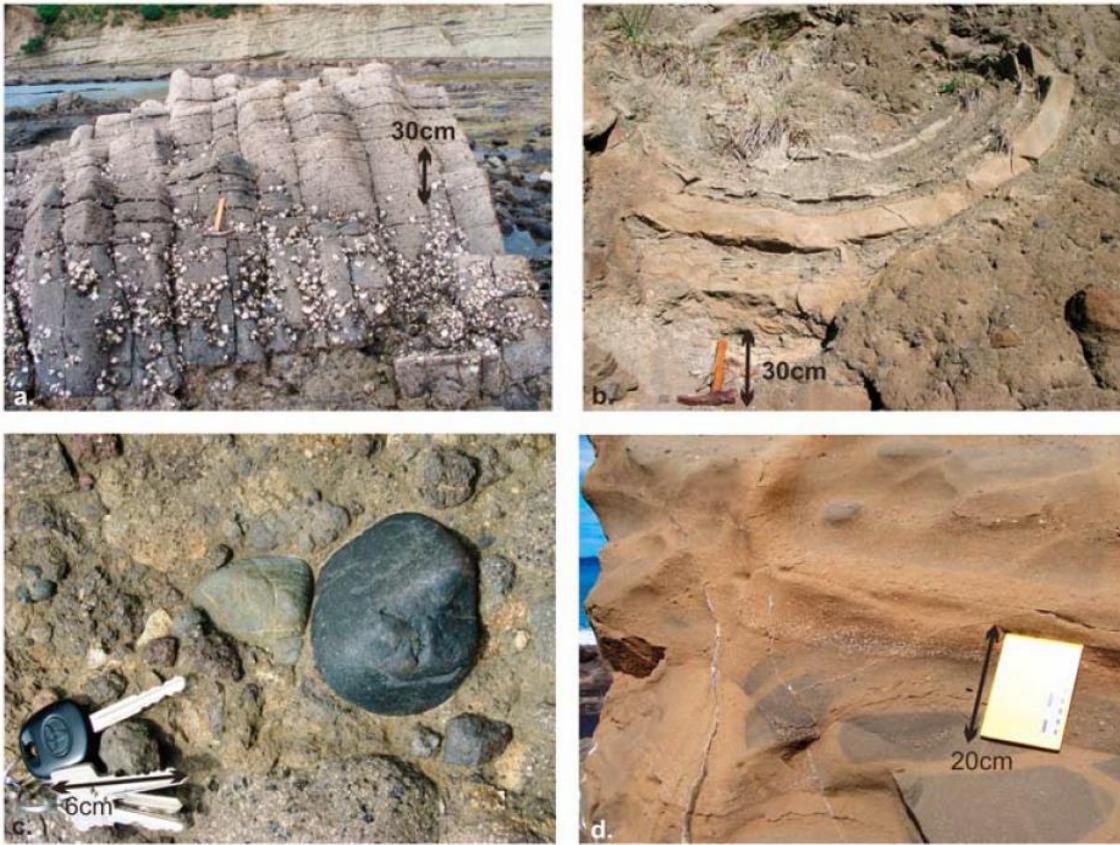
Figure 3.5 : Photomontage of clast types in the PVC (Shane, Strachan, & Smith, 2010). (a) Type 1, subangular basalt clast displaying columnar jointing and flow banding. (b) Type 2, sedimentary clasts. (c) Type 3, rounded mafic igneous clasts. (d) Type 4, pumice clasts within a sandstone; pumice clasts identifiable by crude bedding and light colour.

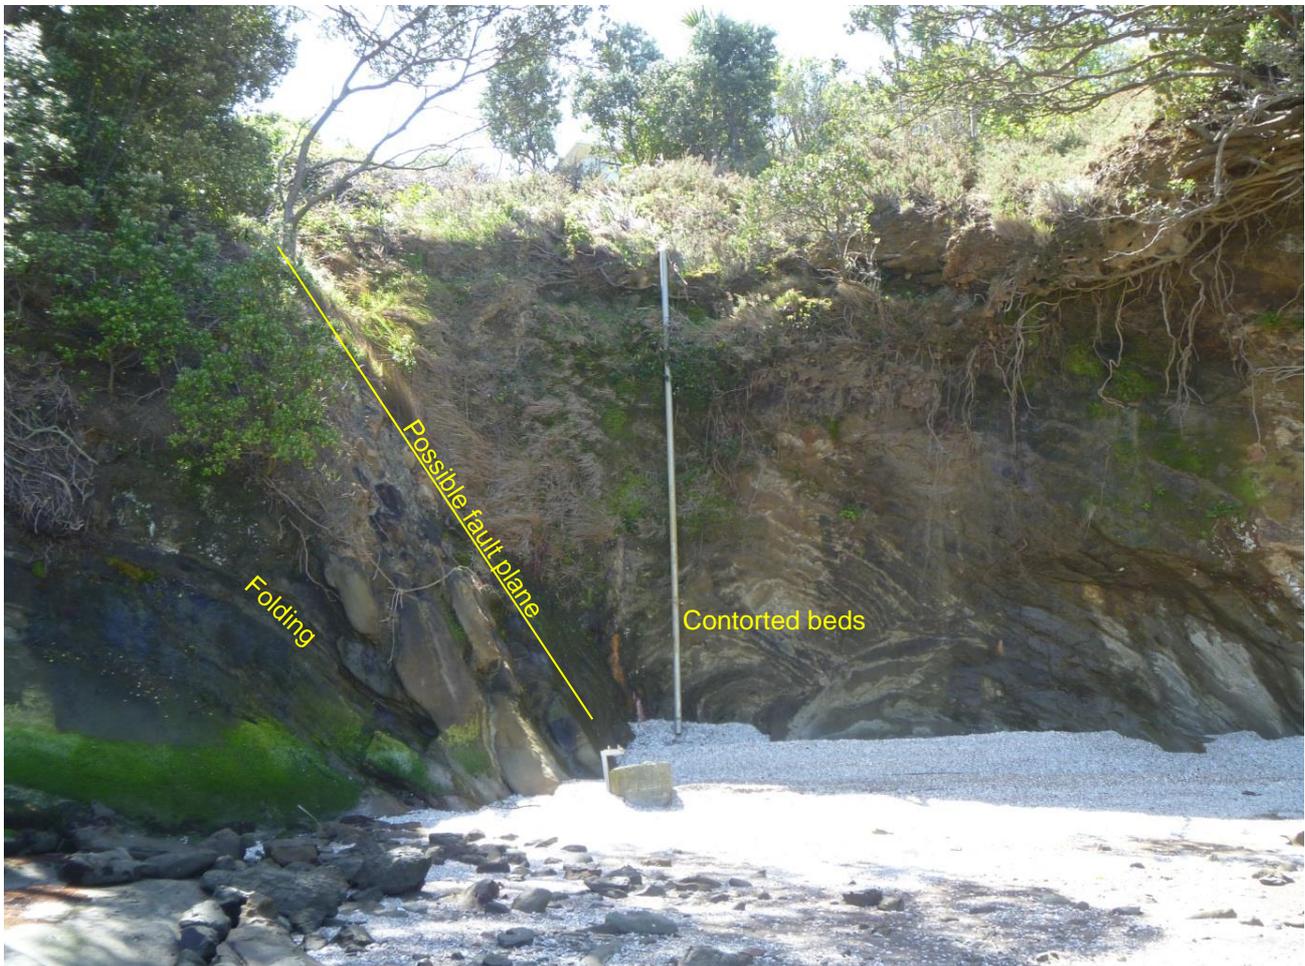
Figure 5.4 : View of cliffs at Hillsborough showing syndepositional deformation in East Coast Bays Formation including folded and contorted beds and a possible fault plane (outlined in yellow).

(Prebble, 1995 and 2001). More complex, tightly folded, complexly folded and closely fractured zones are found between the simple domains (Figure 5.4).

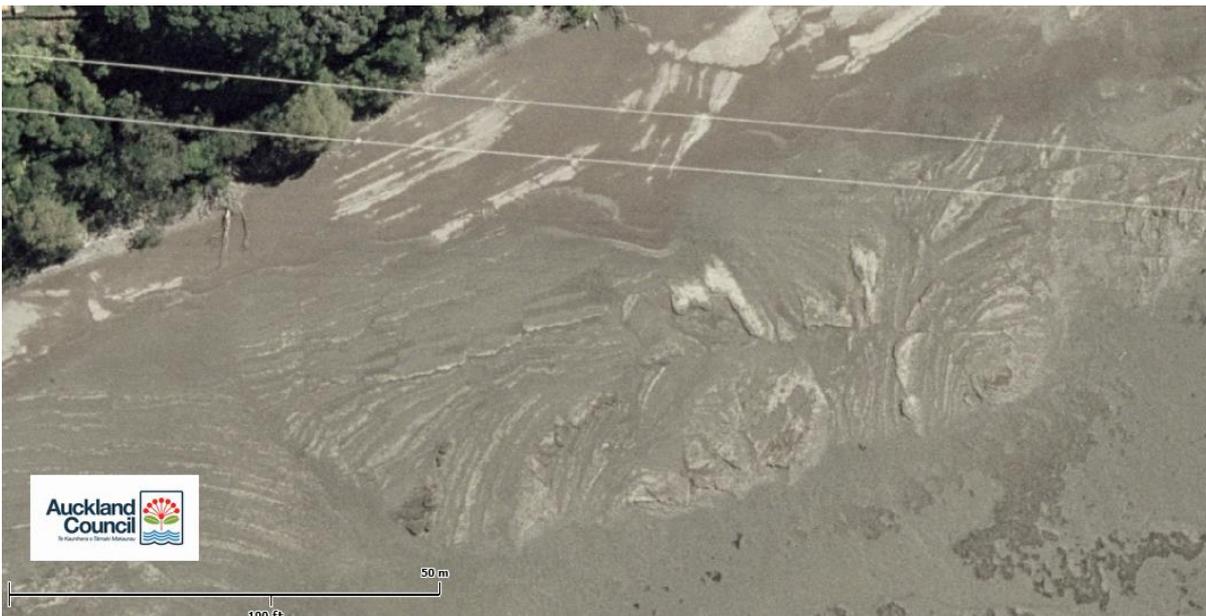
Figure 5.6 : Aerial view of shore platform at Hillsborough Bay. Folding and faulting, the result of syndepositional deformation, can be seen here at a larger scale than in cliff section photographs. Localised features which appear raised from the shore platform are likely Parnell Volcaniclastic Conglomerate.

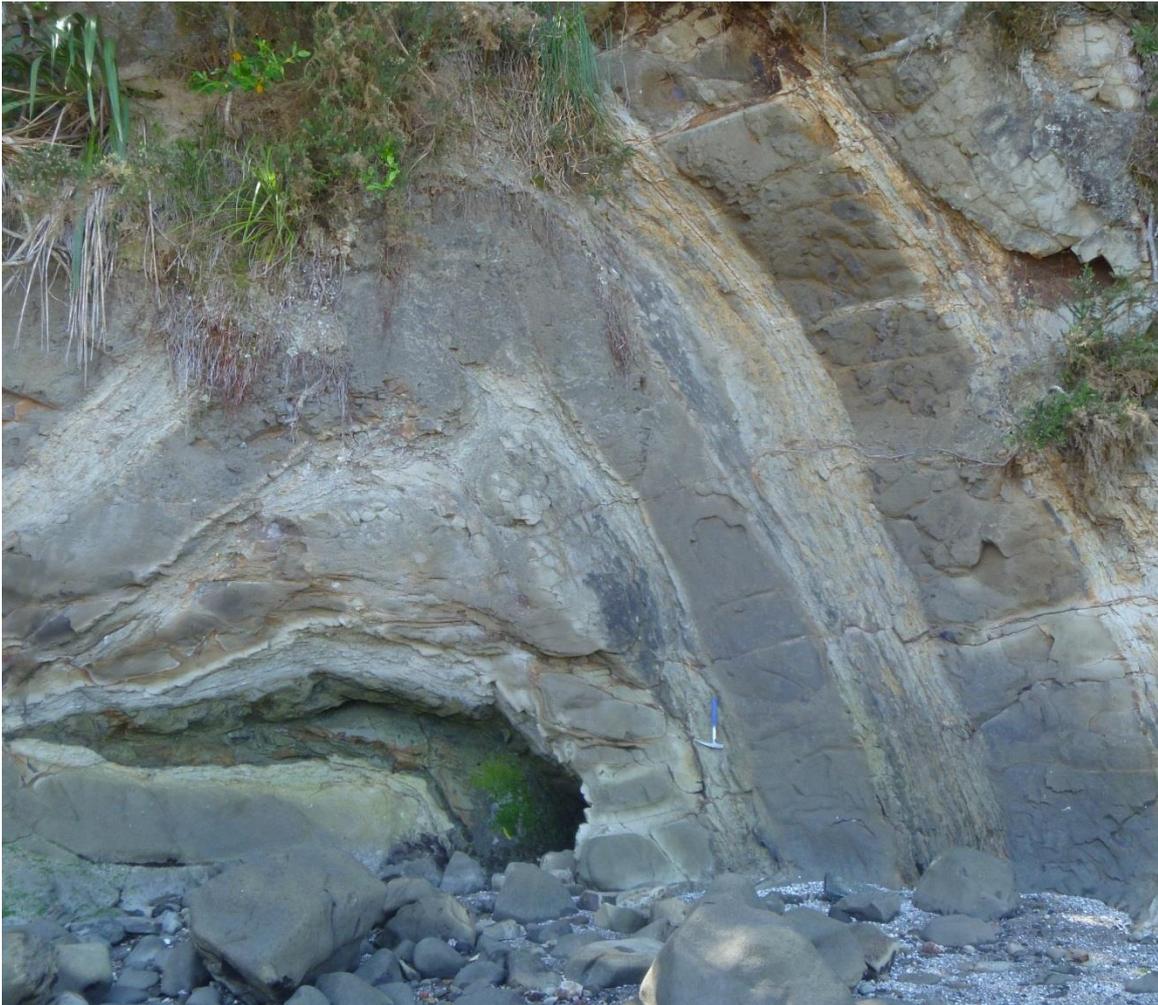
**Figure 5.9 : View of cliffs at Blockhouse Bay showing an antiformal fold in East Coast Bays Formation.**

Joints normal to bedding can be seen in darker grey sandstone bed and appear stained and infilled. The joints often extend through a single bed only however several are seen with greater persistence. Brown staining parallel with laminations in the lighter grey mudstone is also visible. The small cave at the base of the cliff is taken to be associated with coastal weathering processes.

These defects tend to have low persistence (length typically less than 2 m), commonly terminating at bedding (Figure 5.9).

An indication of the scale of defects and likely resulting block sizes are given in Figure 5.9 and Figure 5.10 and are typically decimetre to meters in size.

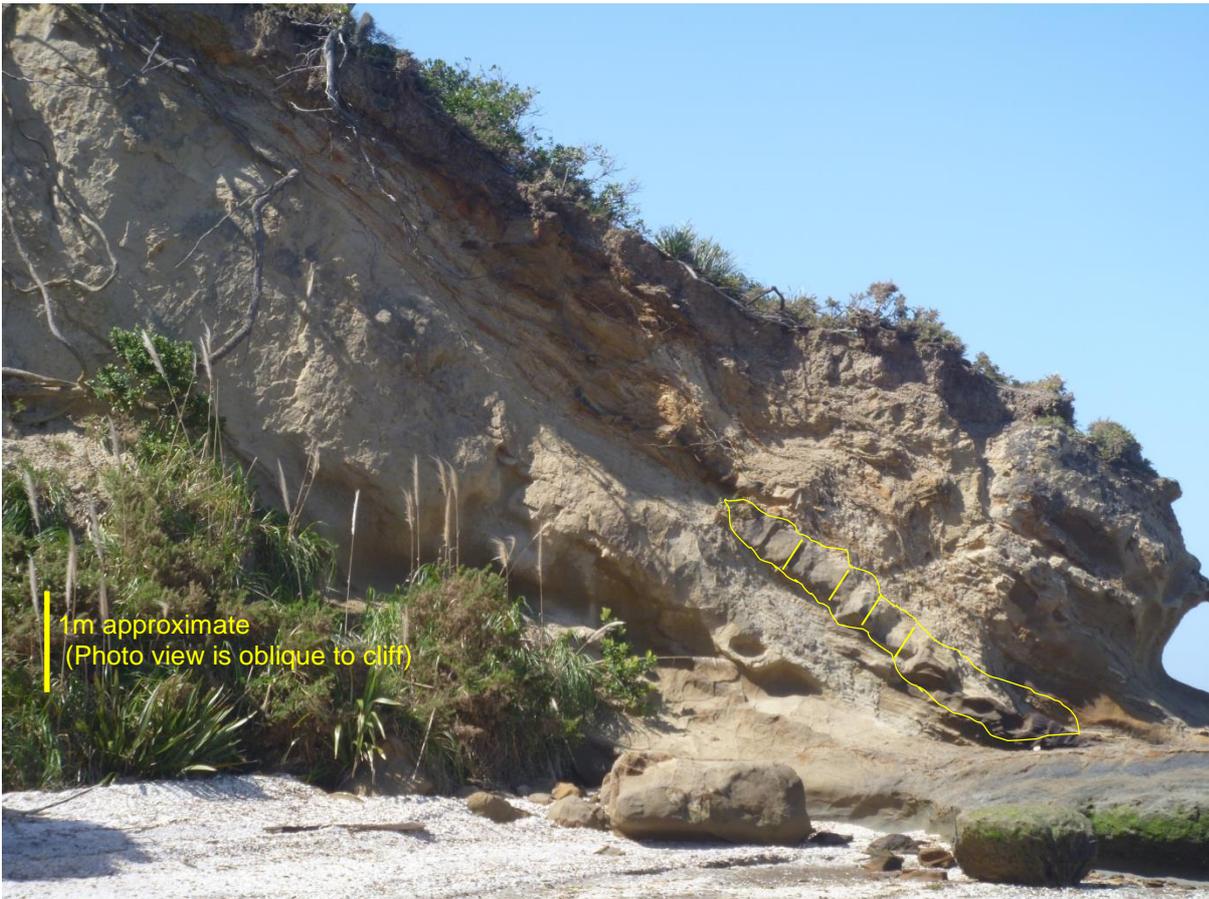
**Figure 5.10 : View looking east at cliff near White Bluff showing surficial weathering profile and inclined beds of East Coast Bays Formation, including a bed of sandstone (outlined in yellow) terminating midway up the cliff with several joints normal to bedding.**

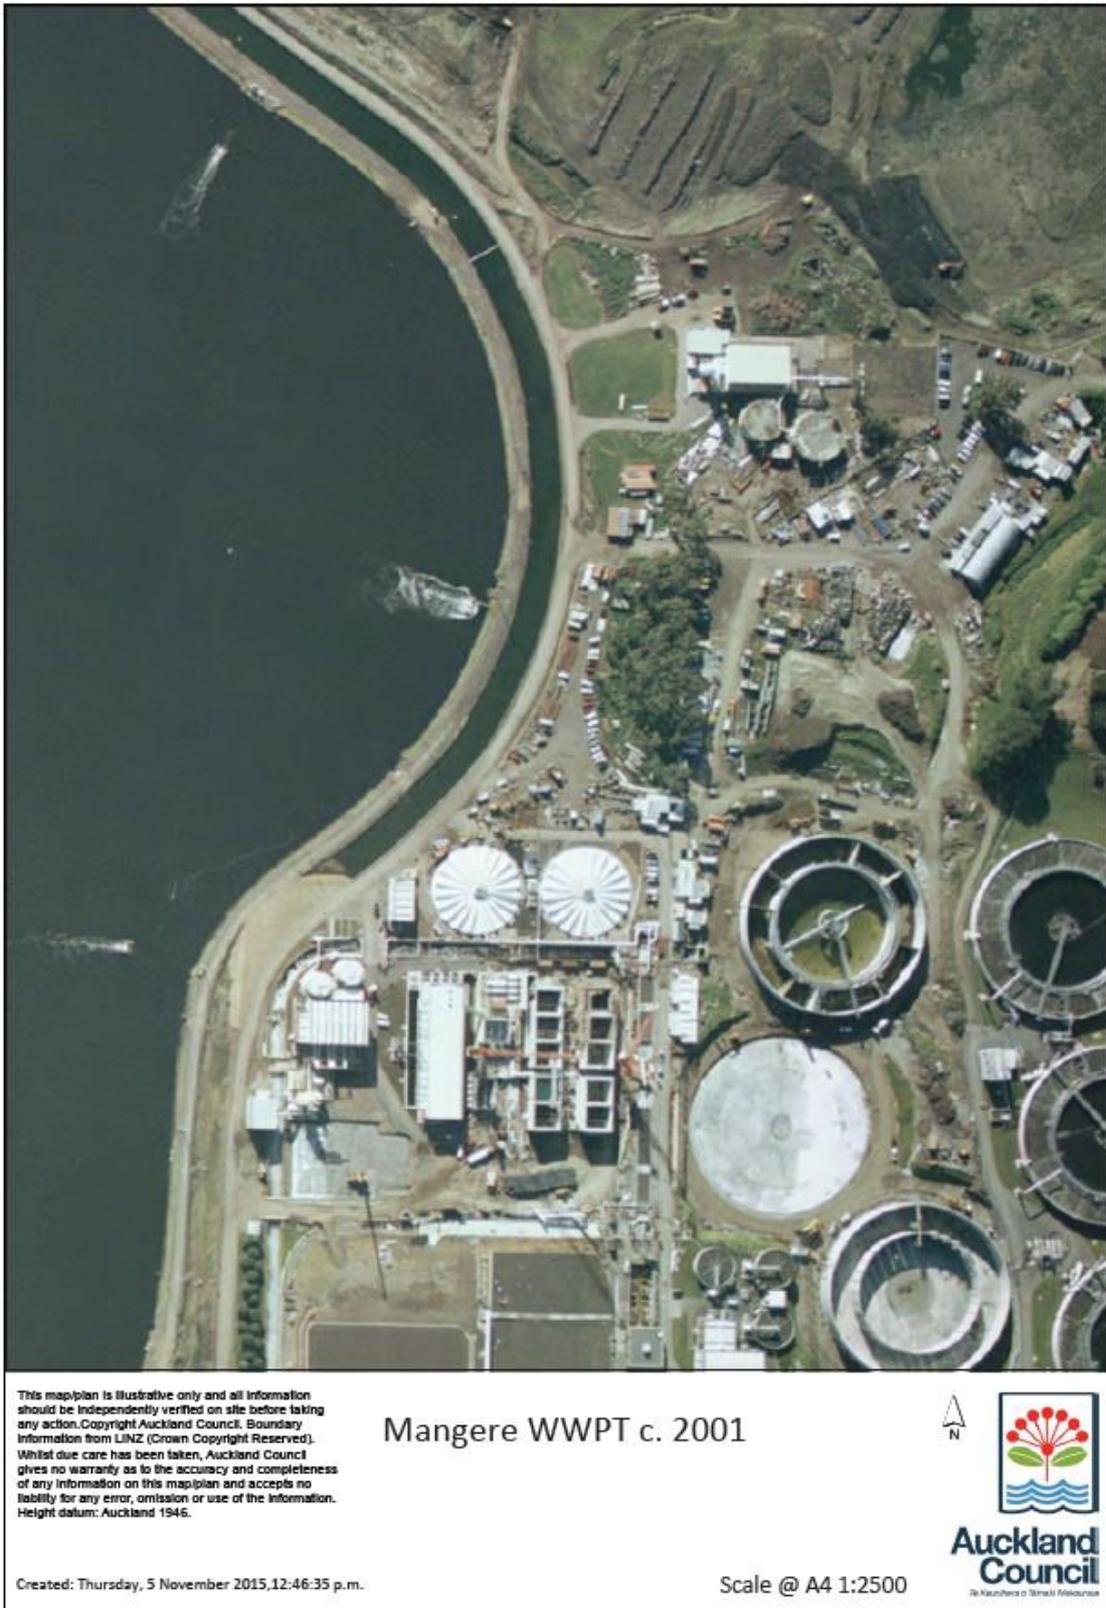
Figure 11.2 Aerial Photograph of Mangere WWTP circa 2001. Ponds appear to be being filled where the proposed emergency pressure relief chamber and rising mains will pass.
