Minutes

Board meeting	Public session
Date	10 October 2023
Venue	Watercare Services, Level 3 Boardrooms, 73 Remuera Rd, Remuera and via Microsoft Teams
Time	10am

Ōrākei Main Sewer Failure and associated sinkhole

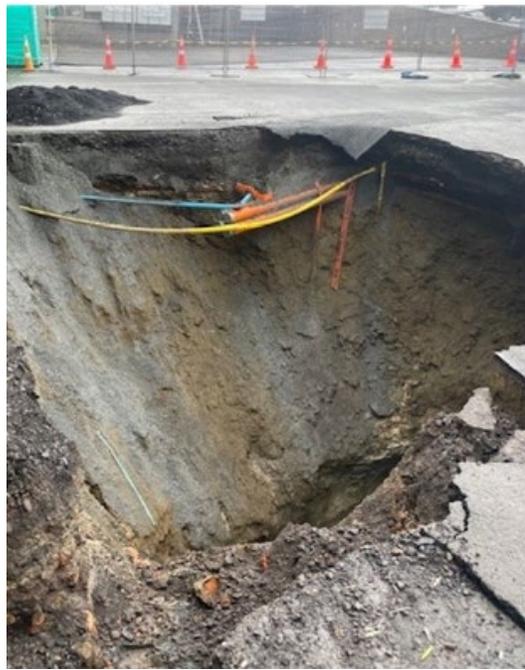
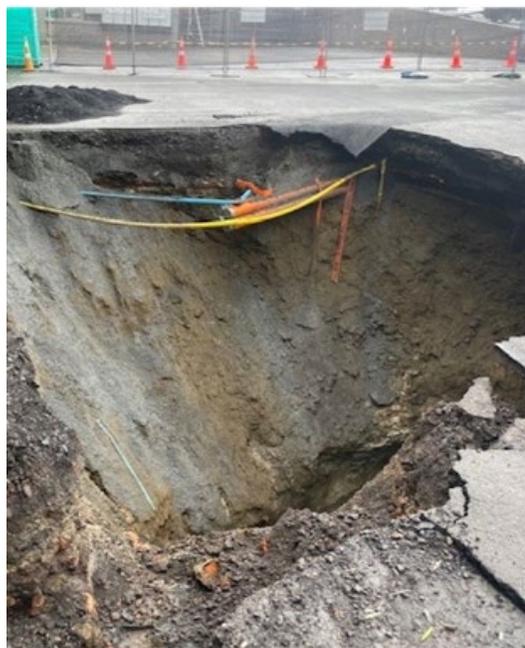
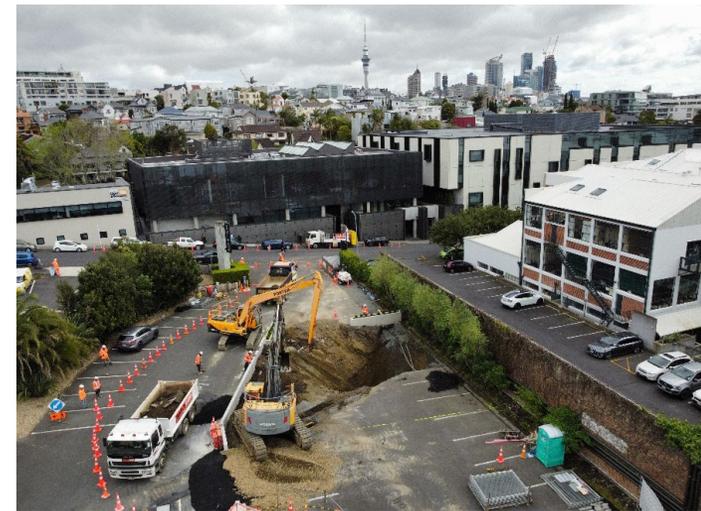
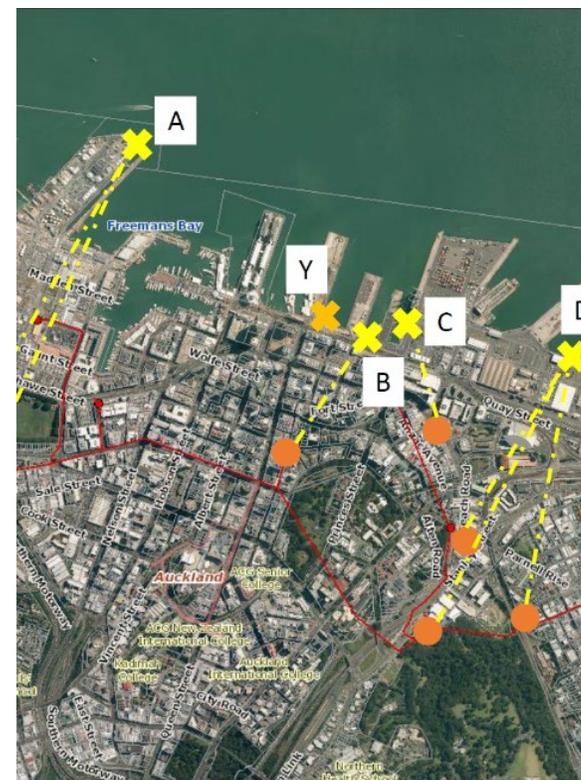
What happened?

- CCTV of the blockage shows it was originally 25m long, comprising boulders and rocks. The broken part of the sewer is 4m long. The sewer is an egg-shaped sewer, and similar in type and size to our Eastern and Western sewers.

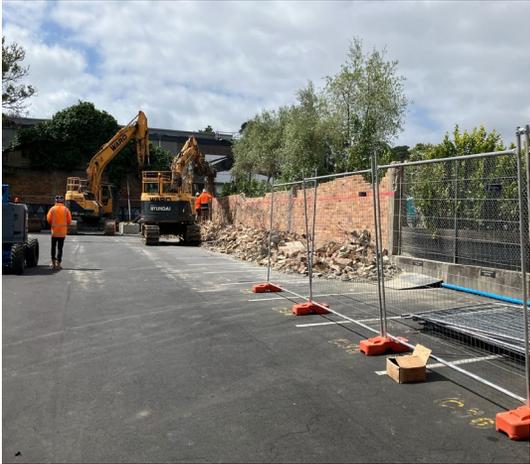
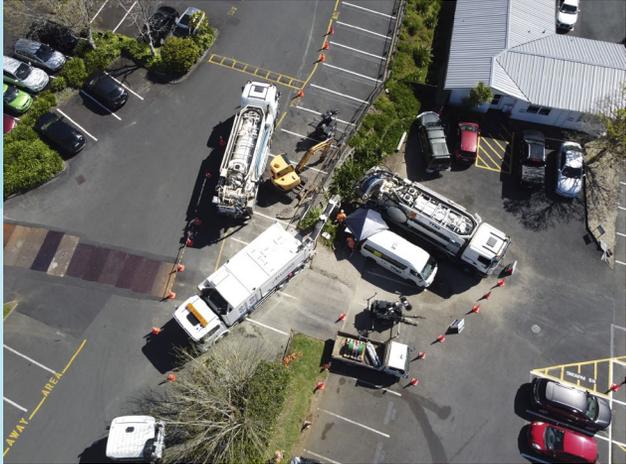
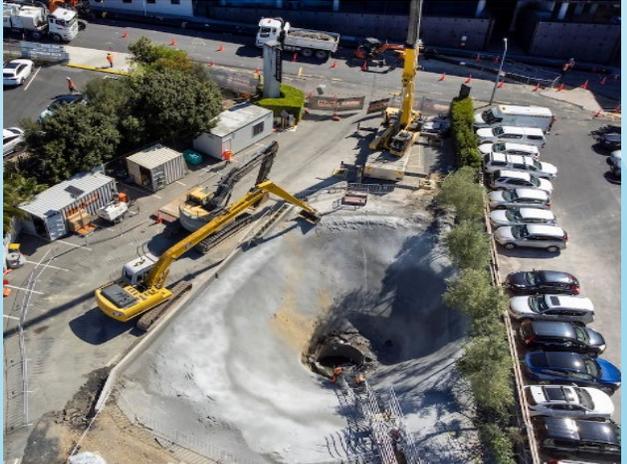
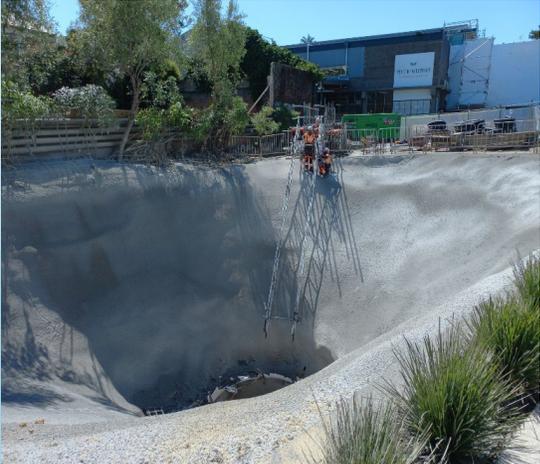
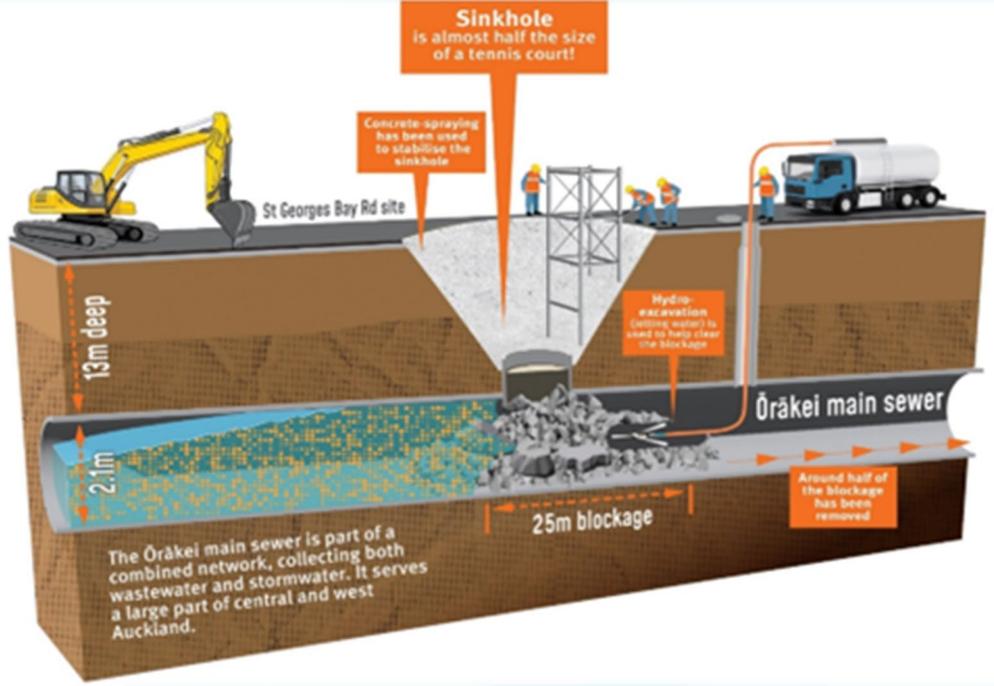
Response works

- In the meantime, we started planning a bypass pumping solution that will transfer wastewater between two manholes on either side of the blockage.
- Bypass pipe laying is underway, as is excavation of the space that will hold a very large, 8m deep, underground pump station. This pump station will pump 600L/second of wastewater, making it one of the country’s largest pump stations.

- The polyethylene diversion pipe is 600mm-diameter in 12-metre sections and each section is welded together to form the pipeline. Around 400m of pipe is being laid and it will run both below ground, and over land. Many other utilities have had to be moved to accommodate the bypass. The team is not cutting corners and ensuring we take the time to properly relocate other utilities.

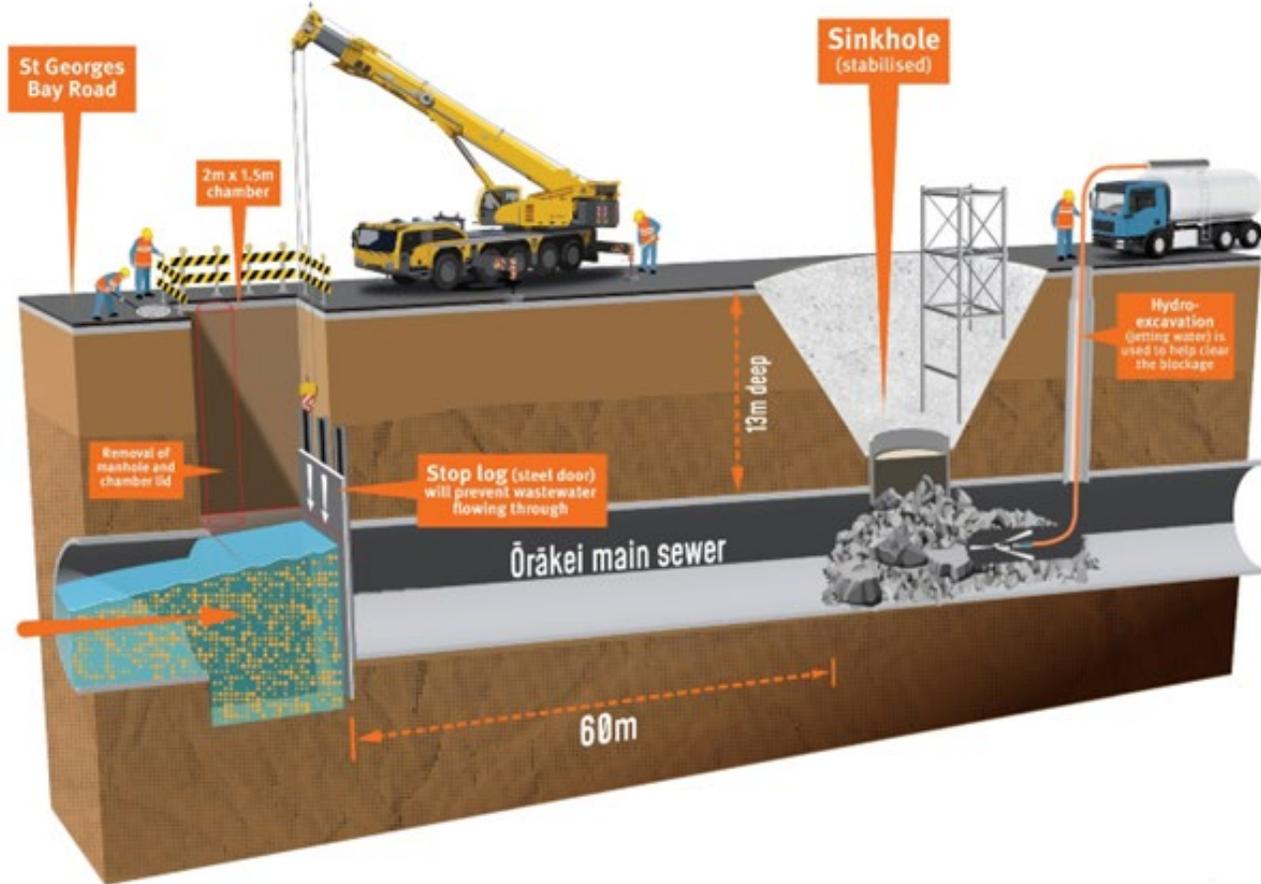
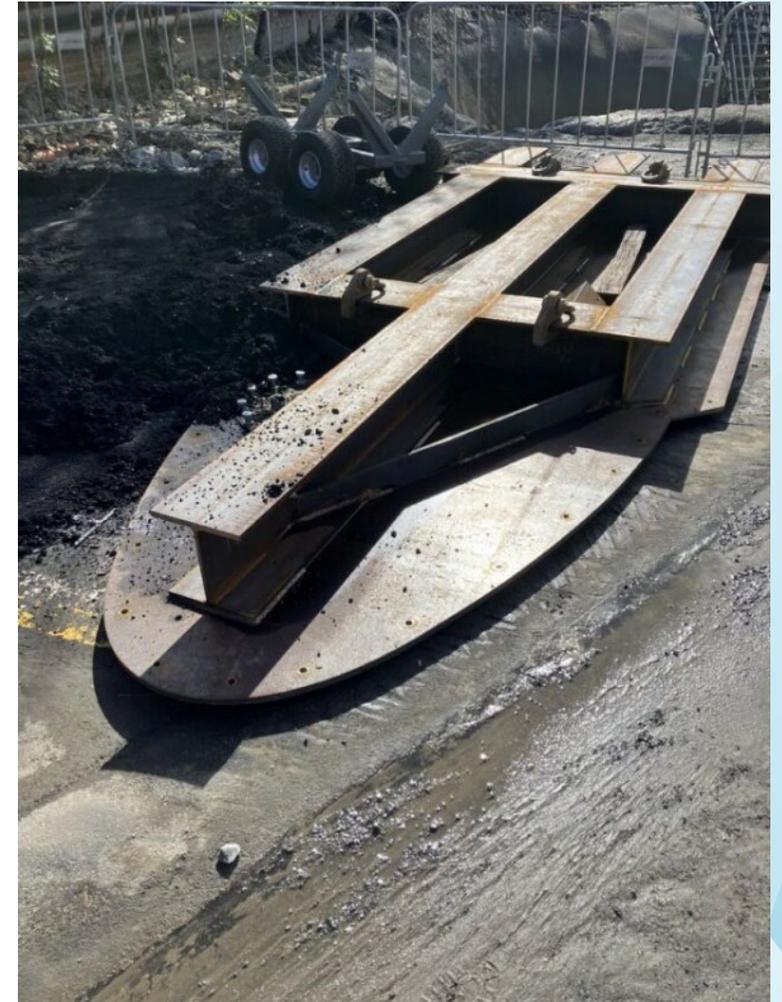
Response works

- Contractors are now hydrojetting the blockage and sucking the debris out. Approximately 4-5m of blockage is left to clear, but this will need to be done by hand/machines going into the pipe. This will not occur until a heavy metal barrier is installed, to block off the wastewater pipe so it is safe to enter the enclosed space.

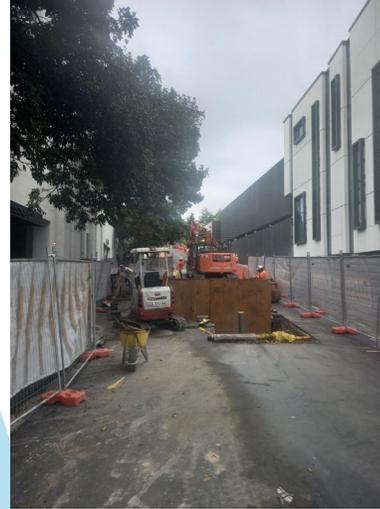
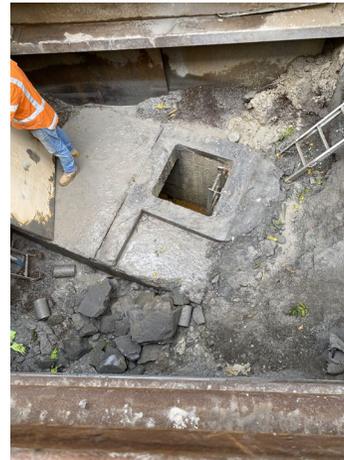
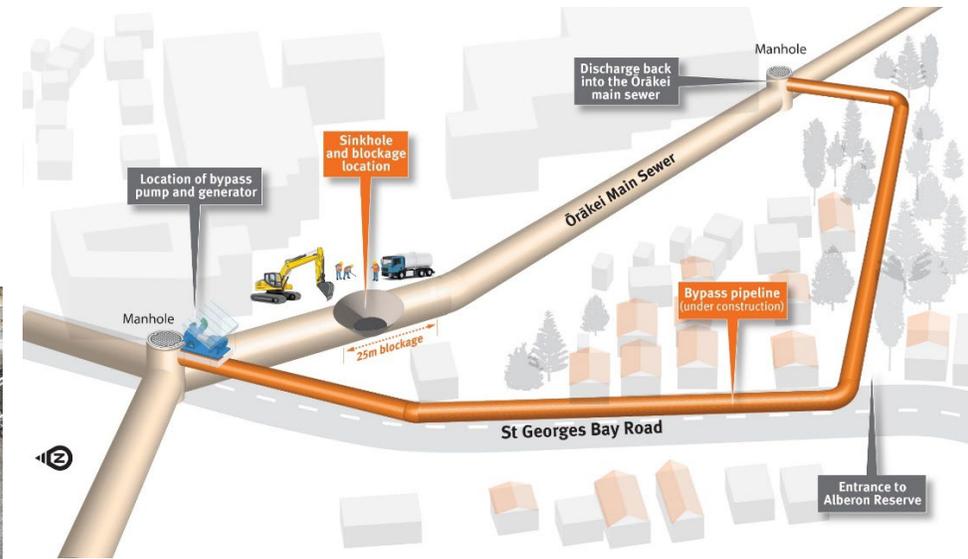
Upcoming works

- Completion of bypass pumping
- Development of a safe methodology to remove the blockage
- Development of a design for the rehabilitation of the pipeline

- 2/3 of the bypass pipeline has been installed, and we expect it to go into service by 17 October 2023.
- Modelling is underway to analyse what an extreme weather event could result in, whilst the bypass is in place.
- Whilst the pipe is out of service, we will be using all the technology available to us to inspect the pipe.
- Once the bypass pumping solution is completed, it will stay in place for three/four months, whilst the remaining blockage is cleared and the sewer permanently repaired. The repair is likely to involve a bespoke GRP liner, which is a glass reinforced plastic.
