Huia Water Treatment Plant

Shortlist Options Analysis: Ecological Effects Evaluation Report
Prepared for Watercare Ltd

8 May 2017

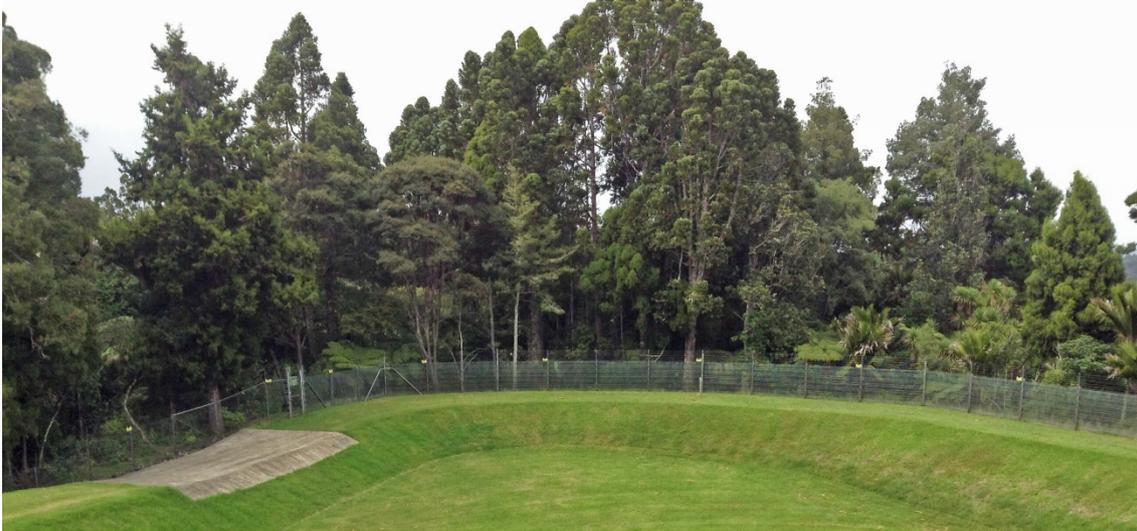
Figure 1: Indicative WRP footprint for existing WTP site.

The proposed development footprint (Fig. 1) also includes two reservoirs to be located within an area of existing kanuka forest (portions of which have been cleared or substantially modified) on the northern side of Woodlands Park Road.

Groups of kauri are present around the existing treatment plant (Fig. 1, 2) and in the south-western quarter of the Watercare property to the north of Woodlands Park Road. Most kauri trees within the Watercare property are within the “ricker” stage, though numerous trees are greater than 60cm dbh, with a spreading crown characteristic of ‘mature phase’ kauri. Associated canopy and subcanopy species include rimu, kahikatea and kanuka, with occasional totara, rewarewa, kohekohe. Younger kauri and podocarps are also interspersed through the surrounding kanuka forest, both within the canopy and as occasional emergents.

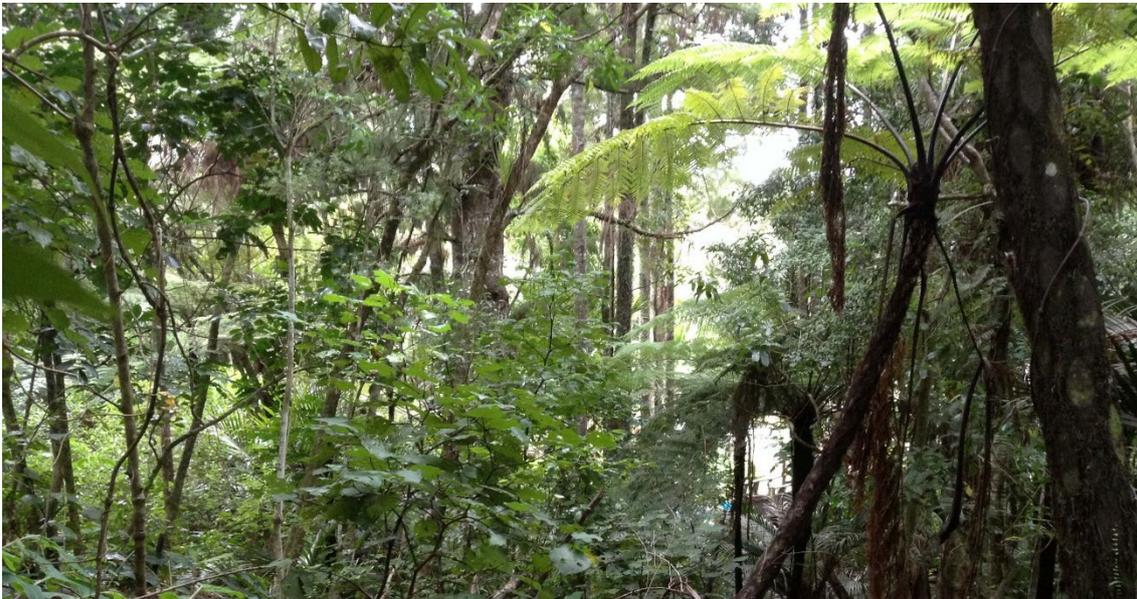
Figure 2: Kauri forest (WF10) on eastern side of existing WTP site.

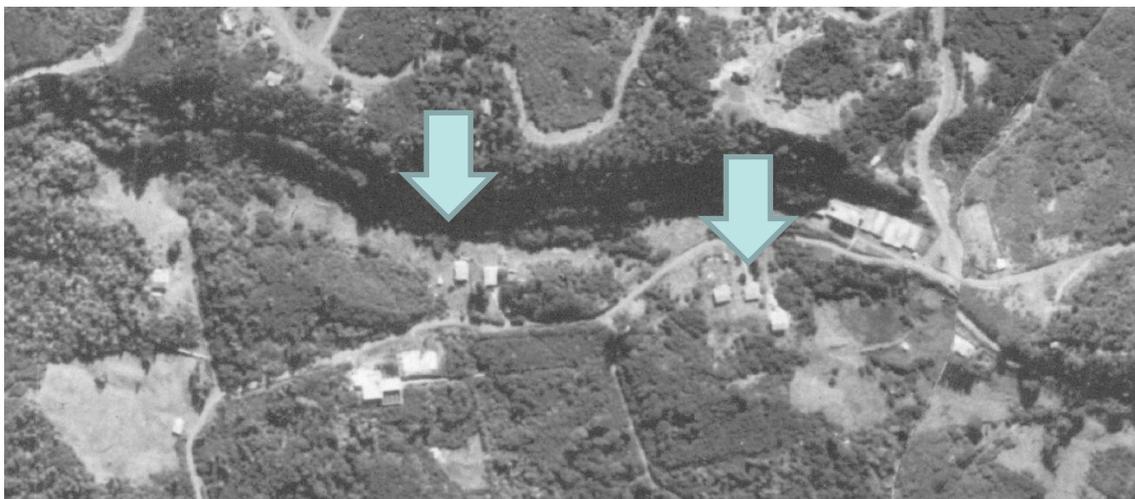
Figure 6: 1940 aerial photograph of Huia WTP and surrounds. Arrows indicate proposed reservoir site (north of Woodlands Park Rd) and Manuka Rd site.

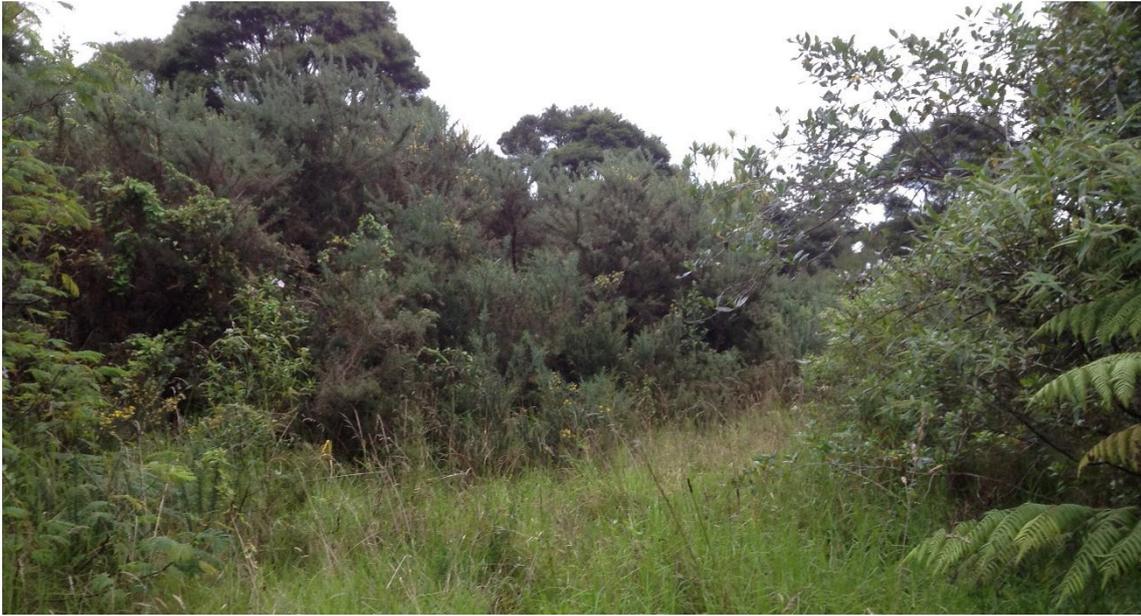
Figure 7: Modified scrub and weedfield within northern portion of Manuka Rd site.

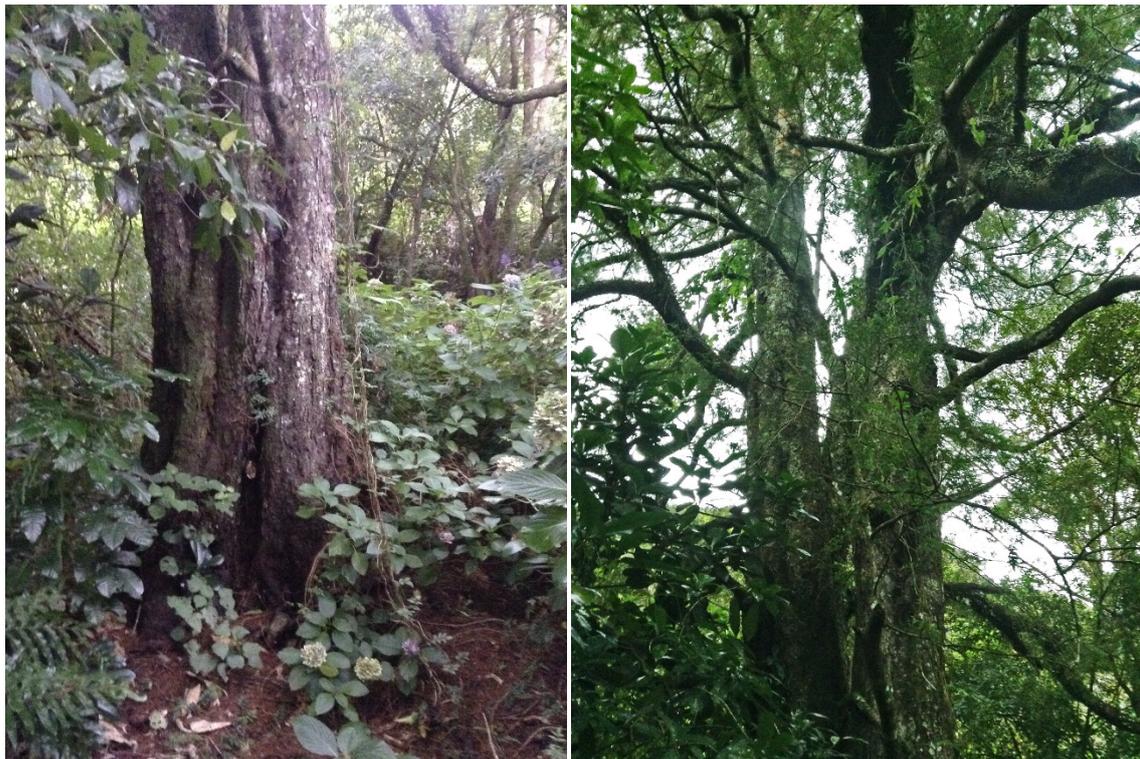
Figure 8a, b): Mature podocarps within kanuka forest in Manuka Rd site.

A walking track (“Clarks Bush track”) intersects the Manuka Road property approximately east – west, descending towards the south-eastern corner of the site. Northwards of the track, the site has been modified by partial historic clearance (dwellings were once present in this part of the site; refer Fig. 6) and subsequent weed encroachment. Vegetation comprises a mosaic of stands of mature kanuka with scattered kahikatea and rimu (an early successional stage of WF11 kauri-podocarp-broadleaved forest; Singers et al 2017); patches of secondary scrub containing mahoe, kanuka and associated native trees and shrubs (cabbage trees, nikau, tree fuchsia, matipo, treeferns, etc); and weedy exotics (gorse, pampas, wattle, shrubby garden escapes; Fig. 7). Occasional mature podocarps (Fig. 8a, b) and saplings of canopy trees (rimu, kahikatea, kauri,

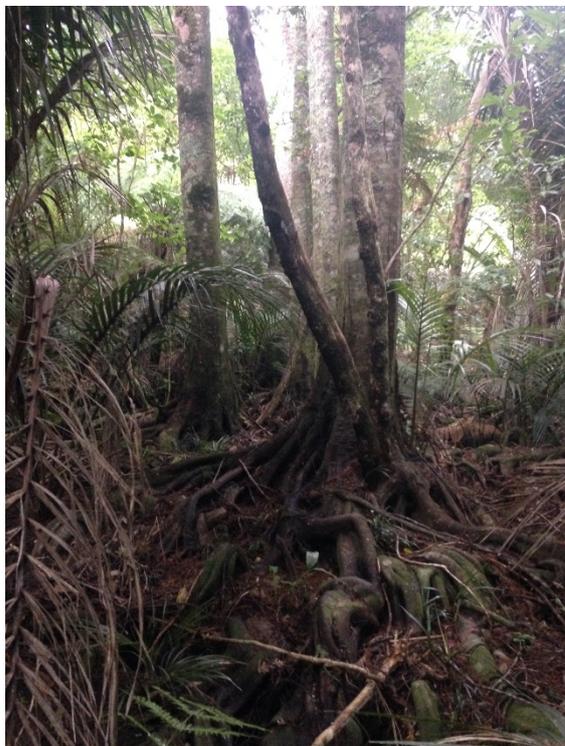
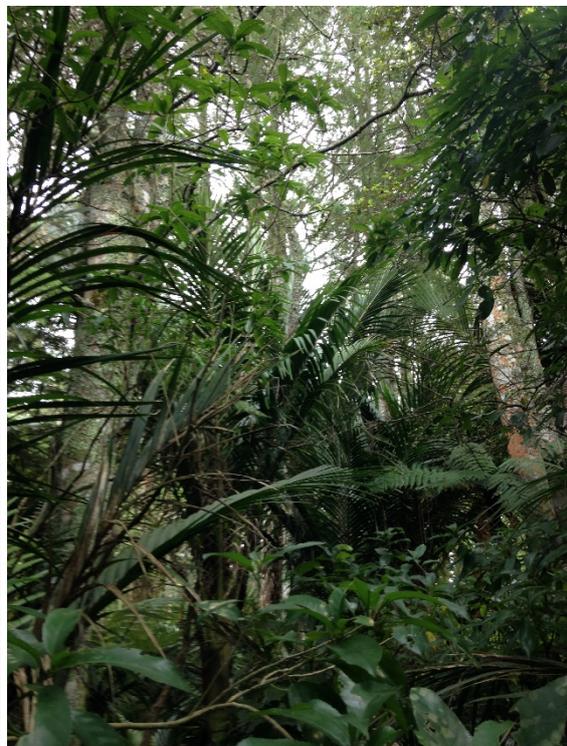
Figure 9a - c: Kahikatea-pukatea (WF8) forest understorey

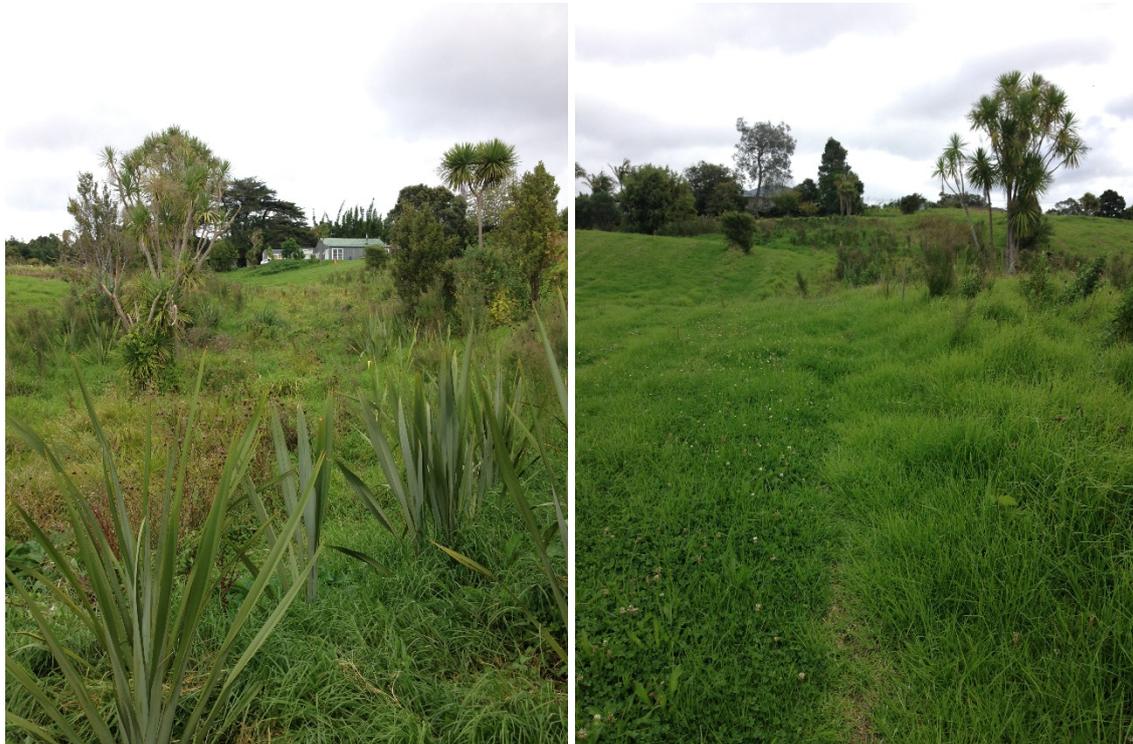
Figure 12a,b: Grassland with intermittent plantings across Parker North site. ‘

The western side of the property is primarily grass covered and was historically an orchard, while the eastern side contains native forest known as Allen’s Swamp. A low-lying area has been patchily planted in wetland species (Fig. 12a), and scattered native trees (mainly cabbage trees, with a few karamu, matipo, manuka, etc) are sparsely scattered across the site (Fig. 12b).
