# Quarterly Summary

## Māngere Wastewater Treatment Plant

Reporting period: December 2025 – February 2026

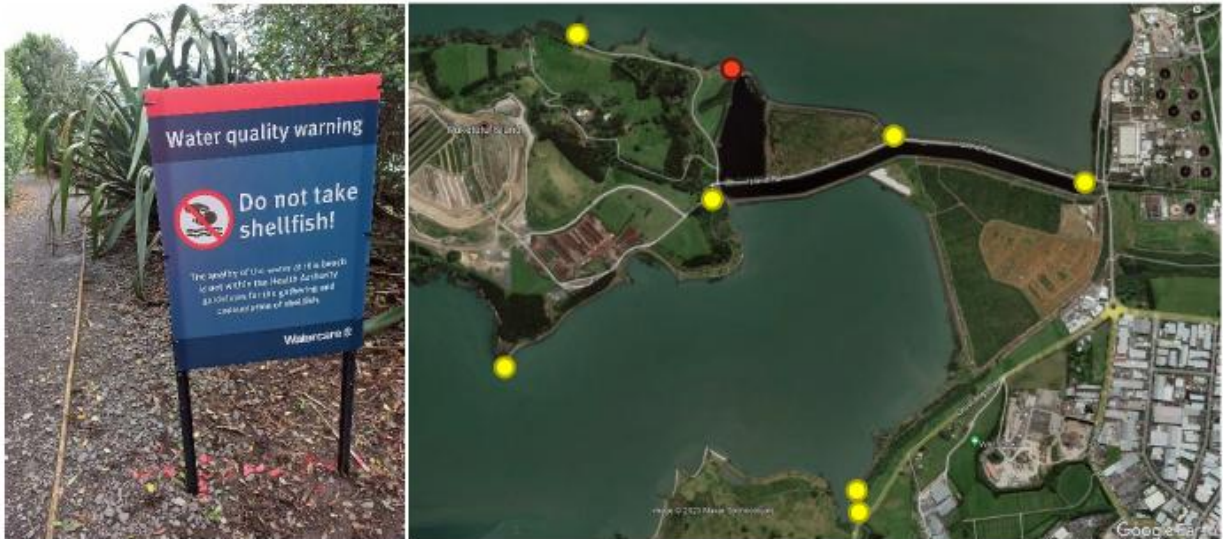
Figure 2-1: Example and locations of shellfish warning signage put out in response to plant UV incidents (yellow dots); the red dot indicates the permanent signage near the discharge.

Temporary warning signage was placed at the seven locations, as indicated on Figure 2-1 below, following notification of each incident. The signs remained in place until the test results were received confirming no virus was detected in the shellfish samples. In addition, a warning flag was posted on the Safeswim website, as per Figure 2-2.

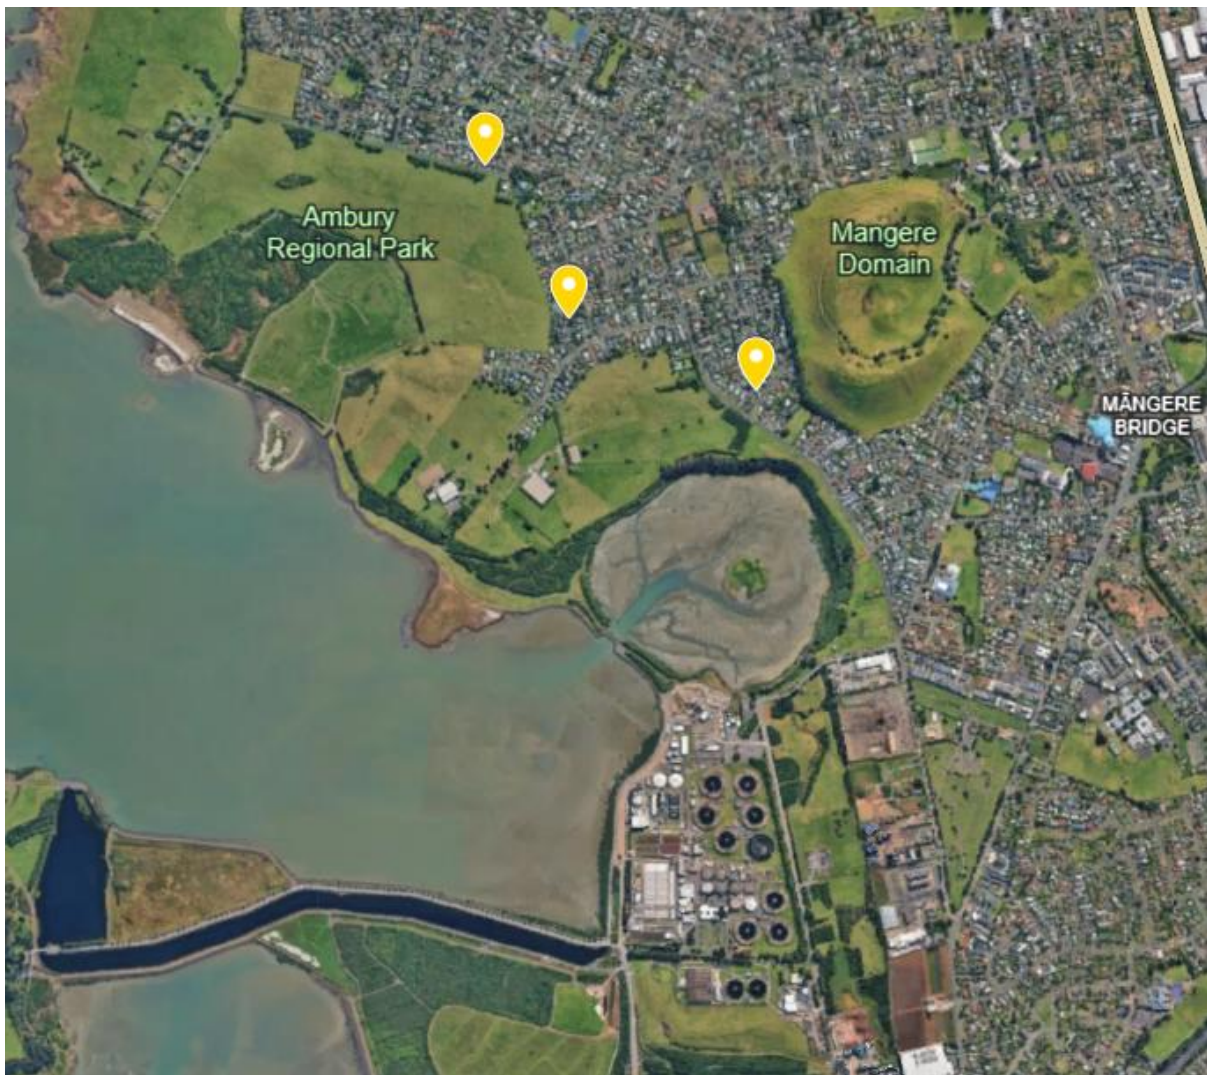
**Figure 6-1: Locations of the odour complaints from February / March in relation to the WWTP.**

In response to these complaints, local network lines in the direct vicinity of each property were inspected following each complaint, and the manholes of the Western Interceptor within this area were also inspected to investigate potential odour-causing issues. Whilst no obvious odours or issues were identified during these inspections, as a precaution, manhole seals on the Western Interceptor were replaced. Recent flow diversions as part of the Central Interceptor Project have significantly reduced the flow through the Western Interceptor. Additional community odour scouting has also been undertaken over the weeks of 2 and 9 March in attempt to validate the odour and identify the source(s). Due to time constraints, monitoring methodology was a reduced version of the standard monthly community monitoring, focussing on at least one upwind and three downwind locations (as per the locations in Figure 5-1), with a minimum of two runs on each day (am and pm). Areas around each of the complaint addresses were also visited on multiple occasions. Field sheets from this additional monitoring have been saved electronically; as of the time of issuance of this report, no odours have been detected downwind of the plant that could be associated with plant operations.

Via	Type	Date / Time	Address	Feedback	Follow up/ Additional Comments
Auckland Council	Odour	27 February 2026 7:00 am	Ambury Road, Mangere Bridge (see Figure 6-1)	Via Auckland Council Complaints: “ <i>Significant odour was being emitted from the Mangere Wastewater Treatment Plant</i> ”	<p><u>Comments:</u> Complaint initially lodged with Auckland Council, reporting odour from the WWTP on 27/02, received by Watercare 3/03. Customer was phoned and described the odour as obvious sewage type odour and rated it a 9/10. The odour persisted for about an hour. They said they experience faint odour from time to time but that on this occasion it was particularly strong. No further odour have been noticed since 27 Feb. The southern networks team investigated the network in the area on 3 March but found all manholes etc to be flowing as normal. They noted no odour at the time.</p> <p><u>Wind data:</u> Variable, average of ~4km/h (light air) from midnight through to 8am, then picking up to ~9km/h (light breeze). Direction was dominant NE @ 5am, switching SE to 7am, then S/SW for remainder of day.</p> <p><u>Conclusion:</u> No maintenance occurred at the plant that could have contributed to odour, no incidents or other known issues occurred at this time. Ongoing issues with Digester 3 are known, but weekly onsite monitoring since January has not identified a change in odour around the plant, and community monitoring, consistently undertaken during S-SW winds over the last two months, has also not detected odours within the Māngere Bridge area. Nonetheless, with the address being roughly north/northwest of the plant, the plant cannot be excluded as a potential source.</p>

Faults	Odour	27 February 2026 9:00 am	Waiana Ave, Mangere Bridge (see Figure 6-1)	I just had a customer that lives at Waiana Ave complaining about a strong sewerage smell coming from the Mangere Wastewater Treatment plant.	<p><u>Comment:</u> The customer was called at approximately 1:30pm on 27/02, they said the odour was present around 8-10am this morning and that it was a strong foul/sewage odour that hung around; rated it a 7 or 8/10. They weren't home when called but did not think the odour had persisted longer than 10am. They said it is the second time they have noticed it recently. The Southern Networks team inspected the surrounding wastewater network; no issues or odours were identified.</p> <p><u>Wind data:</u> Wind records from Mangere Bridge are light (between 1.9-7.4km/h) in the hours prior to the complaint. Direction was variable; predominantly W/SW until around 4am, then switching NE until around 5am, then switching SE-SW from 6am onward.</p> <p><u>Conclusion:</u> As above, with the address being roughly north/northwest of the plant, the plant cannot be excluded as a potential source.</p>

<p>Faults</p>	<p>Odour</p>	<p>24 February 2026 10:27 pm</p> <p>27 February 2026 11:09 pm</p> <p>3 March 2026 10:26 pm (outside of this reporting period).</p>	<p>Pikitea Road, Mangere Bridge (see Figure 6-1)</p>	<p><i>“Smell of sewage plant is unbearable at this time from our street. Can this be registered as an official complaint”.</i></p>	<p><u>Comments:</u> Complaint received by Envcare 4/03. Customer was called, they advised the smell has been on and off for roughly 10 days. Customer advised he had logged earlier complaints that were not followed up. Described the odour as pungent/sewer odour, rated 8 or 9 out of 10. The odour is present in the evenings but not at other times of the day. It gets drawn into the house through the ventilation and persists. Followed up with Faults team, who sent through the previous two complaints from 24/02 and 27/02.</p> <p>The southern networks team investigated the network in the area on 6/03 but found all manholes etc to be flowing as normal; no odour was noted at the property during the inspection. The Western Interceptor transmission line around this area was also inspected; whilst no odours or issues were noted, manhole seals were replaced as a precaution.</p> <p><u>Wind data 24/02:</u> Dominant SSW from ~11am, switching S around 9pm. Average of ~18km/h (gentle breeze).</p> <p><u>Wind data 27/02:</u> Dominant S-SSW direction from 3pm through to 11pm, average of 15km/h (gentle breeze).</p> <p><u>Wind data 3/03:</u> Dominant Southerly direction from 8pm (SSW prior), average of 20km/h (moderate breeze).</p> <p><u>Conclusion:</u> As above, with the address being roughly north/northwest of the plant, the plant cannot be excluded as a potential source.</p>
