Quarterly Summary

Māngere Wastewater Treatment Plant

Reporting period: June – August 2025

Watercare

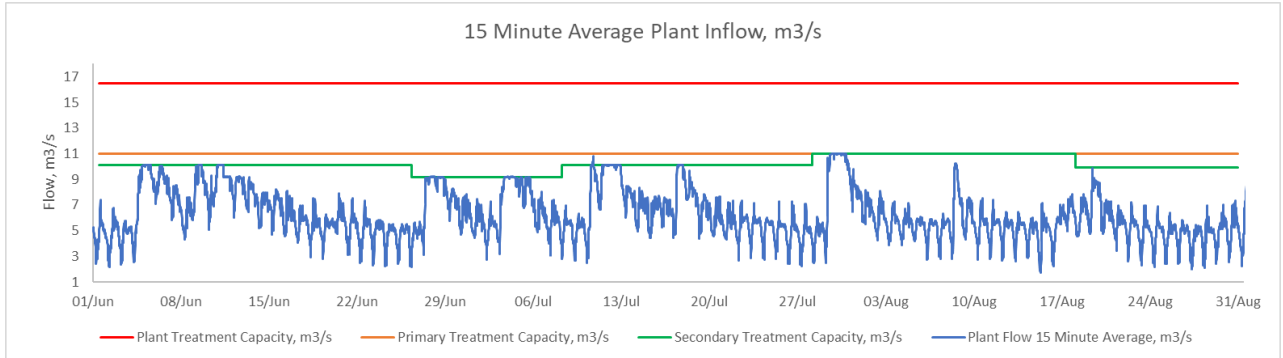
15-minute interval plant flow

There were eleven RC Filter bypass events during this quarter. Please refer to the detailed information in the high flow diversion table. Secondary Treatment Capacity set point was 9.2 – 11.0 m³/s in this quarter.

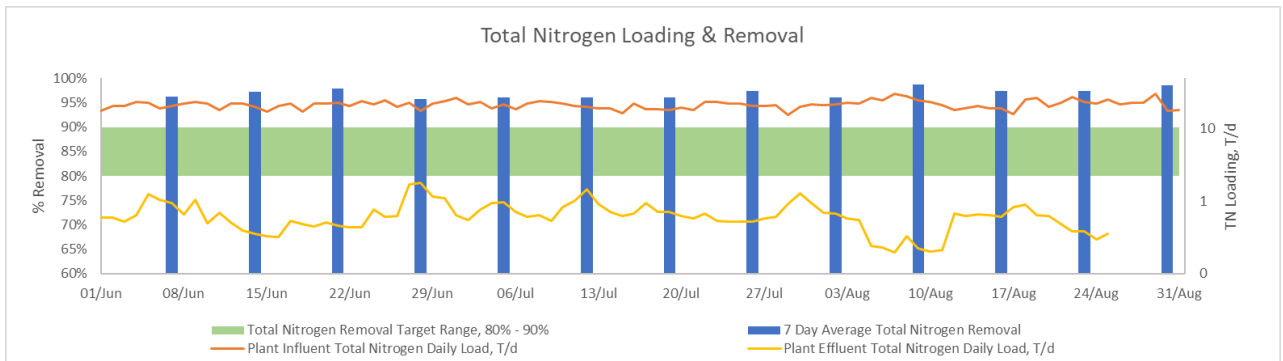
Total Nitrogen removal and loading

Please note logarithmic scale on secondary vertical axis (Loading, T/d).

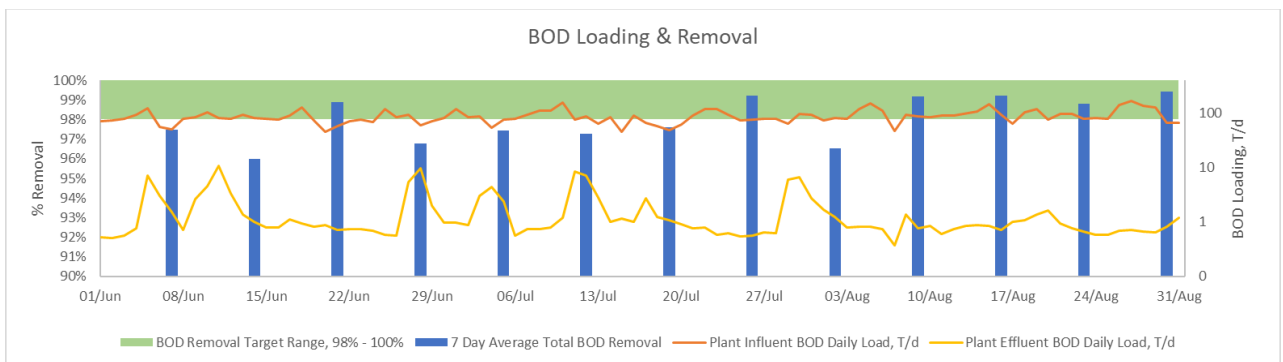
BOD removal and loading

Please note logarithmic scale on secondary vertical axis (Loading, T/d). Seven weekly average BOD removals across this quarterly period were below the target range; each linked to secondary bypass events.

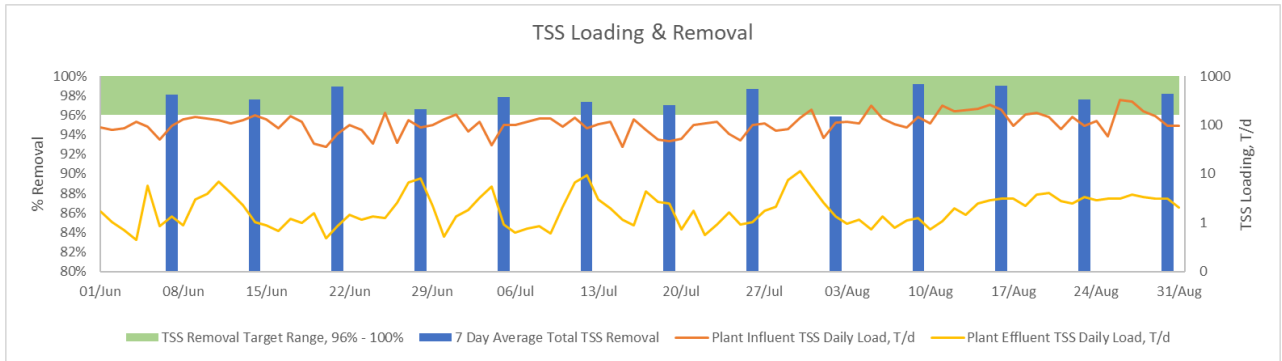
TSS removal and loading

Please note logarithmic scale on secondary vertical axis (Loading, T/d). The slightly lower weekly average TSS removal on 3 August is attributed to secondary treatment bypasses on 29 & 30 July; which resulted in removal rates slightly lower than usual.

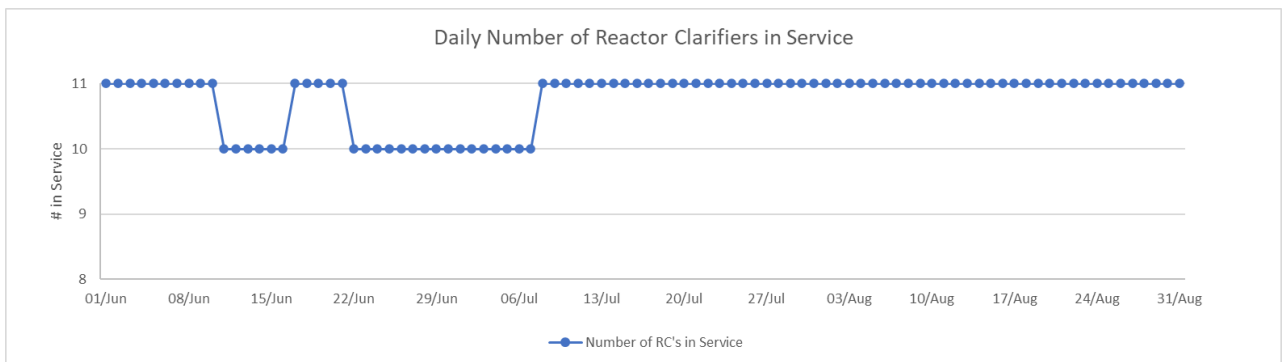
Number of Reactor Clarifiers in service

Reactor-Clarifier 4 was taken out of service for maintenance repairs (scum trough) between 11 and 16 June.
 Reactor-Clarifier 7 was taken out of service for baffle wall repairs between 22 June and 8 July.

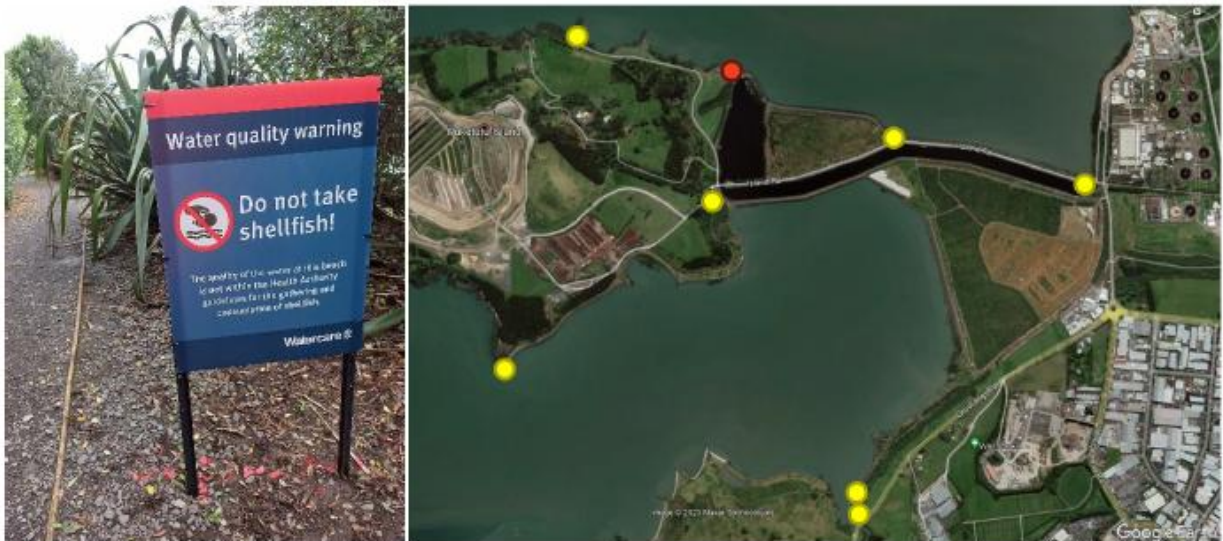
Figure 2-1: Example and locations of shellfish warning signage put out in response to plant UV incidents (yellow dots); the red dot indicates the permanent signage near the discharge.

Temporary warning signage was placed at the seven locations, as indicated on Figure 2-1 below, following notification of the first incident on 11 August. The signs remained in place until the final test results were received from the 2 September sampling confirming no virus was detected in the shellfish samples. In addition, a warning flag was posted on the Safeswim website, as per Figure 2-2.

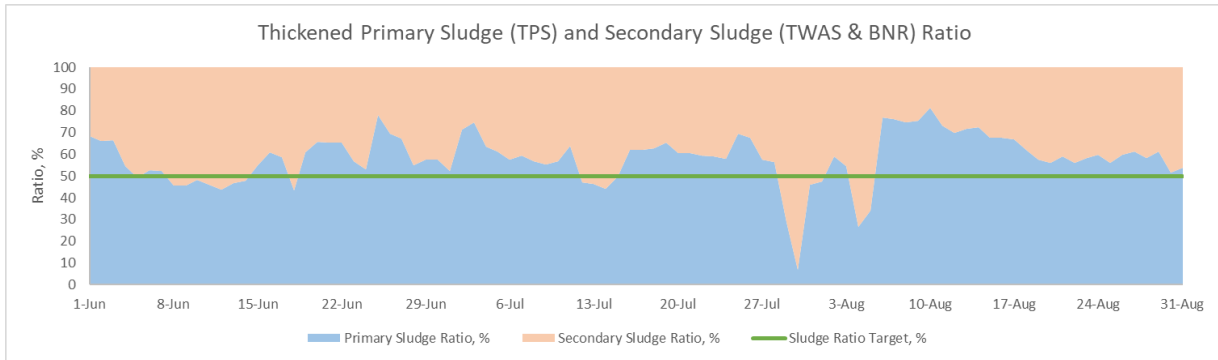
Primary and Secondary sludge ratio

TPS pump suction line was blocked between 28 July and 5 August which caused low TPS flow during that period resulting in low Primary sludge ratio.

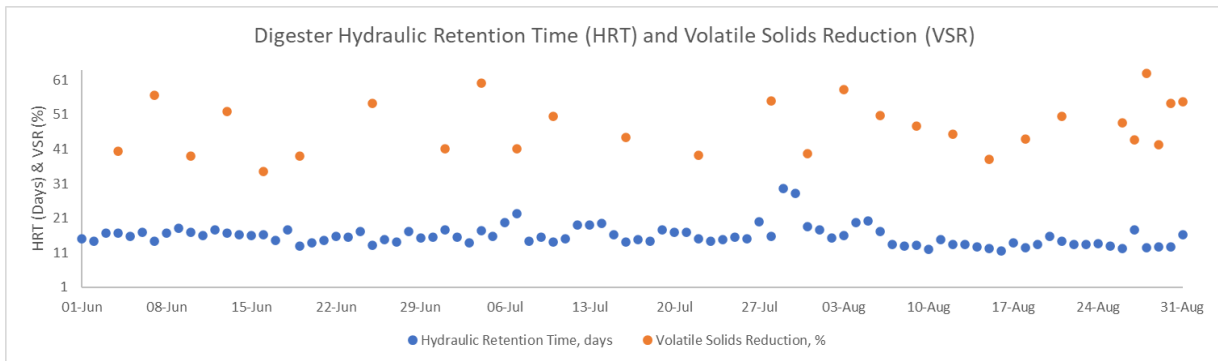
Digester performance

The slightly higher HRT on 29 & 30 July was due to reduced TPS flow because of the line blockage. Feed to the digester was also reduced, resulting in higher HRT.

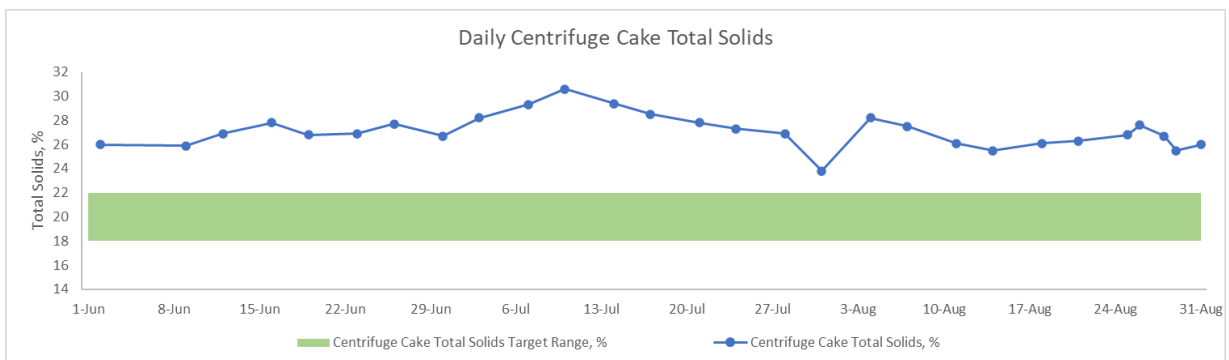
Dewatering performance

Centrifuge cake solids are above the target.

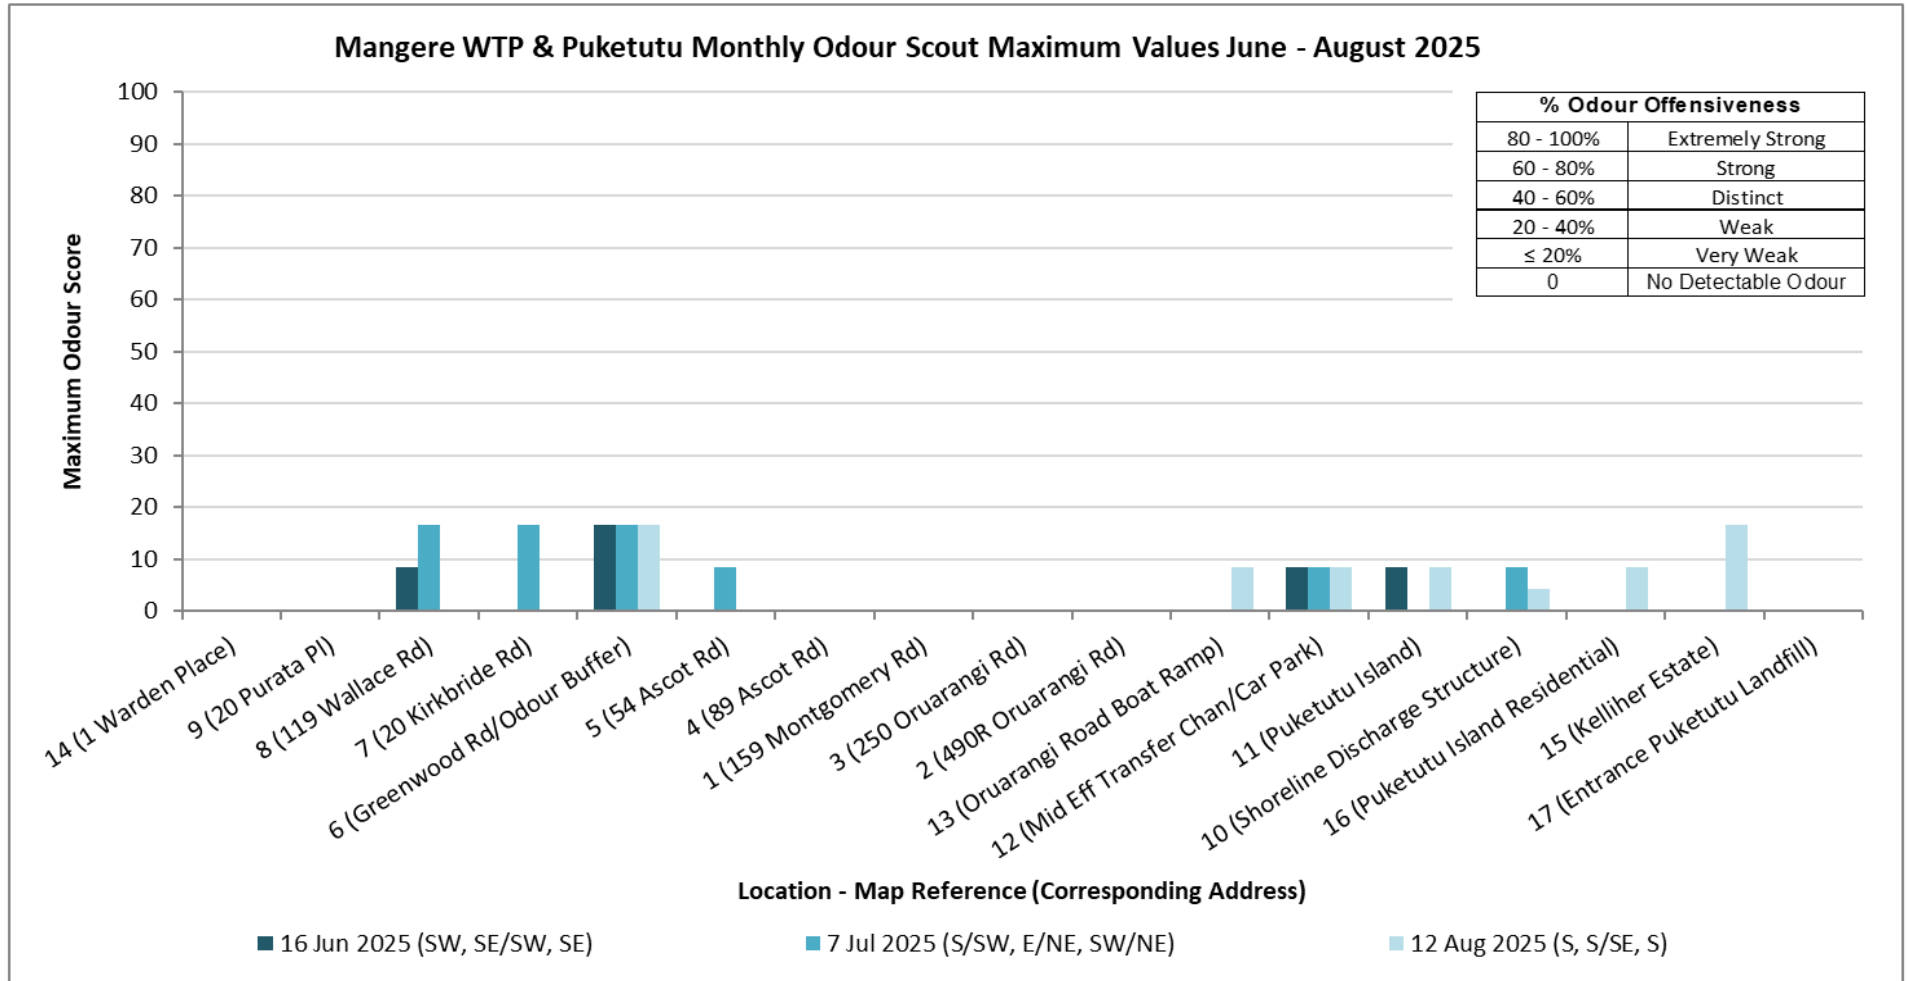
Monthly walkover results (WWTP, Puketutu Island, and surrounding areas)

Note: Odour scout locations on x-axis listed clockwise from northern-most position as per Figure 5-1 below.

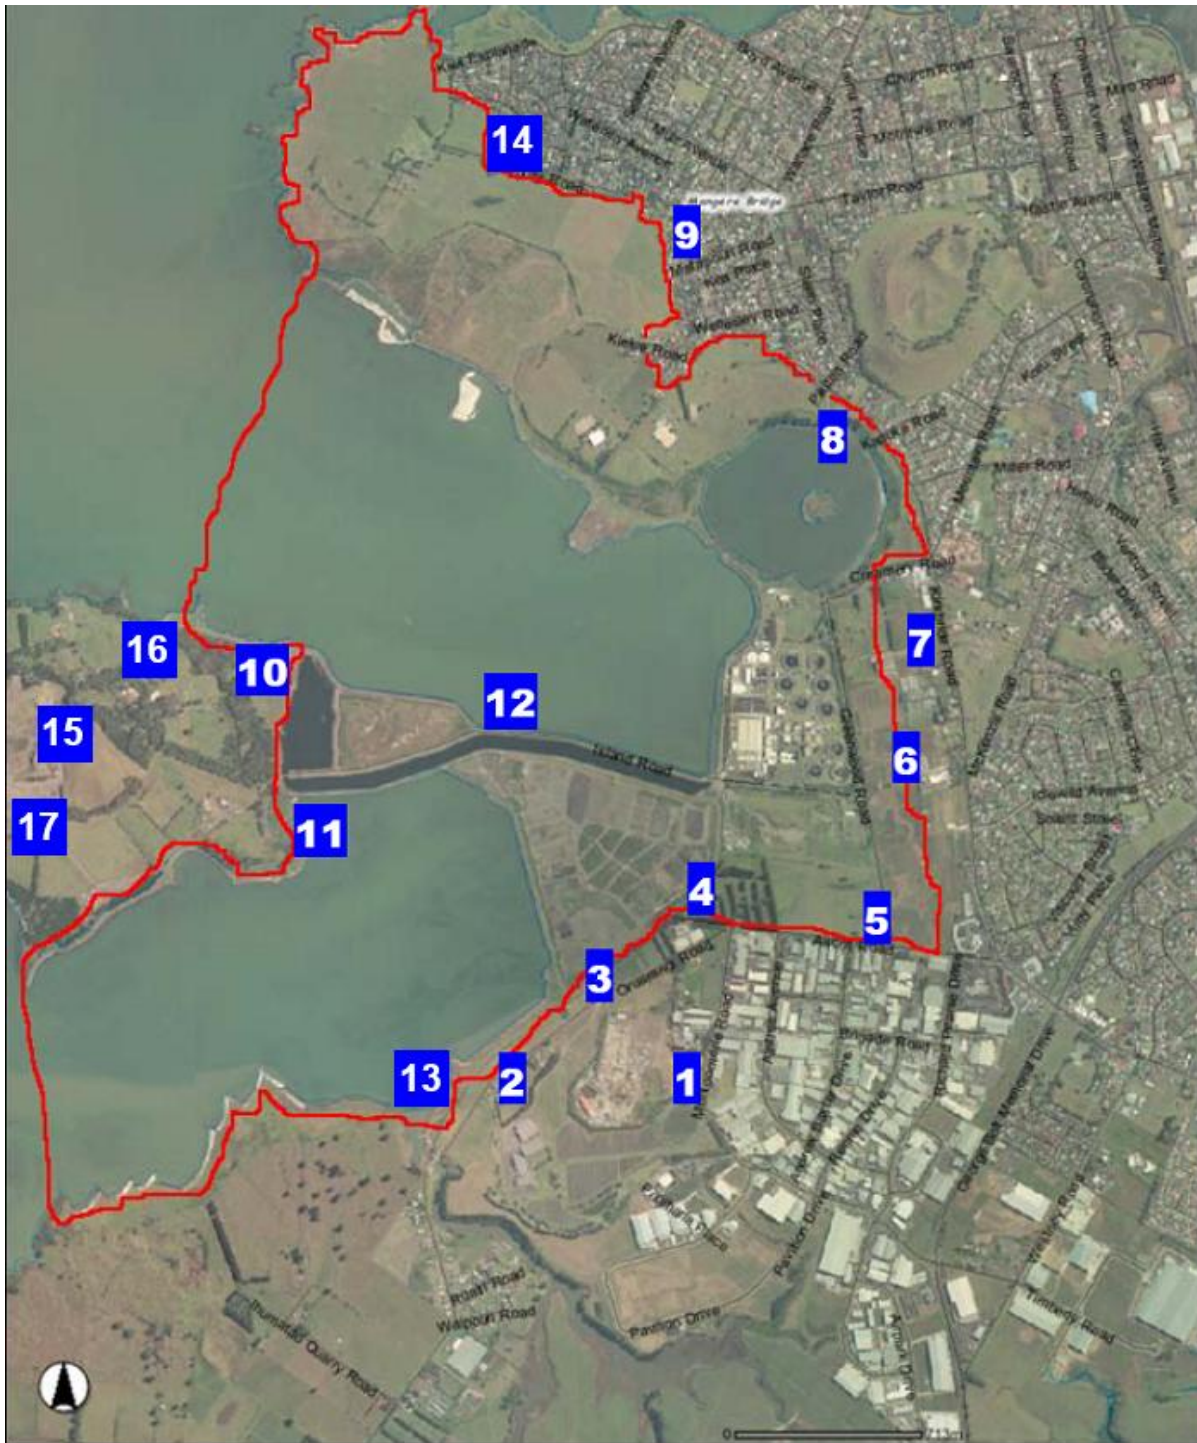
Monthly walkover map

Figure 5-1: Monthly Community Odour Scouting Locations.

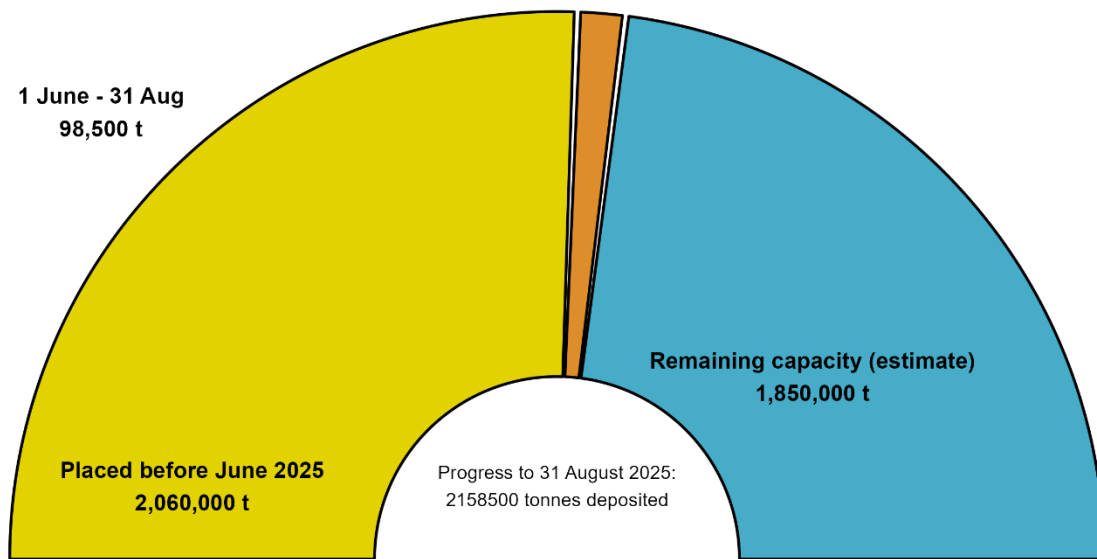
Figure 7-1: Material placement (biosolids and cover/construction) at Puketutu Biosolids Facility to date.

34,425 tonnes of biosolids material was placed at the Puketutu Biosolids Facility during this quarter. Since the commencement of operations on 1 December 2014, Watercare has placed 2,158,500 tonnes of combined biosolids and cover/construction material. The storage capacity is approximately four million tonnes, so we are at 54% completion.

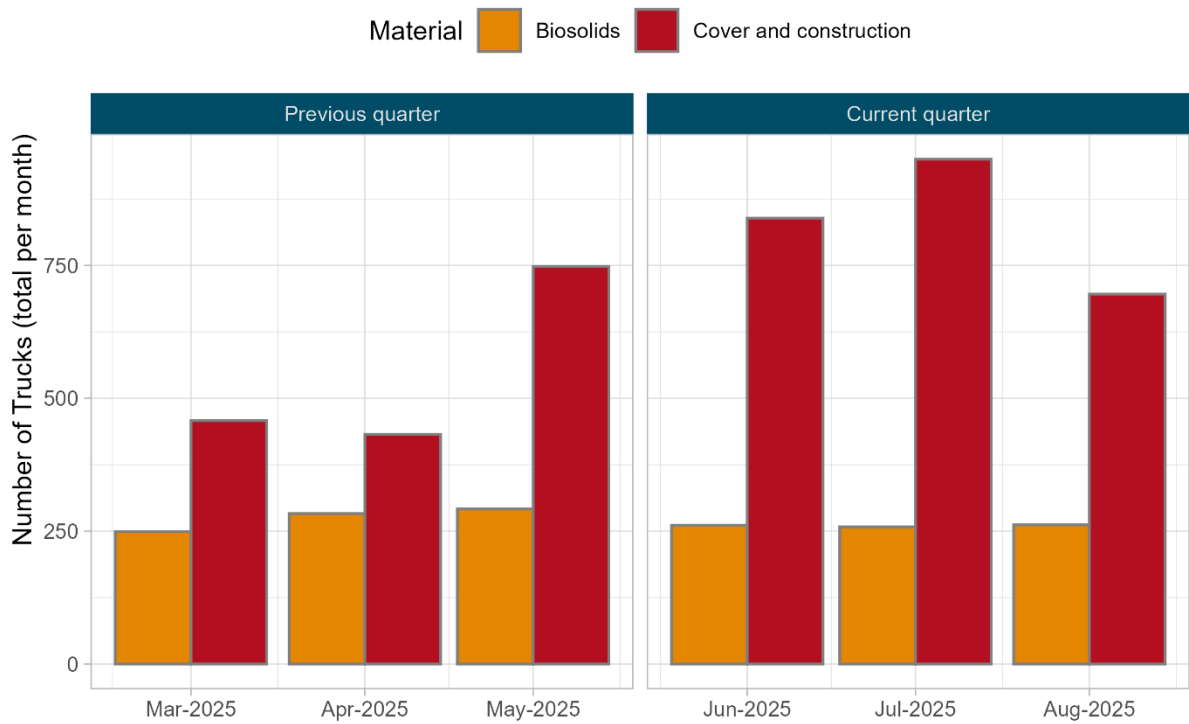
Figure 7-2: Monthly truck deliveries to Puketutu Biosolids Facility

Biosolids truck movements were comparable to the previous quarter. There was an increase in cover and construction material deliveries to the site since approximately May to facilitate road and cell wall construction. Currently, Biosolids are deposited along the phase 5 embankment; this location doesn't allow the installation of long cells and forces the construction of multiple smaller cells. This has led to an increase in the number of cell walls to be built and subsequently more material required to be brought to the island.

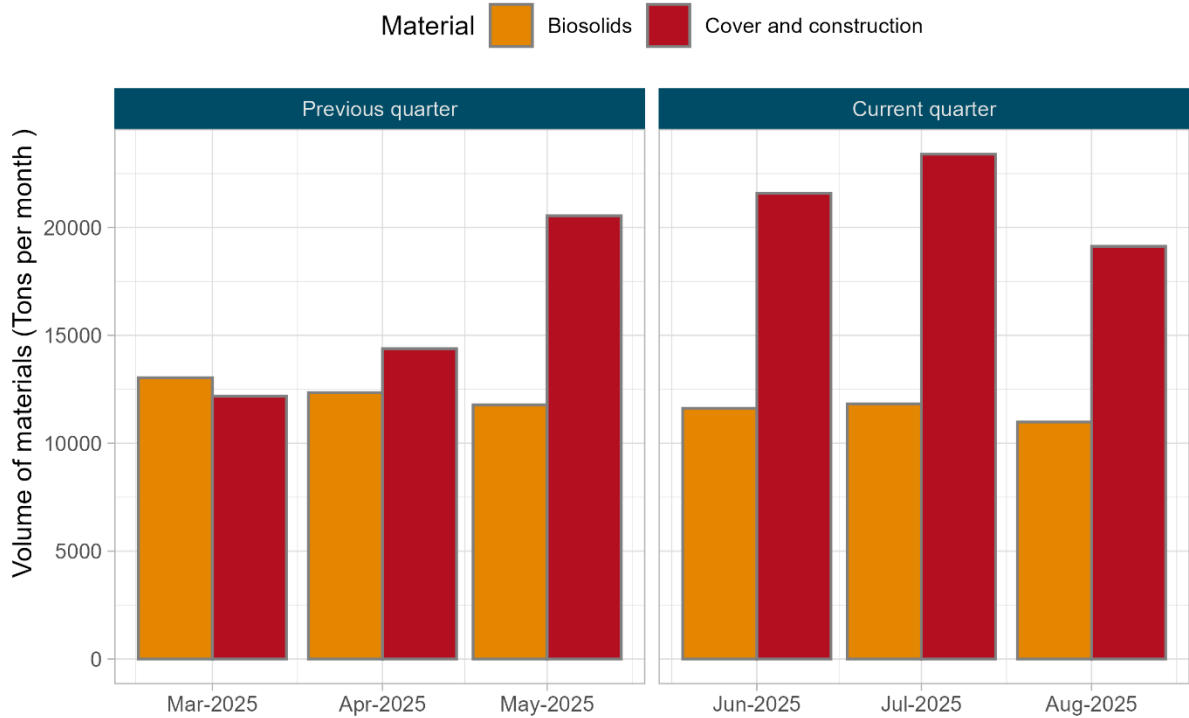
Figure 7-3: Monthly tonnages received at Puketutu Biosolids Facility
