# Quarterly Summary

## Māngere Wastewater Treatment Plant

Reporting period: March – May 2026

## Quarterly Operations Executive Summary

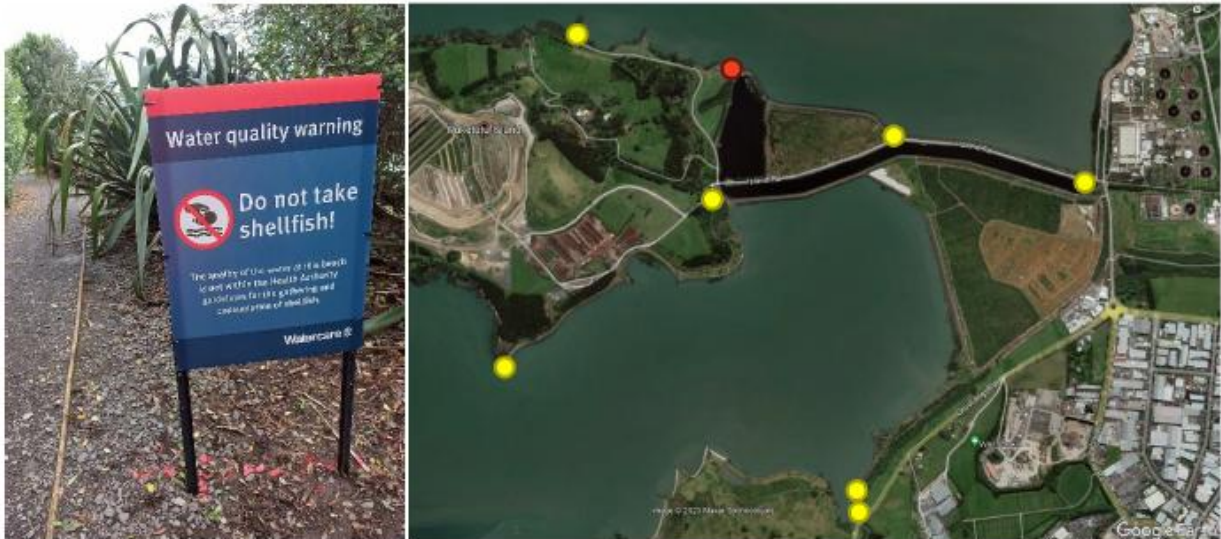
Figure 2-1: Example and locations of shellfish warning signage put out in response to plant UV incidents (yellow dots); the red dot indicates the permanent signage near the discharge.

Temporary warning signage was placed at the seven locations, as indicated on Figure 2-1 below, following notification of the 26 March event. The signs remained in place until the final test results were received from the 29 April sampling, confirming no virus was detected in the shellfish samples. In addition, a warning flag was posted on the Safeswim website, as per Figure 2-2.
