Preliminary Site Investigation

Point Erin Park

Prepared for
Watercare Services Limited

Prepared by
Tonkin & Taylor Ltd

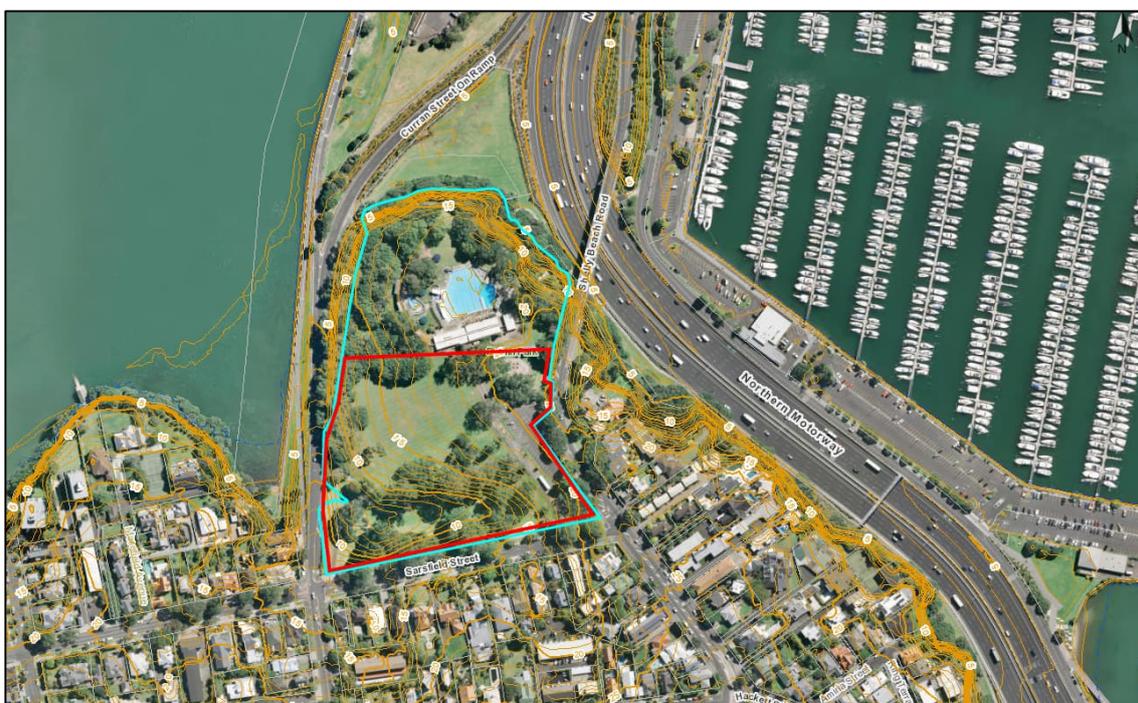
Figure 1.1: Site location (shown in red) and property boundary (shown in blue) with available online contours shown (Source: Auckland Council Geomaps)

Tonkin & Taylor Ltd (T+T) has been commissioned by Watercare Services Limited (Watercare) to undertake a Preliminary Site Investigation (PSI) for the land where infrastructure works is being proposed on the southern end of 94 Shelley Beach Road, Ponsonby (herein referred to as 'the site'). The extent of the site and property are shown by the red and blue solid line respectively on Figure 1.1 below.

The site (shown in Figure 1.1:) is located on the southern end of Point Erin Park and is accessed from driveway and carpark off Shelly Beach Road. The proposed area measures approximately 20,100 m² in area. The topographical survey information available on Auckland Council Geomaps indicates that the site generally slopes toward the southwestern corner of the site. The contours also show a sharp slope towards the northern end of the property and suggests that the northern end of the property is on a cliff and Point Erin Park is on a headland.

The site is bounded by Shelly Beach Road to the east, Sarsfield Street to the south, Curran Street to the west, and the northern area of Point Erin Park in the north as shown in Figure 1.1:. The Northern Motorway runs to the north-east of the site. Site identification information is presented in Table 2.1.

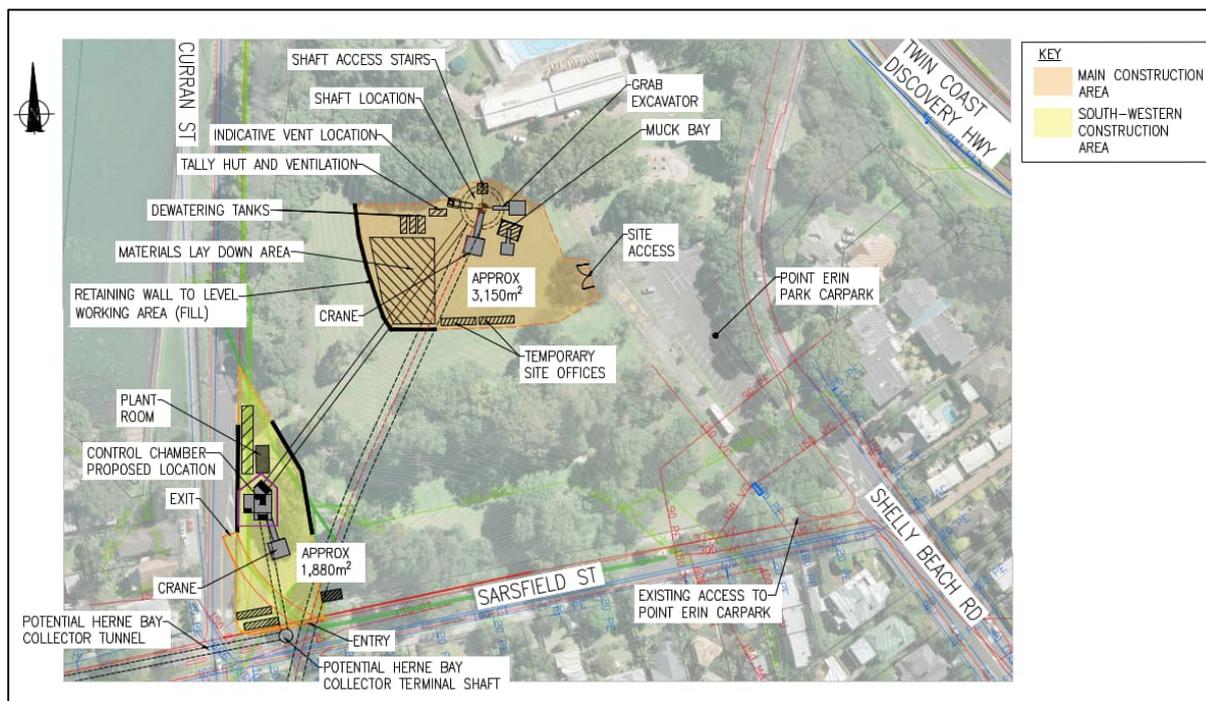
Figure 1.2: General layout of works within Point Erin Park

additional controls and consents under the NESCS and AUP(OP)³ are required. The general site layout for the proposed works is shown below in Figure 1.2.

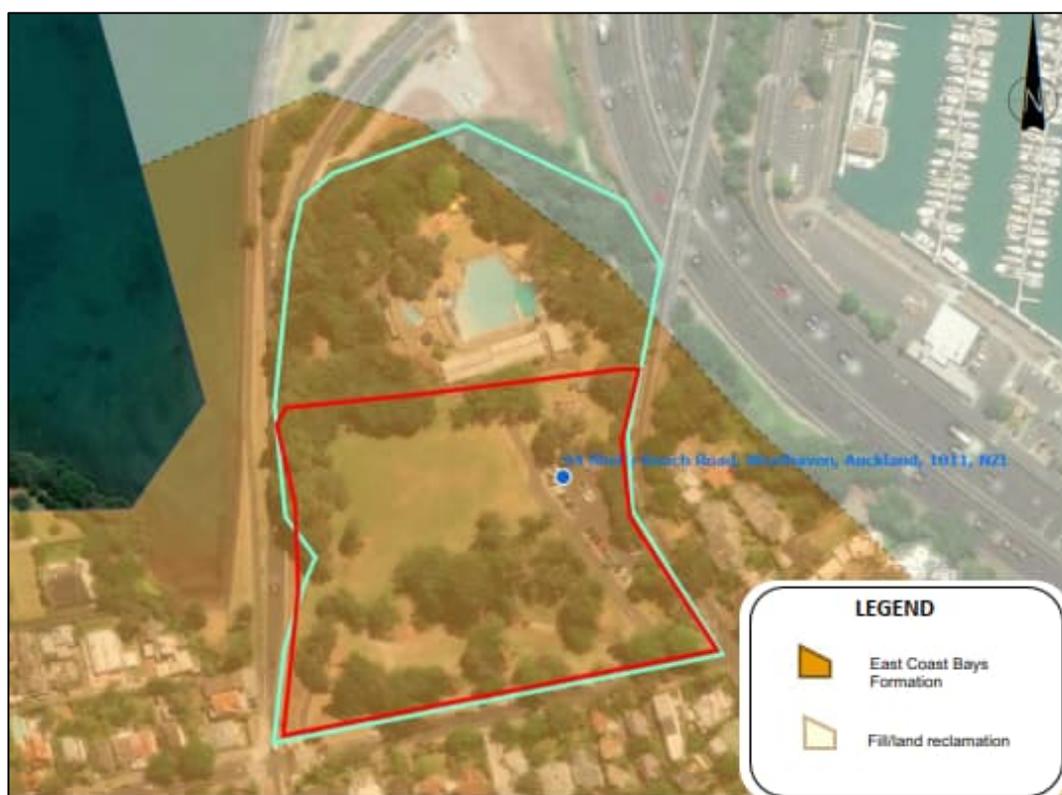
Figure 2.1: Published geology (Source: Kermodé)

Published geology⁴ shown below in Figure 2.1 indicates that the site area (including the northern part of the property which forms the headland) is underlain by rock of the East Coast Bays Formation (ECBF).

At lower elevations towards the north of the headland area, unweathered and weathered ECBF are overlain by fill and mixed marine and alluvial deposits of the Tauranga Group.

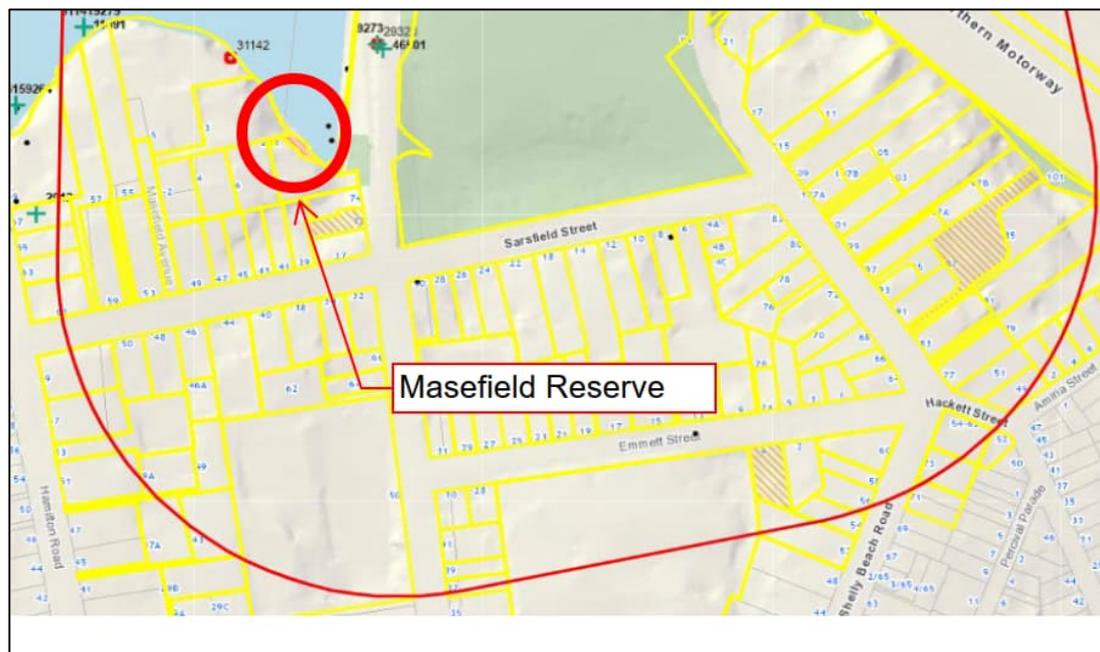
Figure 3.1: Masefield Reserve Closed Landfill, within 200 m of the site (radius shown in red) (Source: Auckland Council)

The Council contamination enquiry identified Masfield Reserve (approximately 40 m west of the site) as an Auckland Council owned closed landfill (shown in Figure 3.1). Auckland Council's Closed Landfill Team (per communications with Oscar Simons⁸) has confirmed that they do not hold detailed information of the closed landfill. Under their Asset Owner Approval criteria (AOA)⁹, the Masfield closed landfill is identified as a "moderate" risk landfill.

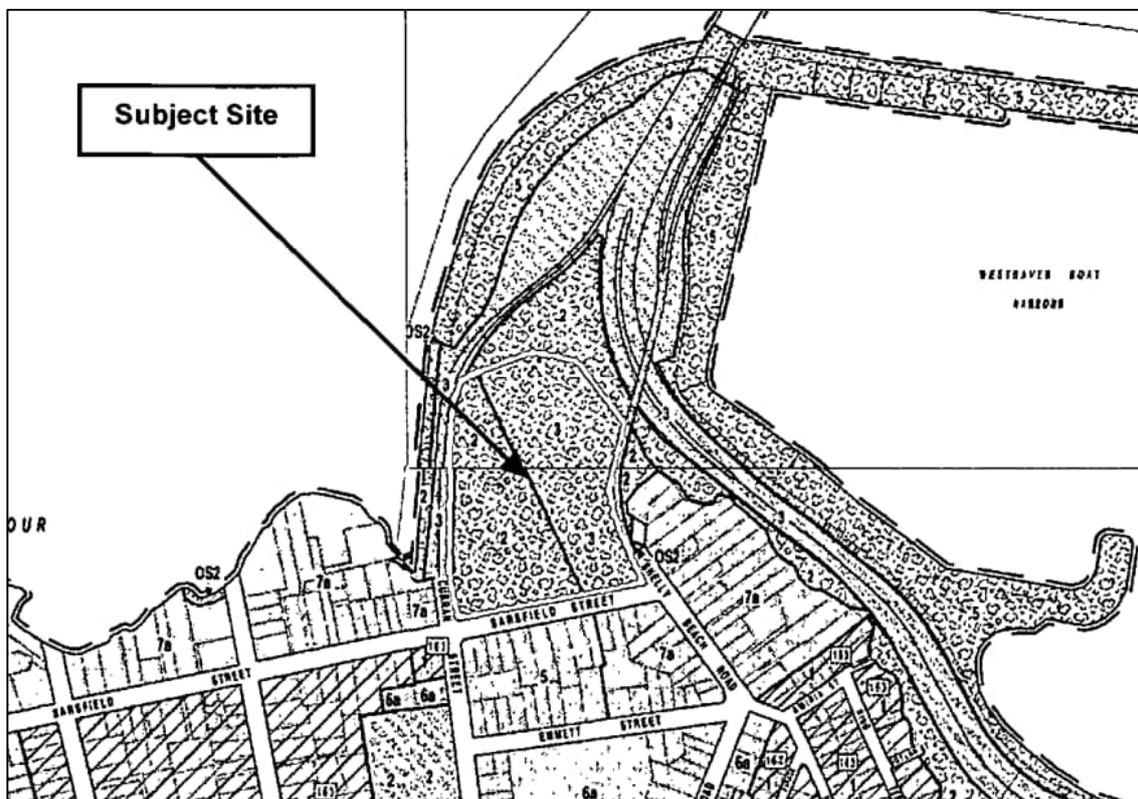
Figure 3.2: Proposed waterline development (Source: Auckland Council)

A reviewed consent report indicates that a consent for new water pipelines running through the subject site (connecting the Point Erin Pool to the realigned waterline) was sought by Watercare in 2010. The proposed water line traverses the property and site in the north-western to south-eastern direction as shown below in Figure 3.2. No documents relating to ground contamination were noted for this resource consent as part of the property file review.

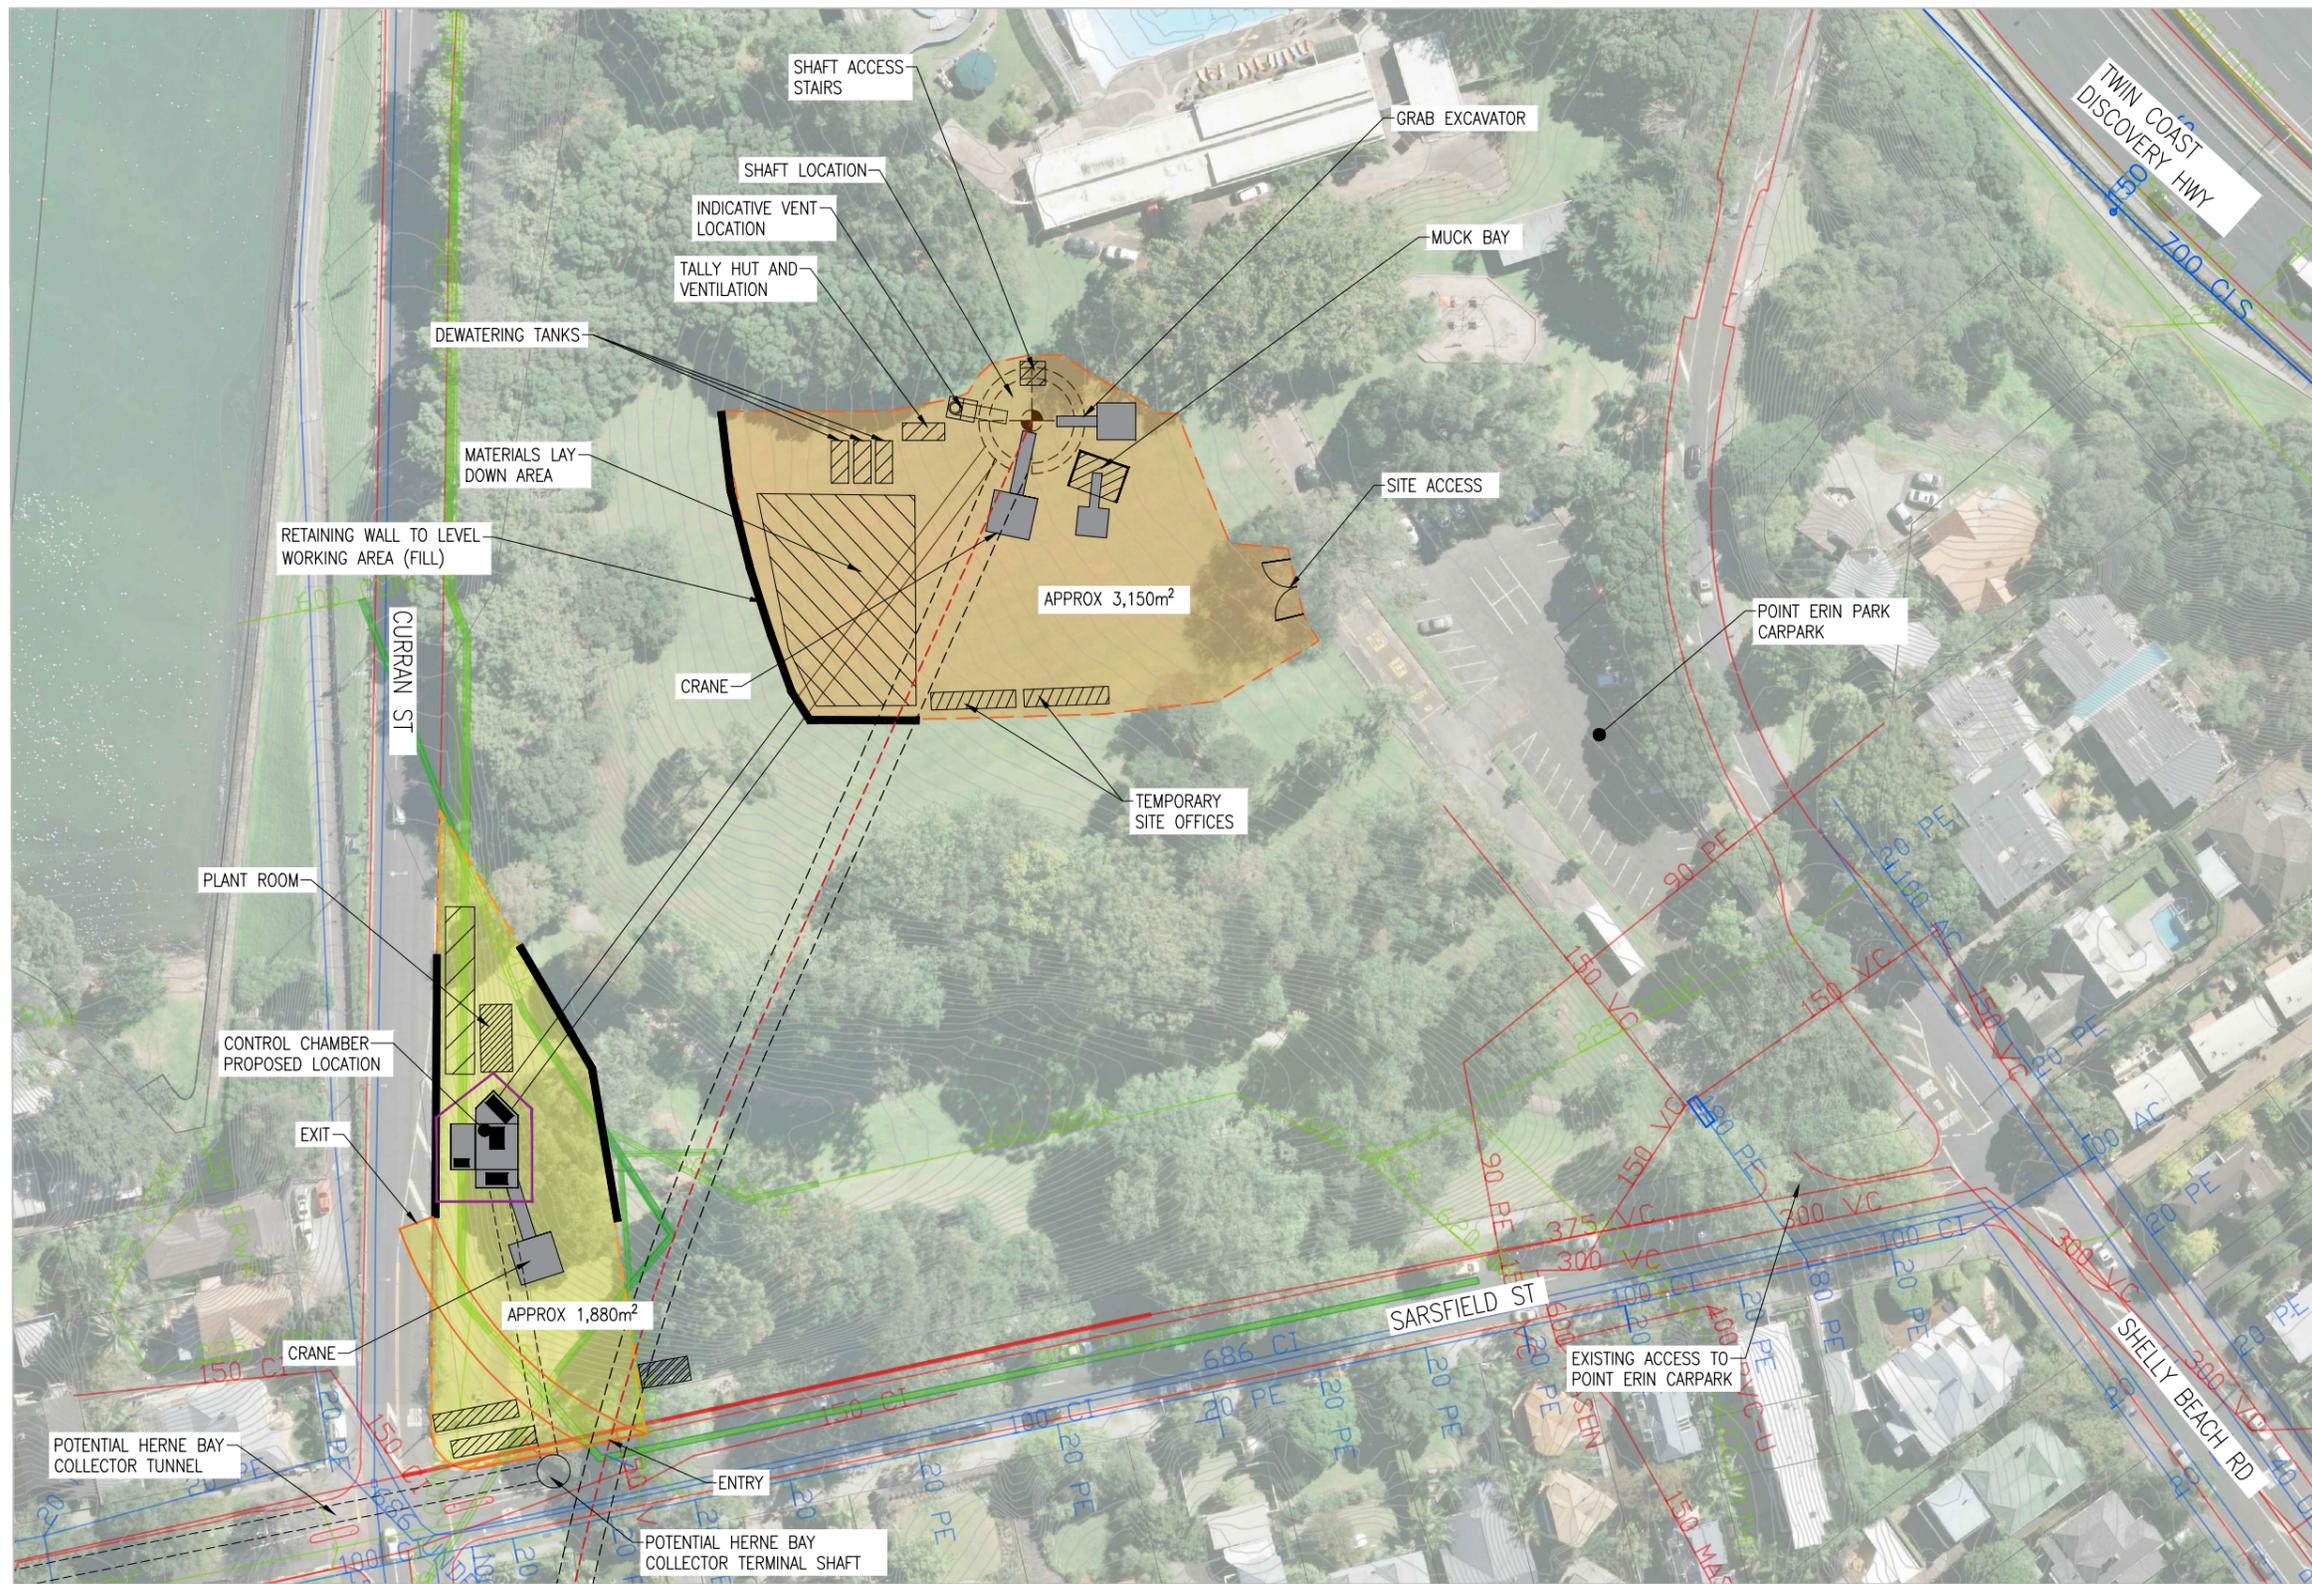
Appendix A Site layout plan

KEY	
	MAIN CONSTRUCTION AREA
	SOUTH-WESTERN CONSTRUCTION AREA

PLAN
SCALE: 1:500

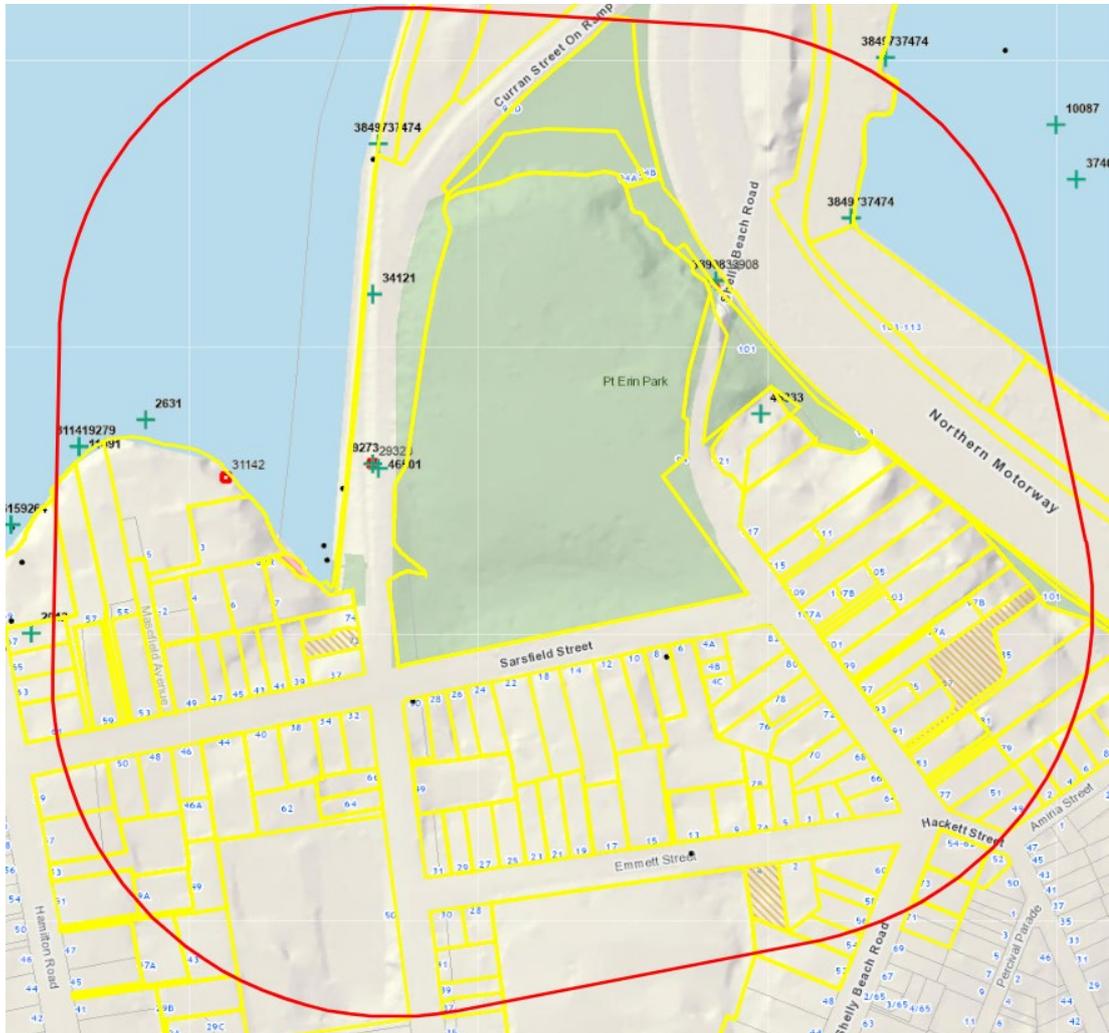
Figure 1: Selected Consents, Incidents and HAIL activities within approximately 200m of the subject site

The HAIL activity hatching in Figure 1 only reflects whether a site has been identified as a HAIL site (both verified and non-verified) by the Council and the type of HAIL associated with the site. This does not confirm whether the site has been formally investigated or the contamination status of the property (e.g. contaminated, remediated etc.). Additionally, due to limitations within Council's records, the specific HAIL activity is not included in the data for all properties. For further information on any of these known HAIL sites, a subsequent site contamination enquiry can be lodged for the specific property (up to 5 adjacent properties can be covered in one request).

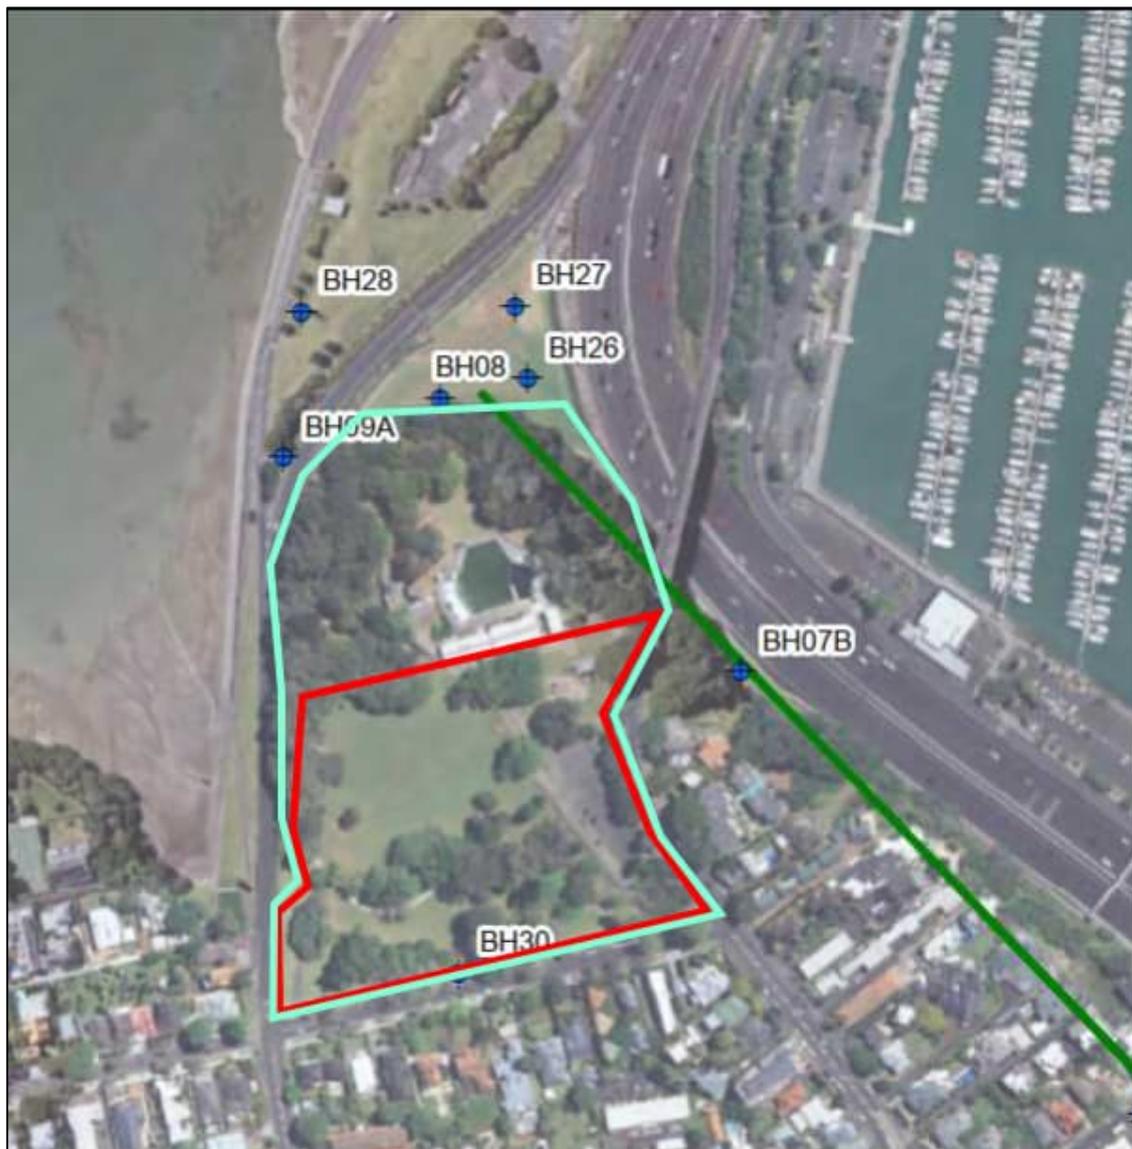
Figure 6-1: Previous soil investigation locations in the vicinity of Point Erin Park (Source: Aurecon DSI)¹². Site location shown in red with the property boundary shown in blue.

¹² BH30 was excluded from the investigations as it was outside the area of disturbance for the project.

A groundwater and settlement report⁵ produced by Aurecon for the St Marys Bay – Masefield Beach Water Quality Improvement Project indicates that for the low elevation areas at the base of the headland, groundwater is generally present at relatively shallow depths, <1 m – 3 m below ground level. Drilling undertaken by Aurecon⁶ indicates that groundwater was not observed to depths of at least 5 m in BH30 (shown in Figure 6-1) located just south of the site along Sarsfield Street.

Intrusive investigations were undertaken at the fringes of Point Erin Park to characterise soils in the area of the proposed St Marys Bay and Point Erin stormwater tunnel. Investigation locations were predominantly in the northern and western area of the park away from the site and within the reclamation fill, shown in Figure 6-1 below.

- Soils returned elevated levels of heavy metals and/or polycyclic aromatic hydrocarbons (PAH) that exceeded AUP Permitted Activity criteria at BH07, BH27, BH28, and BH09, where human health criteria for recreational use was also exceeded.
- The presence of asbestos was detected in BH27 and BH28. It was identified to pose a risk to construction workers and carries obligations under the Health and Safety at Work (Asbestos) Regulations.
- Waste-containing fill was generally classified as hazardous waste that required disposal to a licensed landfill or managed fill, and reworked natural fill was generally classified as clean fill or managed fill.
