Contaminated Soils Management Plan

May Road Development

Prepared for May 1 Limited

Prepared by Beca Limited

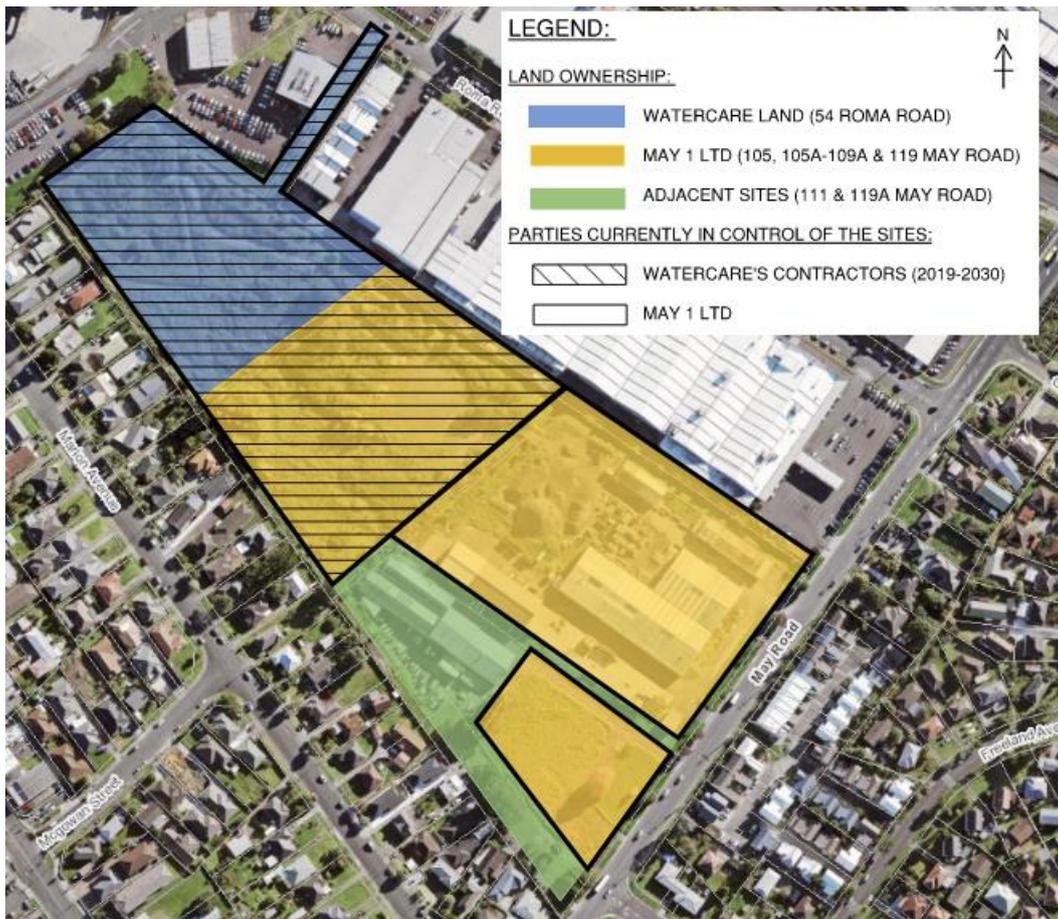
Figure 1: Site Plan

Beca Limited (Beca) has been commissioned by May 1 Limited to prepare a Contaminated Soils Management Plan (CSMP) for the properties located at 105, 105A-109A, and 119 May Road, Mount Roskill, Auckland (the Site). The land to the northeast of the Site will be a shaft site for Watercare Services Limited (Watercare)'s Central Interceptor tunnel. To support the construction of Central Interceptor, Watercare is temporarily leasing 105 May Road Site from May 1 Limited for construction activities such as site offices, truck access, working platforms and stormwater management areas. Figure 1 presents Watercare's land, the Site and adjacent lots.

The Site is located on May Road in the Auckland suburb of Mount Roskill and encompasses three land parcels (Figure 1):

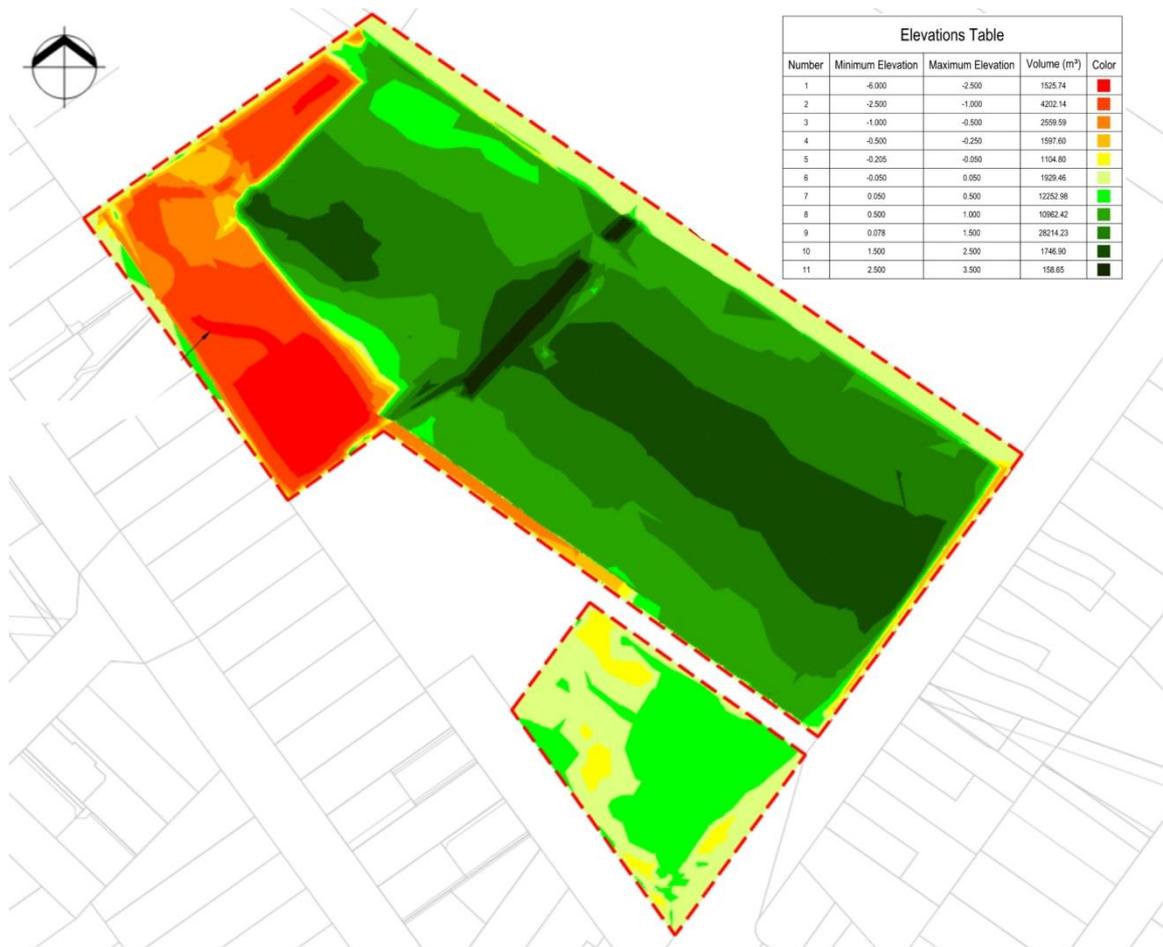
Figure 2. Earthworks Proposed Cut/Fill

Temporary earthworks associated with Watercare's Central Interceptor Project are already underway or due to be carried out soon on the adjacent Watercare land (54 Roma Road) and on 105 May Road as described in the sections below. This application covers the formation of the final landform on the Site once the Central Interceptor Project is constructed but not any interim earthworks on 105 May Road during its construction. Figure 2 shows cut-fill depths of the proposed bulk earthworks within the Site against that pre-development terrain.

Figure 2), earthworks in this area are proposed to comprise some cut in order to realign a public stormwater pipe outfall and regrade the surface levels to provide overland flow path in high rain events. Following completion of the earthworks (cut) it is understood that the Site will be fully sealed.

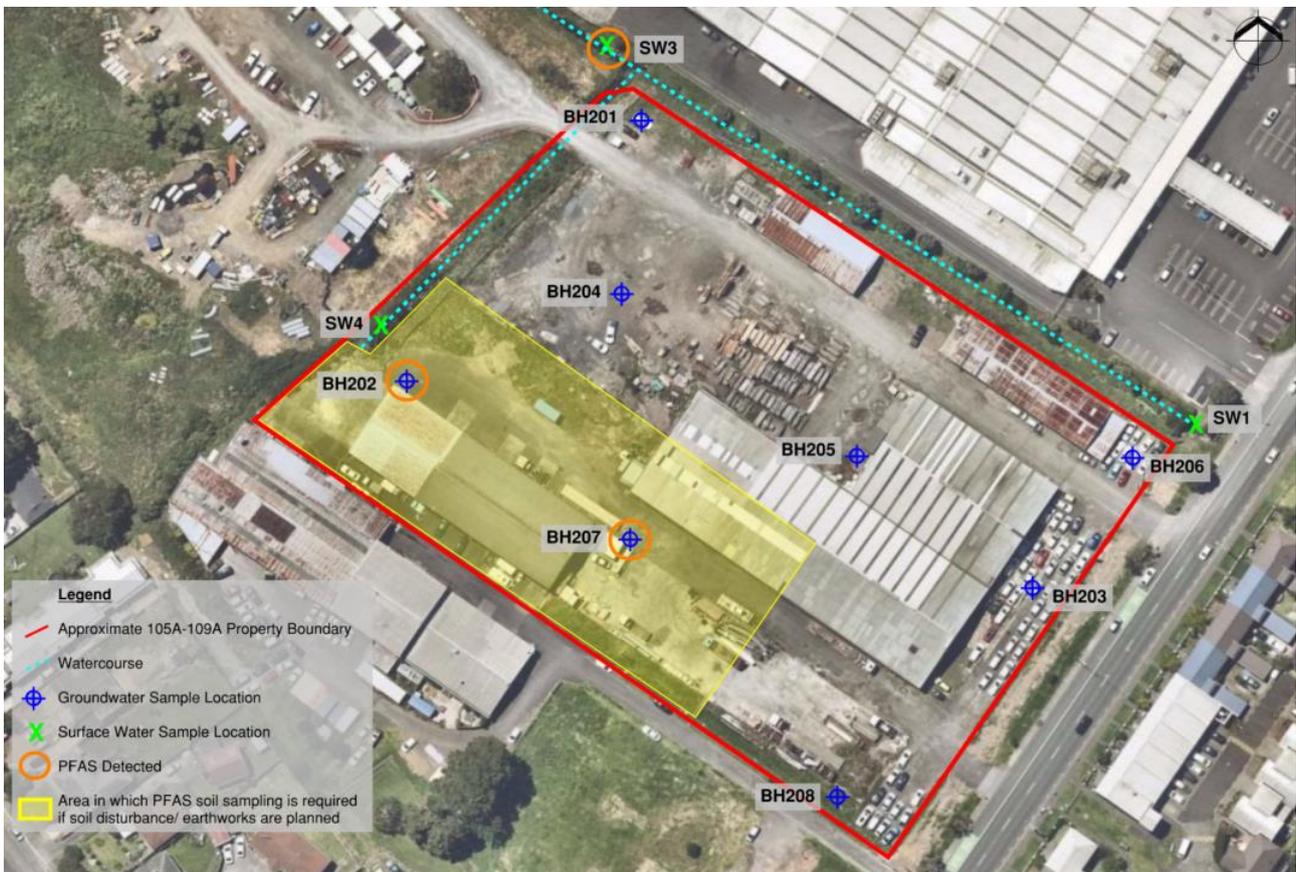
Based on the investigation results there is a possibility there is a soil PFAS source area that is resulting in ongoing input into groundwater, likely located within the south-west corner of the Site, based on the locations of PFOA detections in groundwater. Figure 3 presents a plan indicating an area where potential PFAS impacted soil is more likely.

Figure 3: Plan illustrating the area of Site in which PFAS soil sampling is required if future earthworks/ soil disturbance is proposed (Image Source: Nearmap Australia Pty Ltd)

Additional investigation will be undertaken in the area identified on Figure 3 where there is potential for PFAS to be present in soil. If PFAS is detected, the following section presents the proposed management procedures based on current guidelines, with the procedures subject to change if guidelines/ regulations change in the future.
