## **Section 2**

# **Annual Performance Report Strategic Management Areas & Geographical Catchments**

**1 July 2018 to 30 June 2019**

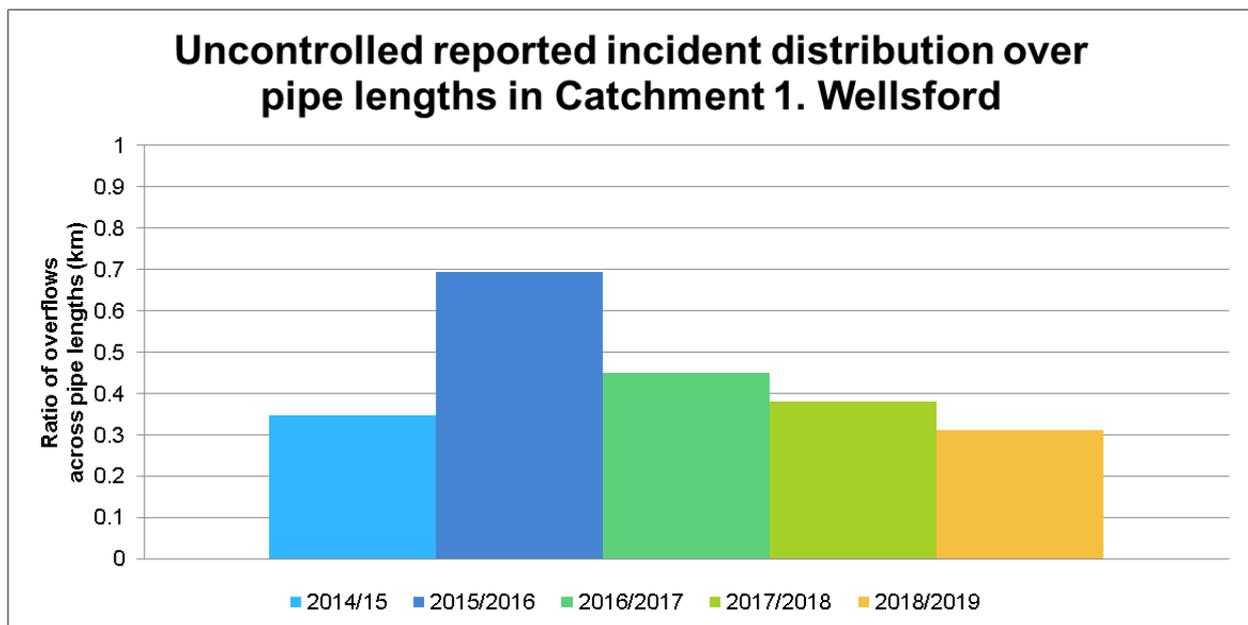
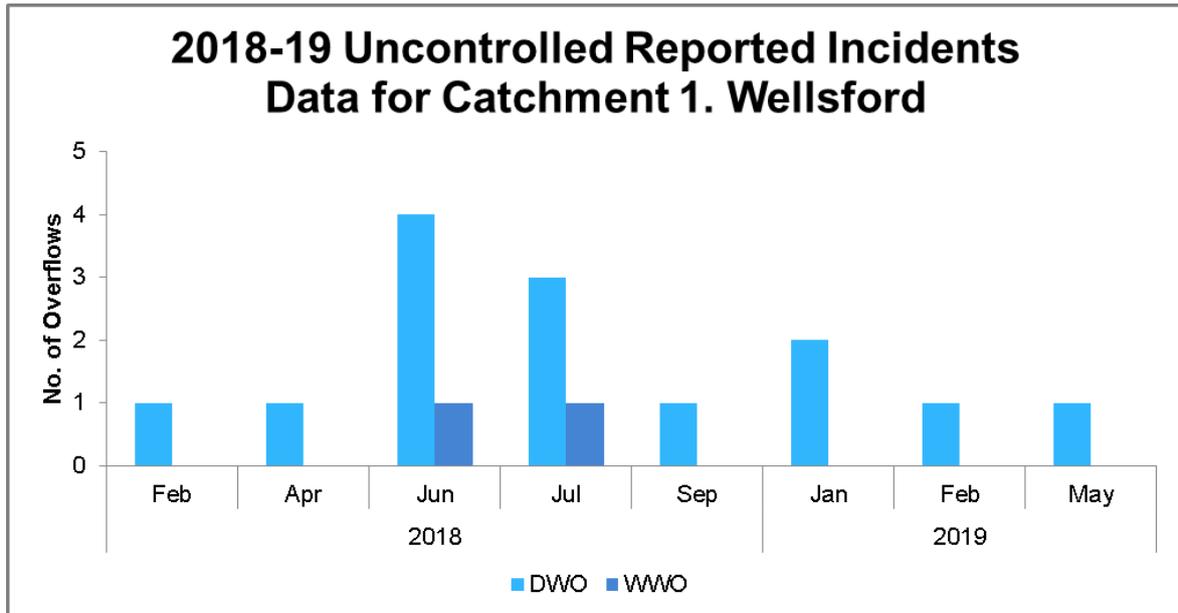
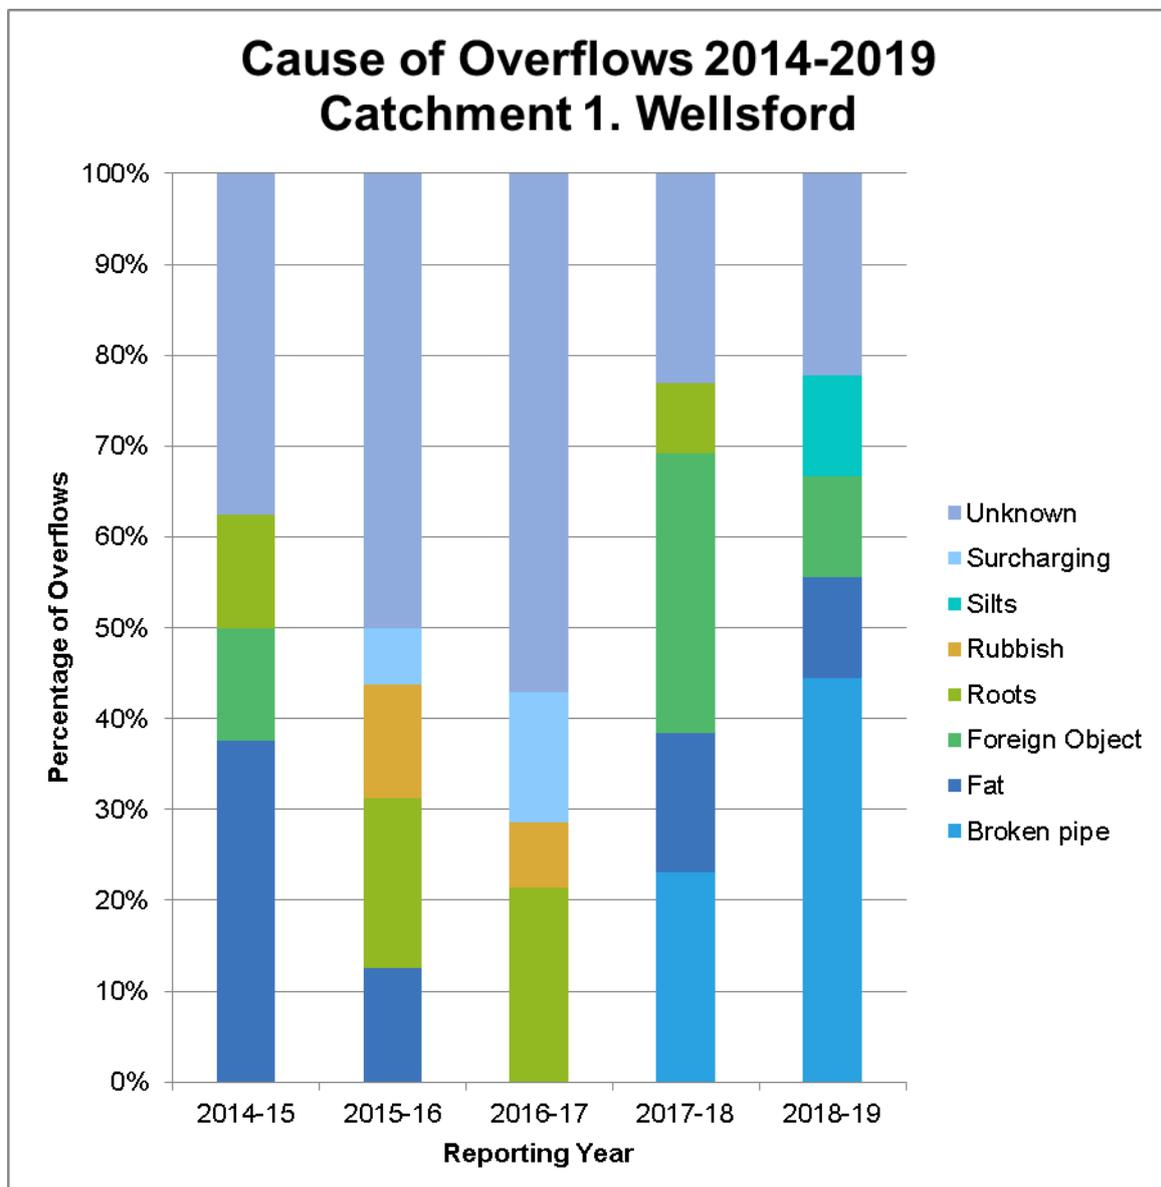
### 2.1.3 Trend analysis of reported incidents

The below graphs reflect the trends distributed along pipe lengths, annual trends, and overflow cause proportions. Trends are displayed over months where overflows occurred.

Trend analysis has been carried out where the cause has been identified.

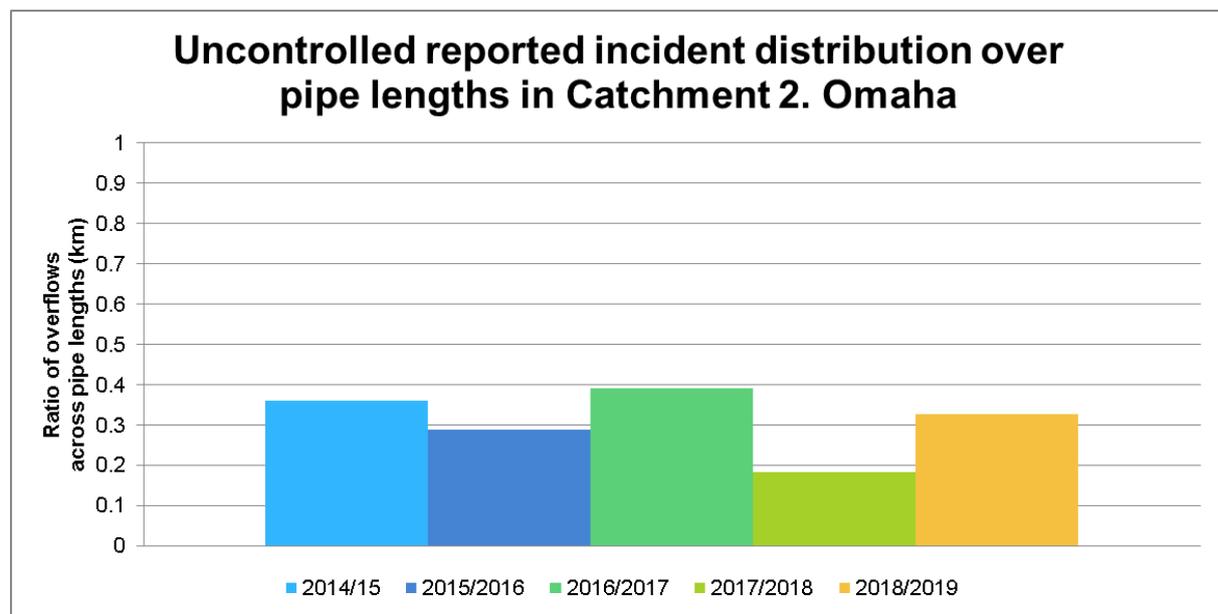
### 2.3.3 Trend analysis of reported incidents

The below graphs reflect the trends distributed along pipe lengths, annual trends, and overflow cause proportions. Trends are displayed over months where overflows occurred.

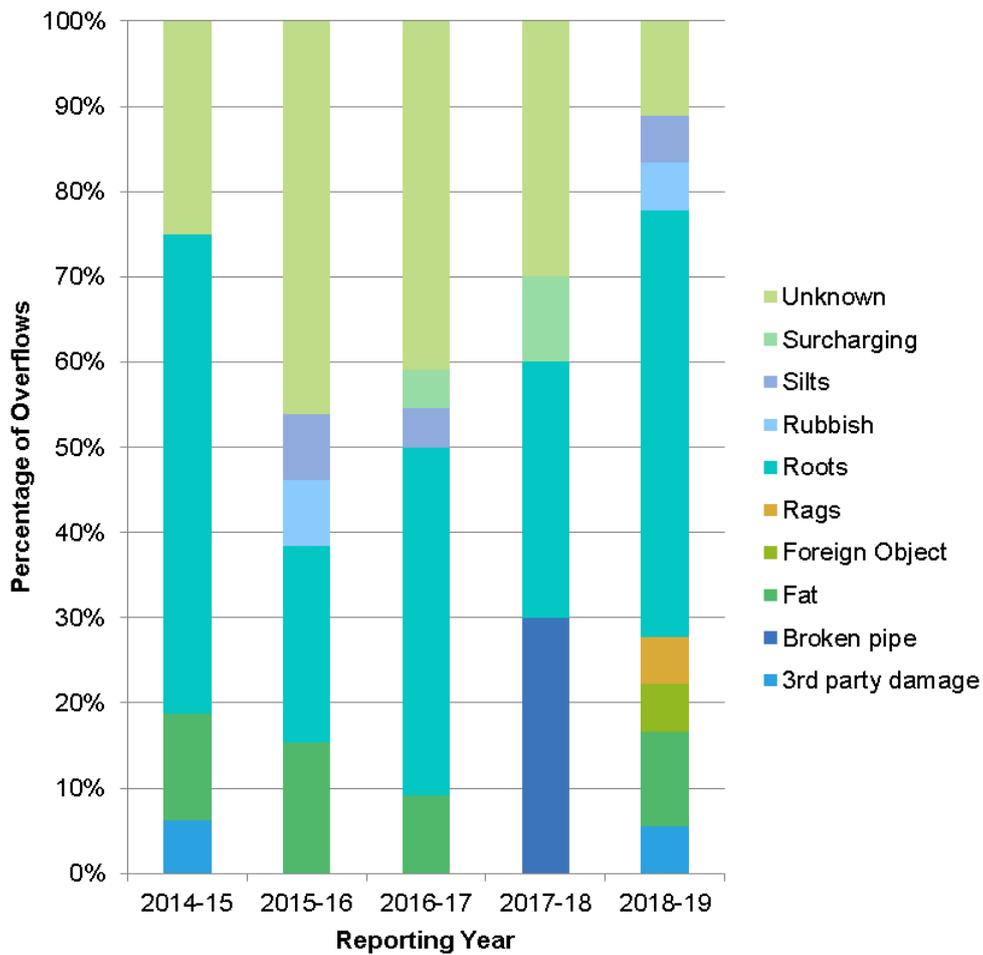
## Cause of Overflows 2014-2019 Catchment 2. Omaha

Trend analysis has been carried out where the cause has been identified.

There have been no pump station overflows in the reporting period of 2018-19. Roots remain a primary cause of overflows, and the density of overflows across pipe length has increased slightly. The overflow history will be analysed and utilised when reviewing future network improvement and I&I programmes. The network has been extended significantly to accommodate the population growth in the region.

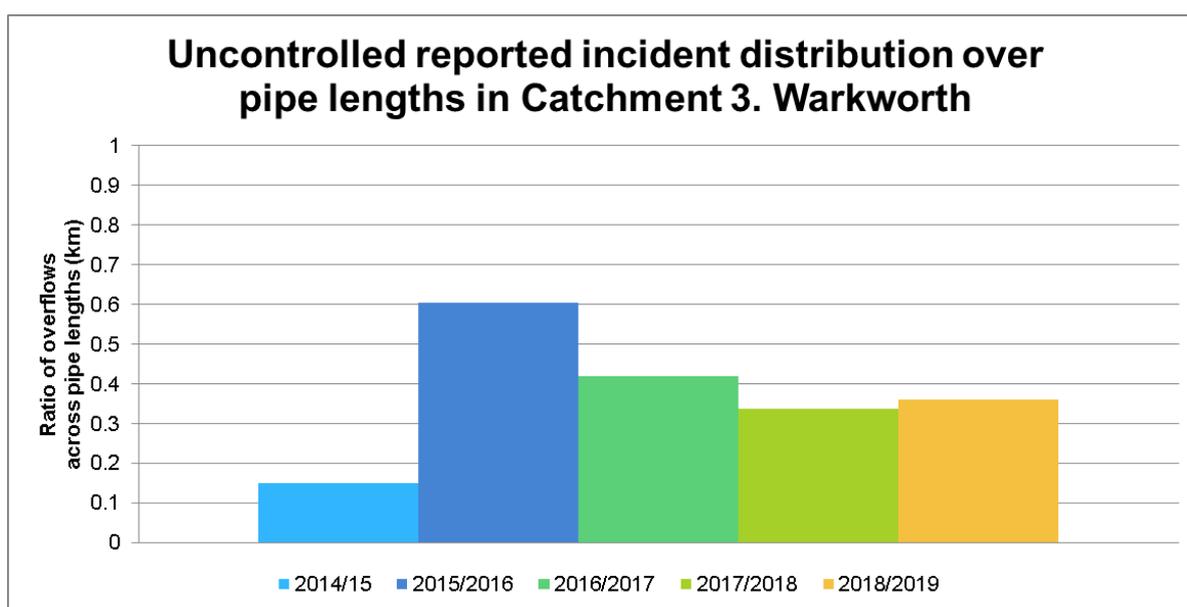
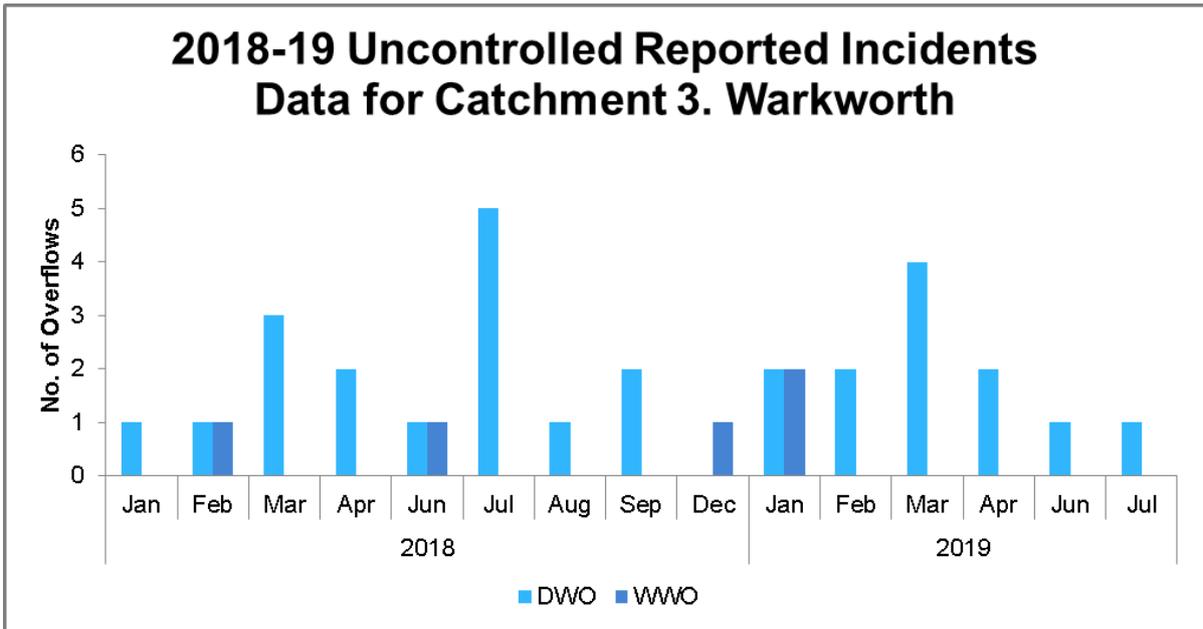
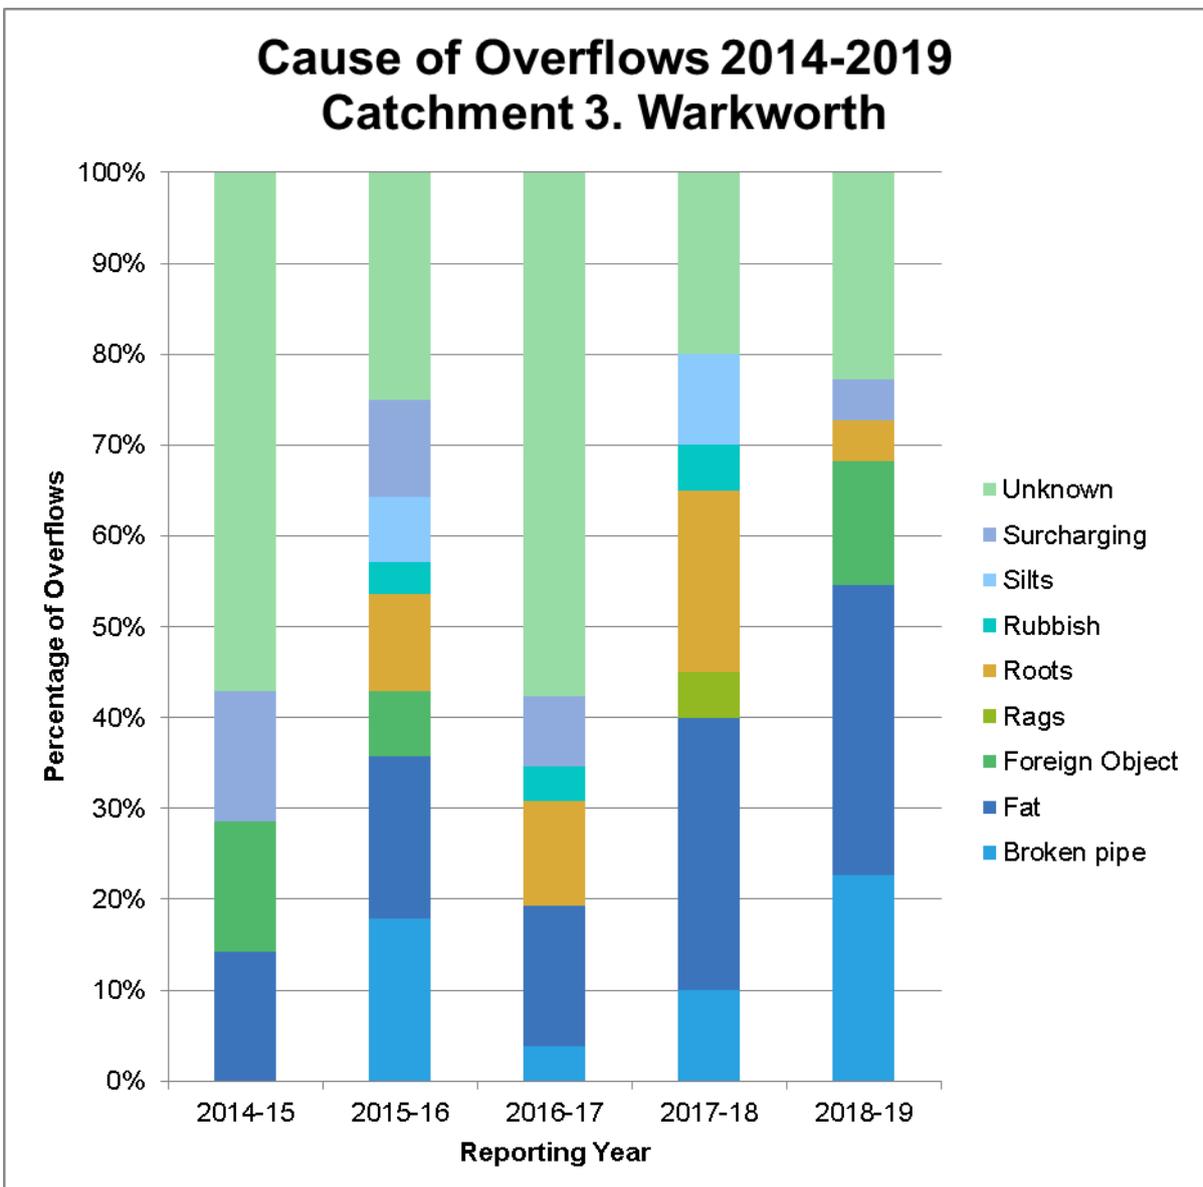
### 2.5.3 Trend analysis of reported incidents

The below graphs reflect the trends distributed along pipe lengths, annual trends, and overflow cause proportions. Trends are displayed over months where overflows occurred.

Trend analysis has been carried out where the cause has been identified.

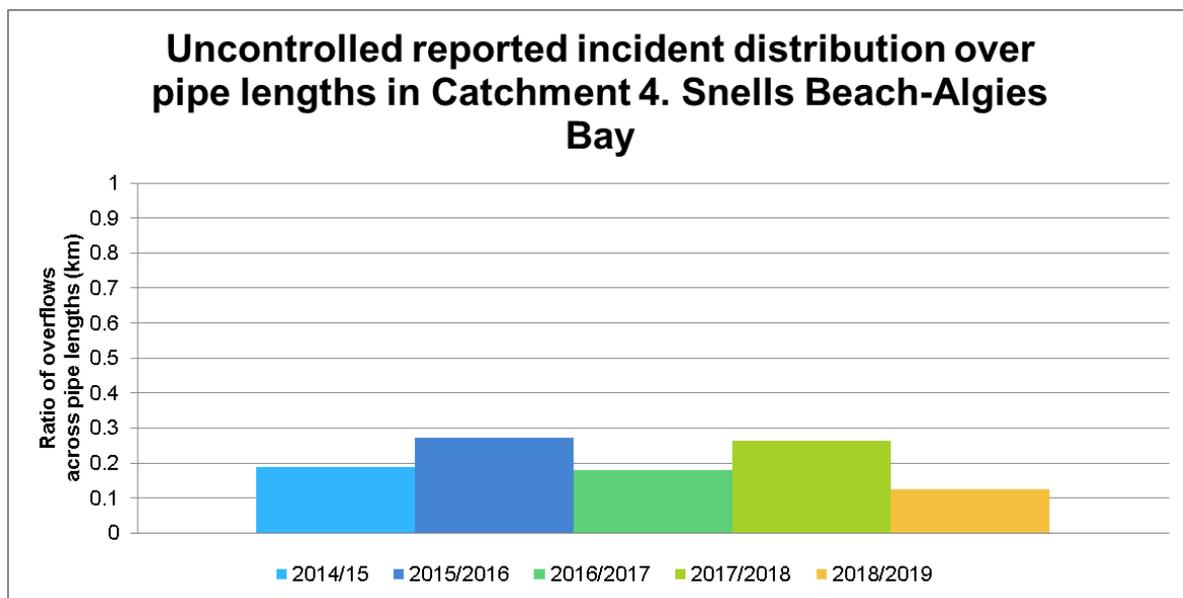
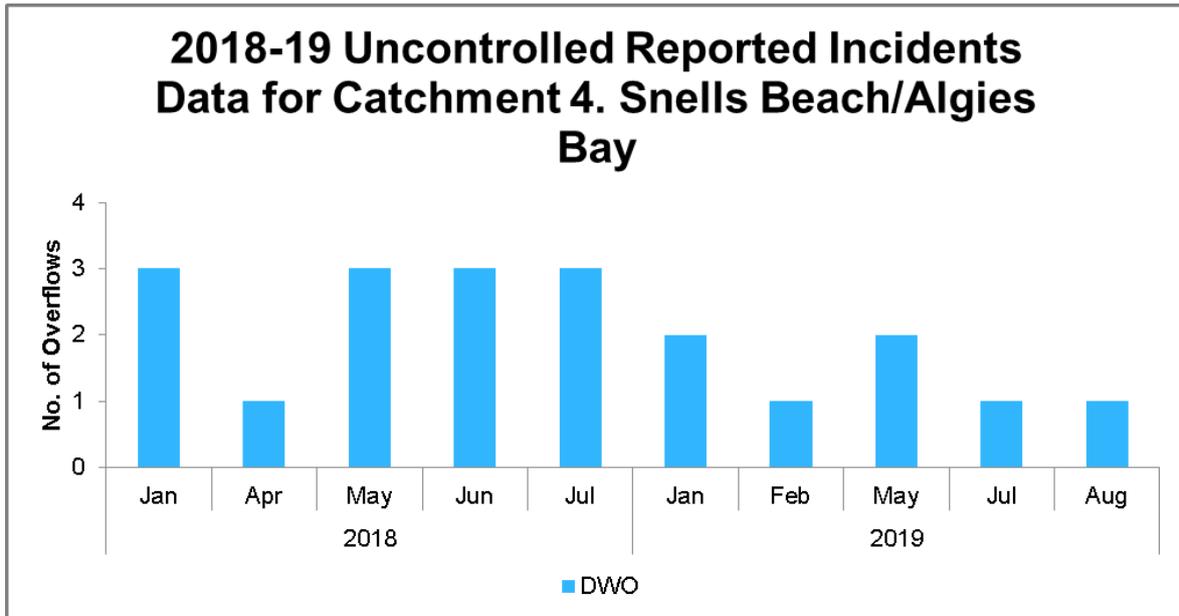
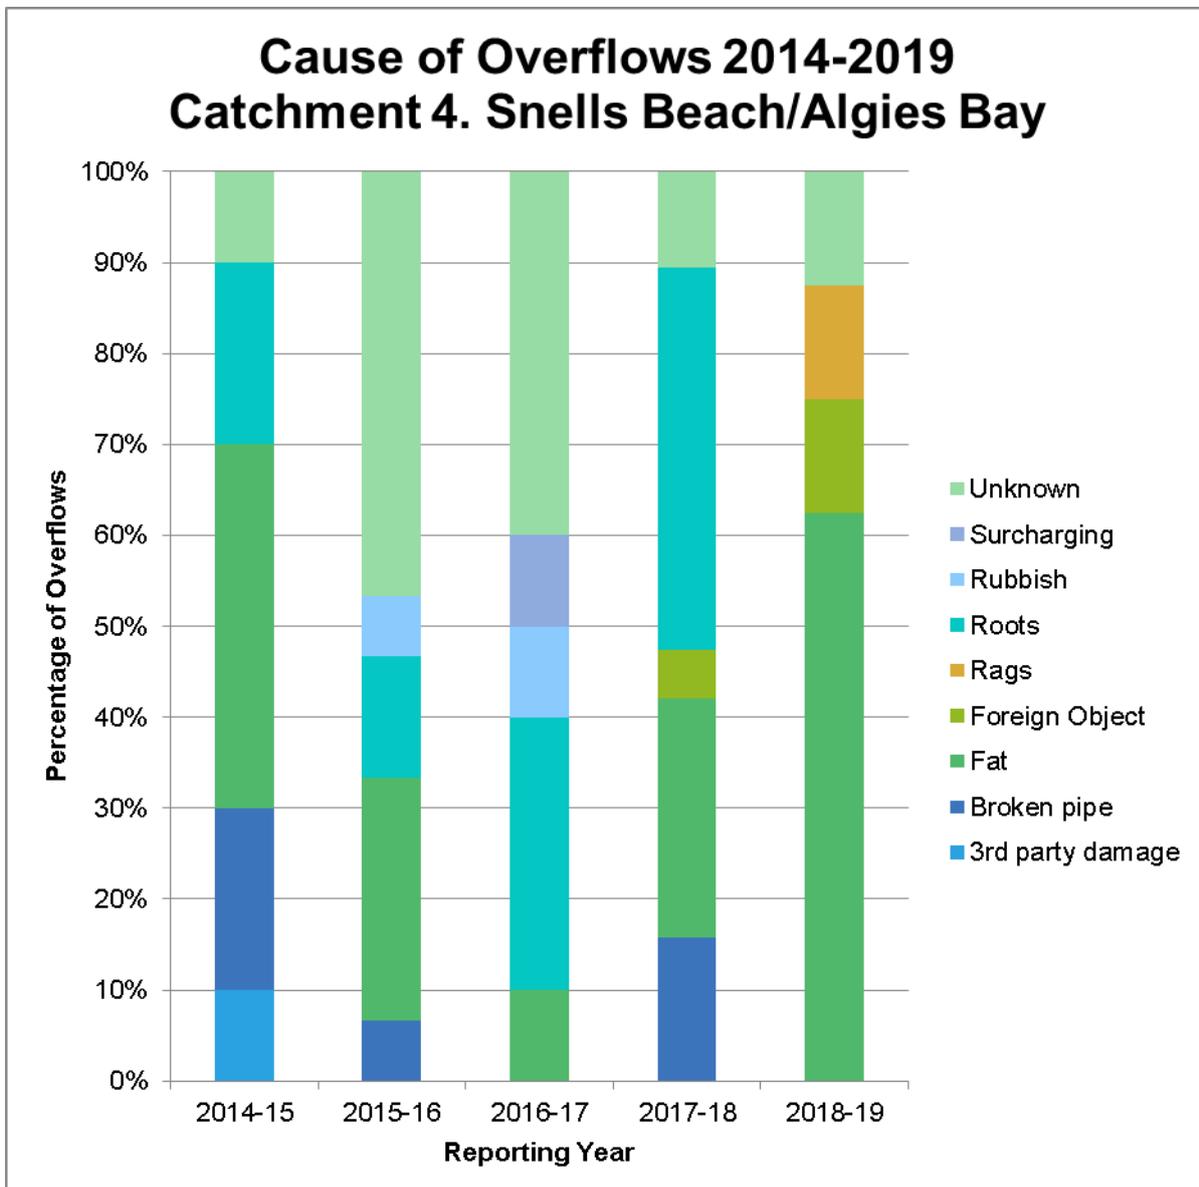
### 2.6.3 Trend analysis of reported incidents

The below graphs reflect the trends distributed along pipe lengths, annual trends, and overflow cause proportions. Trends are displayed over months where overflows occurred.

Trend analysis has been carried out where the cause has been identified.

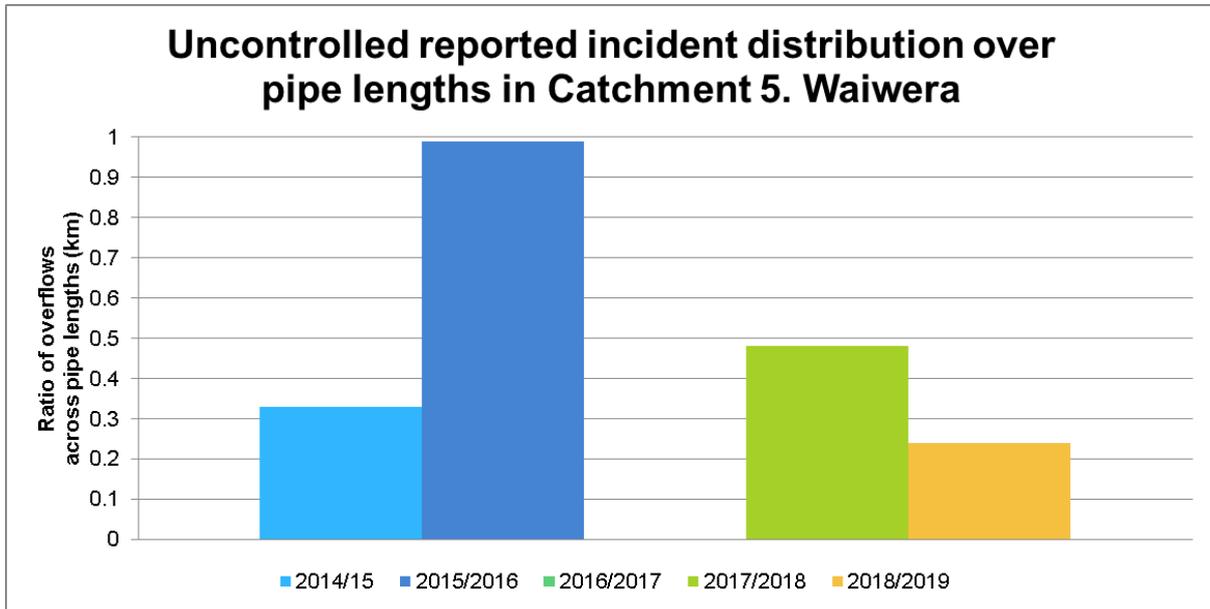
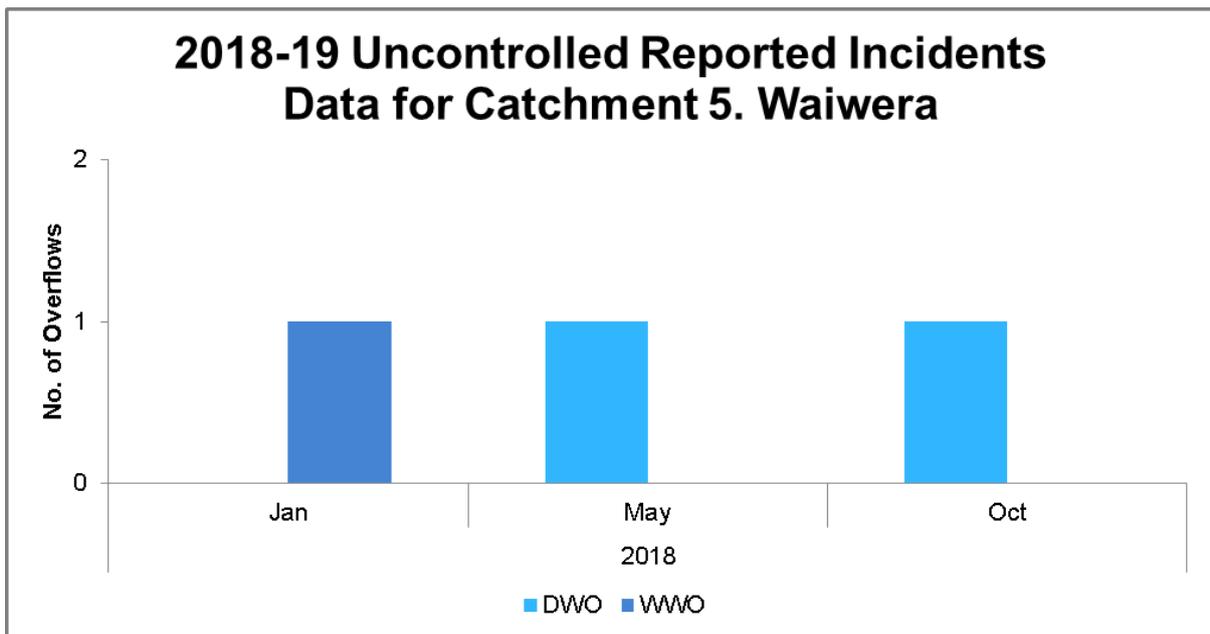
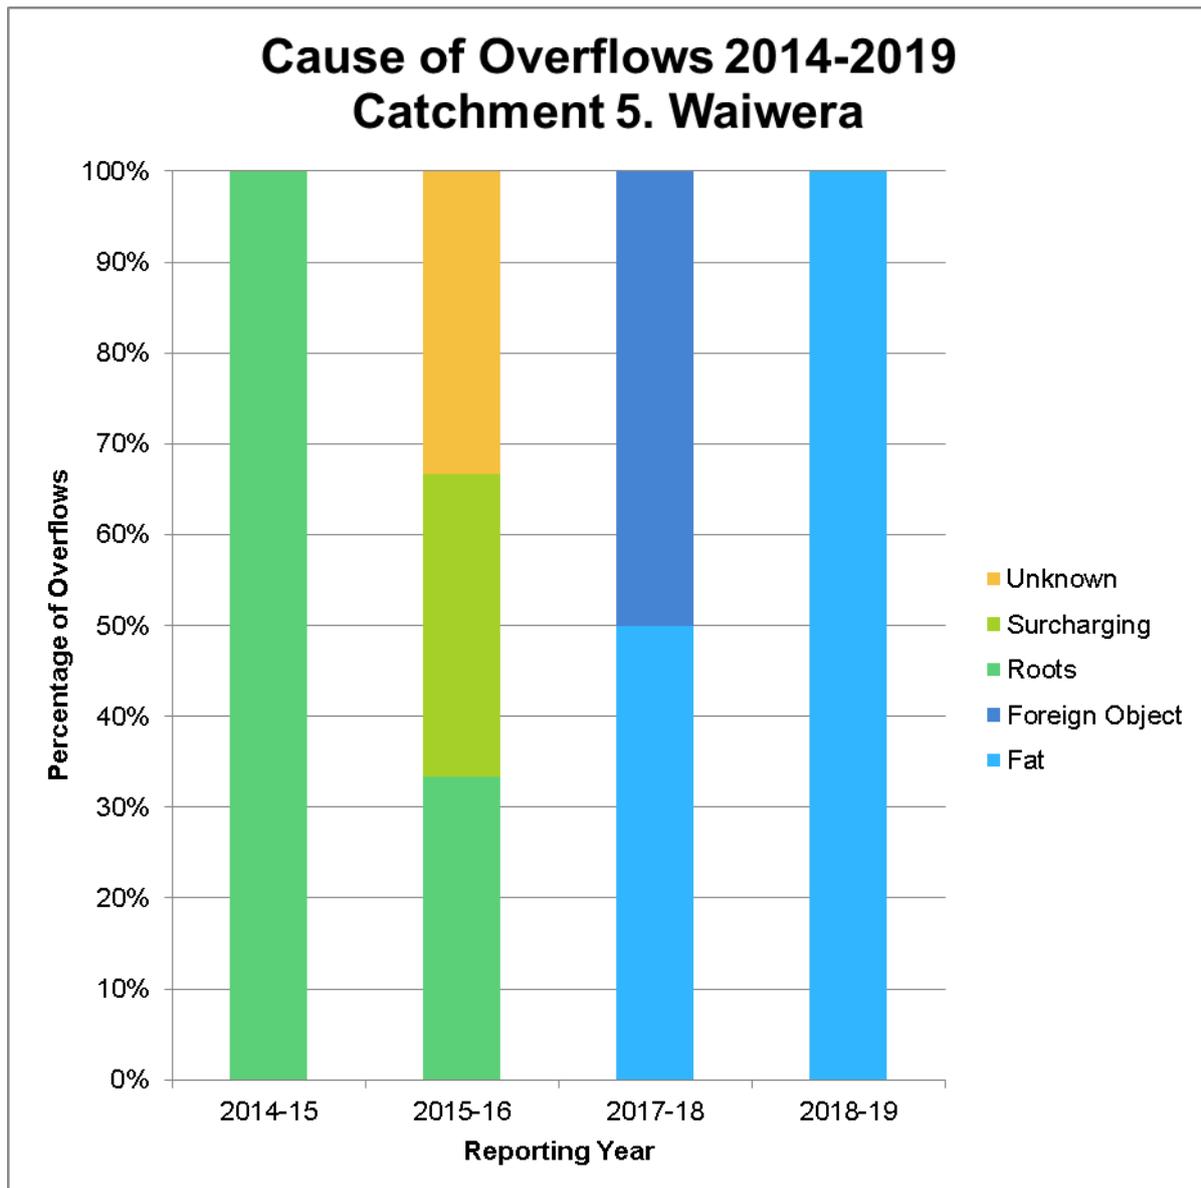
### 2.7.3 Trend analysis of reported incidents

The below graphs reflect the trends distributed along pipe lengths, annual trends, and overflow cause proportions. Trends are displayed over months where overflows occurred.

Trend analysis has been carried out where the cause has been identified. There were no overflow incidents in 2016-17 in this catchment.

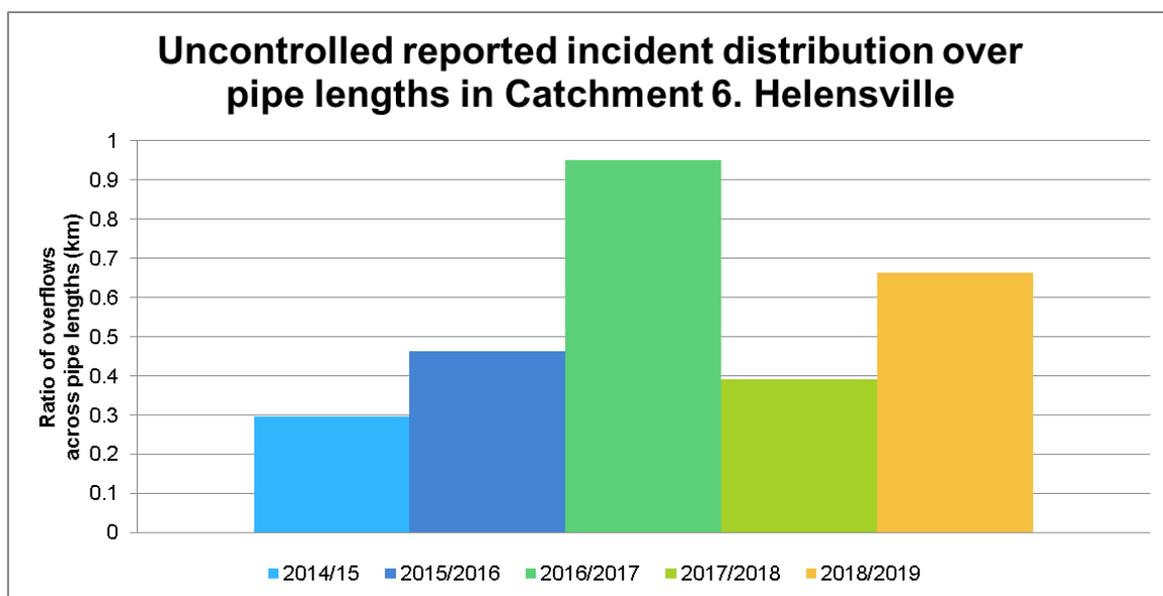
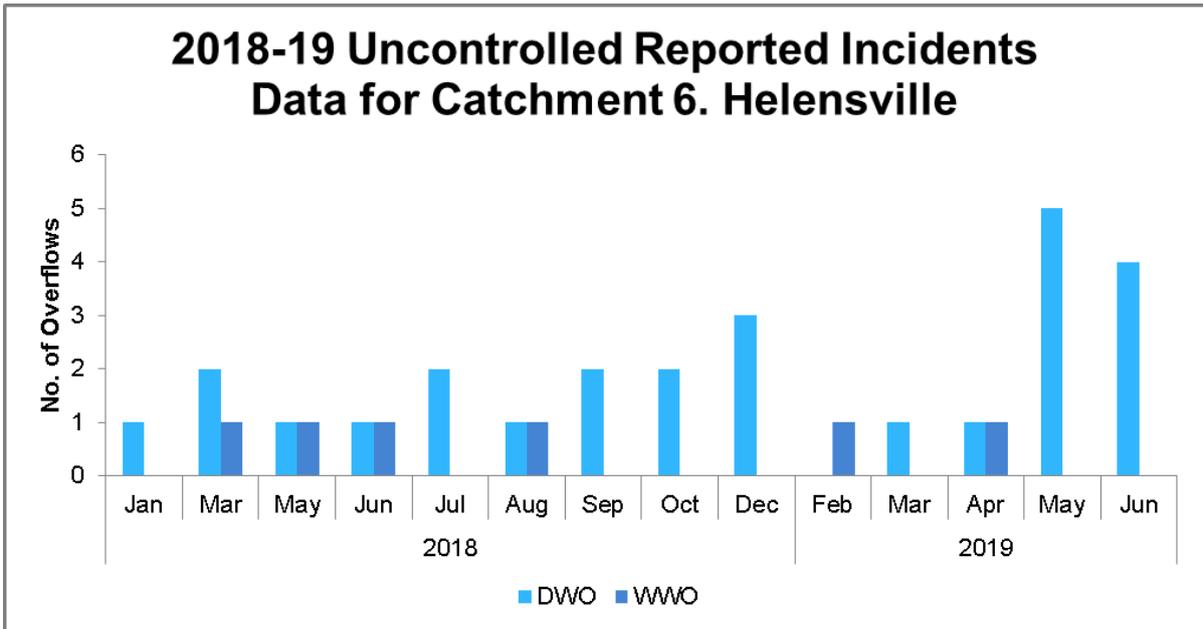
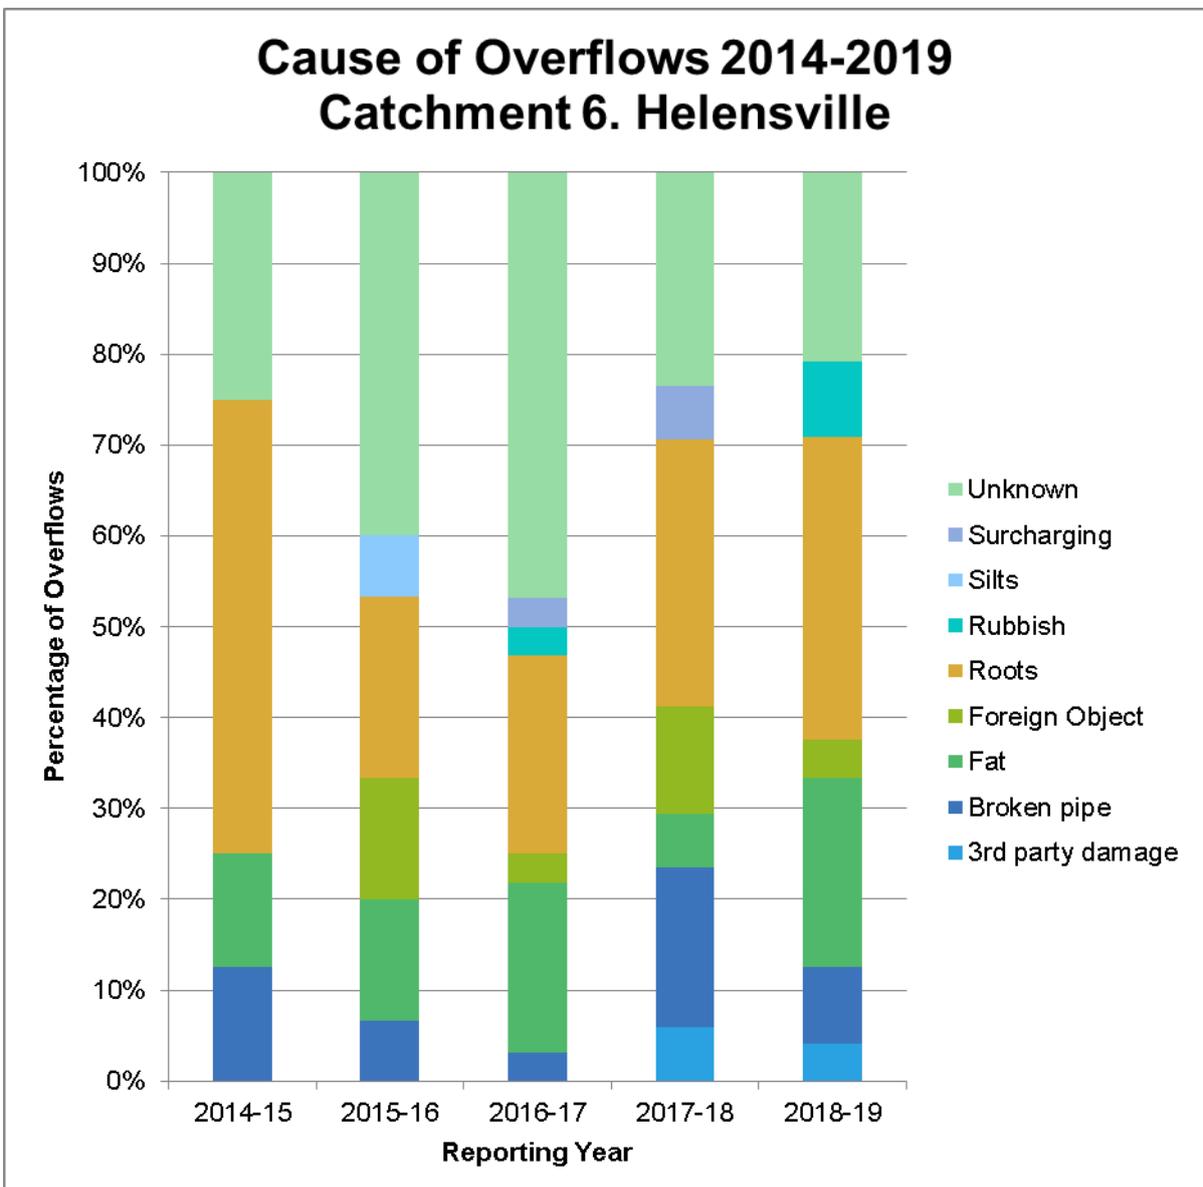
### 2.8.3 Trend analysis of reported incidents

The below graphs reflect the trends distributed along pipe lengths, annual trends, and overflow cause proportions. Trends are displayed over months where overflows occurred.

Trend analysis has been carried out where the cause has been identified.

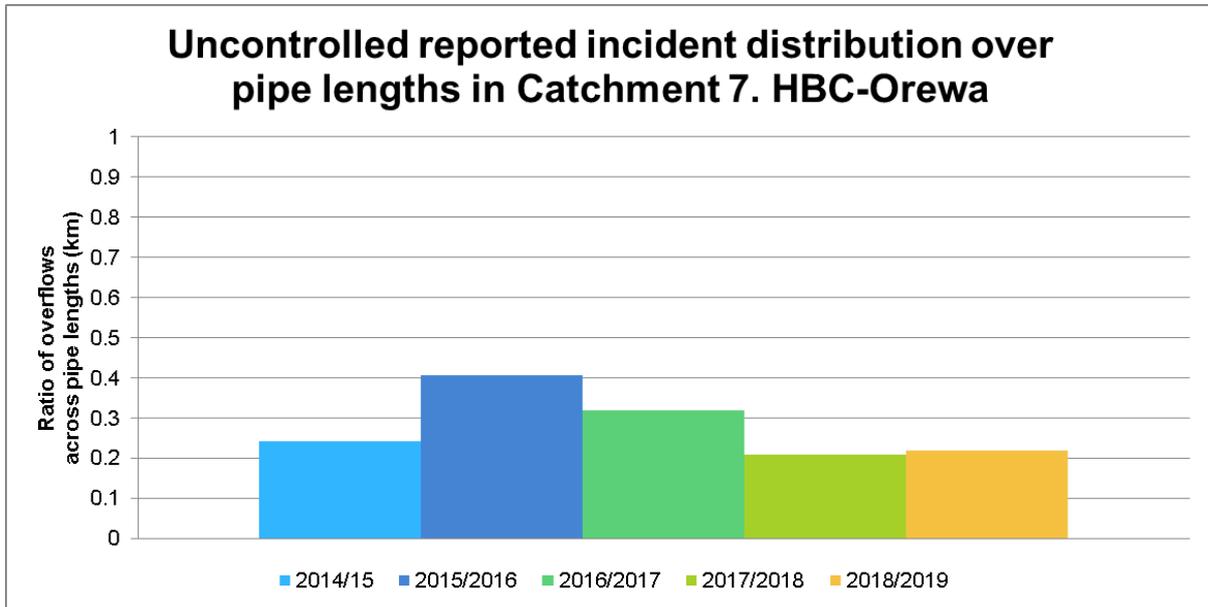
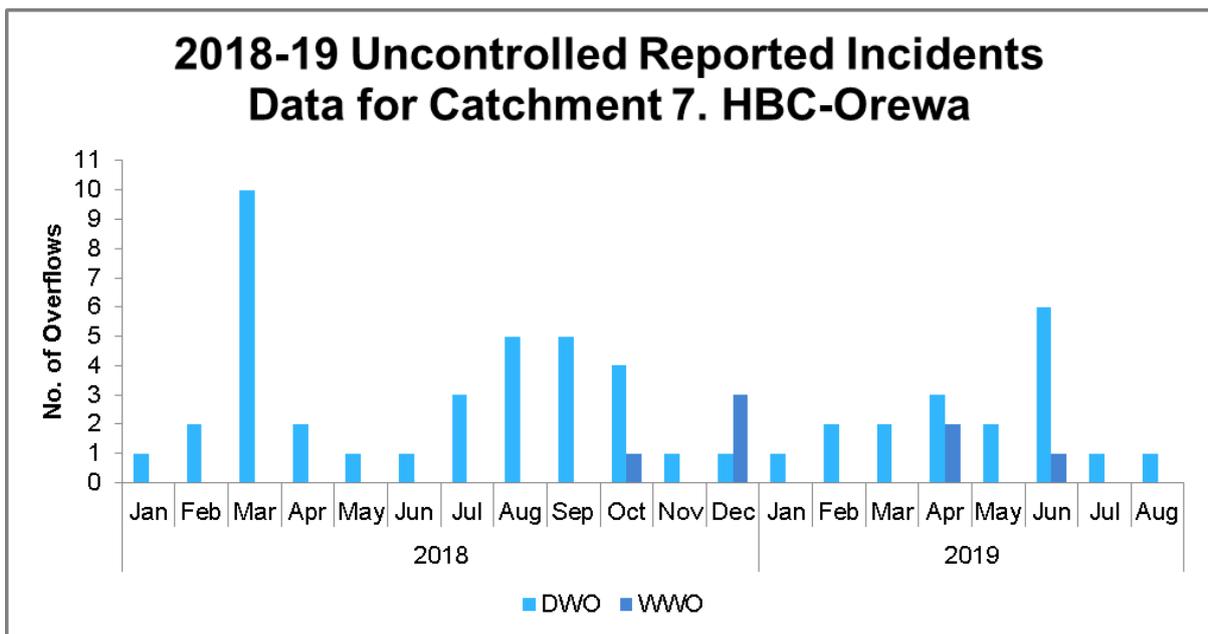
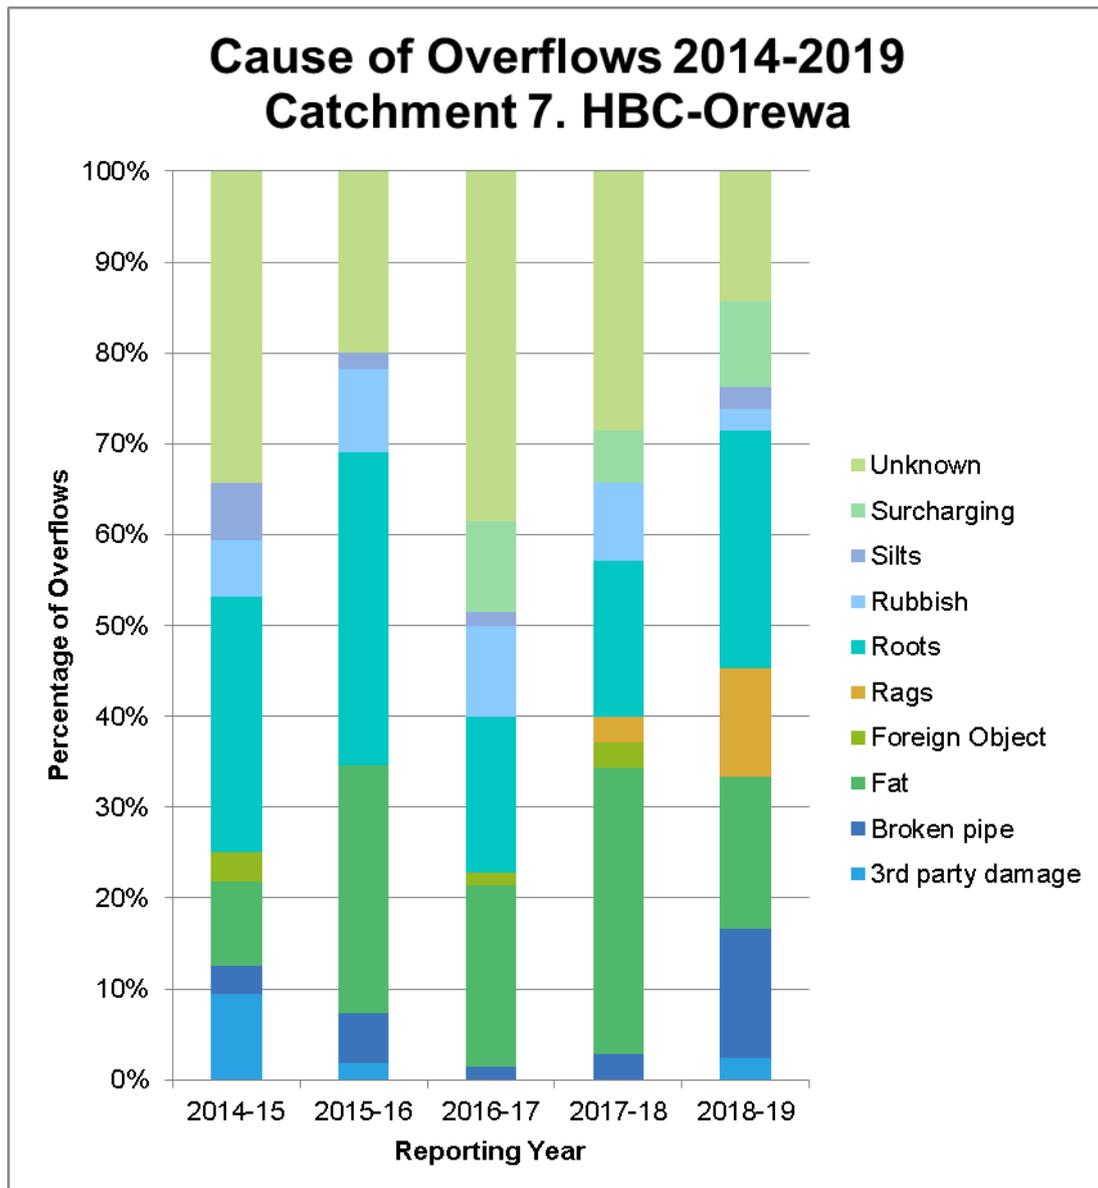
### 2.9.4 Trend analysis of reported incidents

The below graphs reflect the trends distributed along pipe lengths, annual trends, and overflow cause proportions. Trends are displayed over months where overflows occurred.

Trend analysis has been carried out where the cause has been identified.

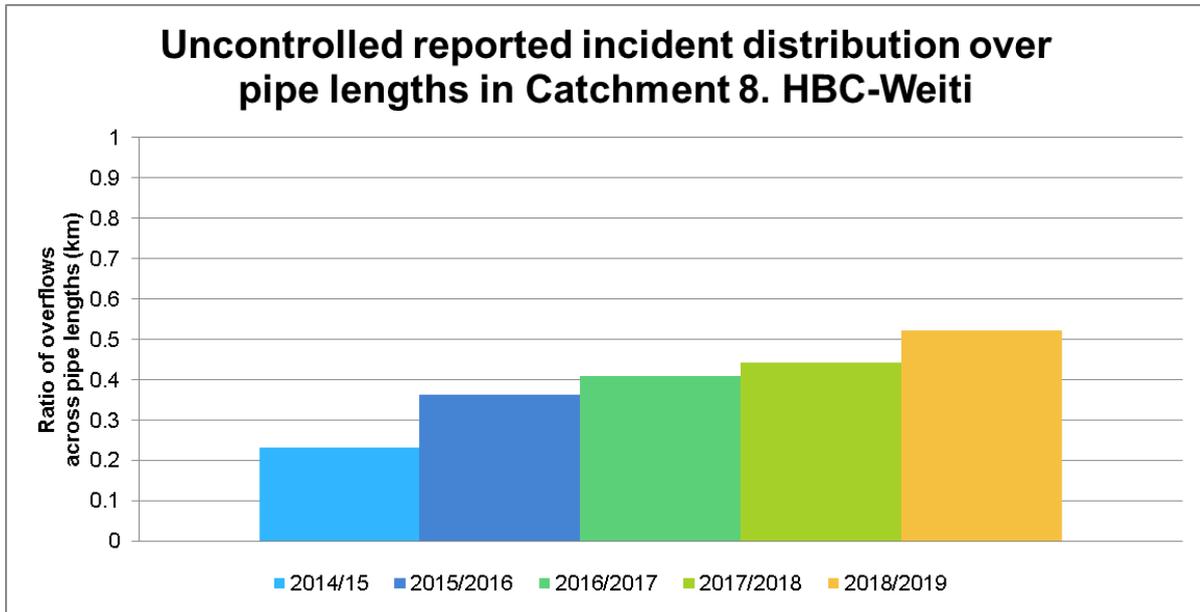
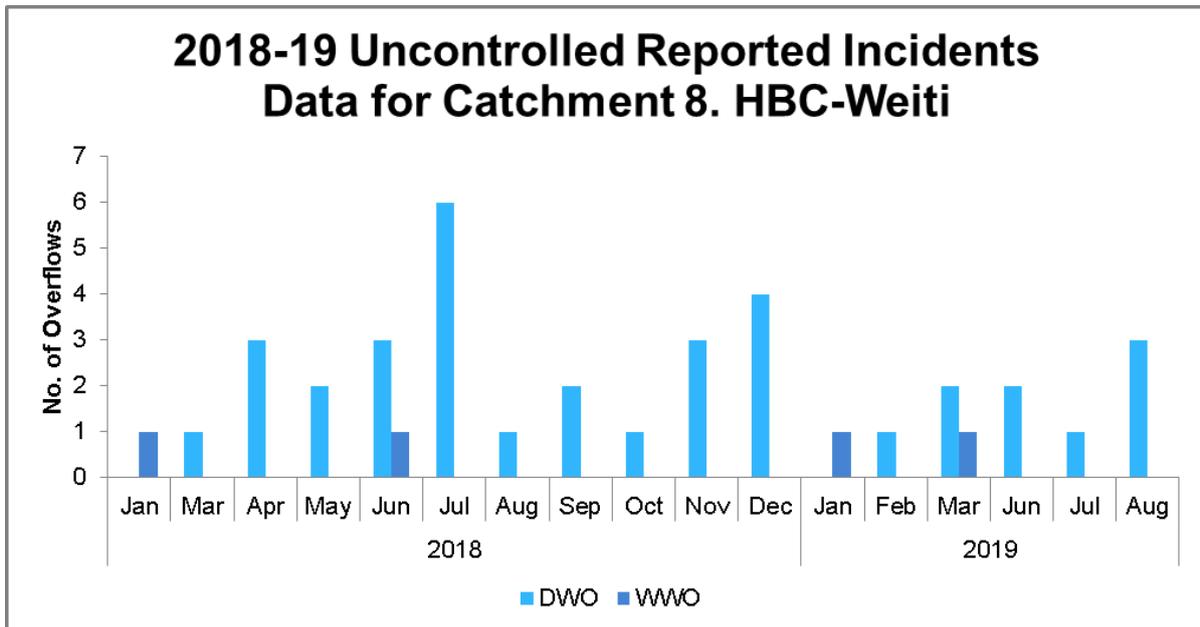
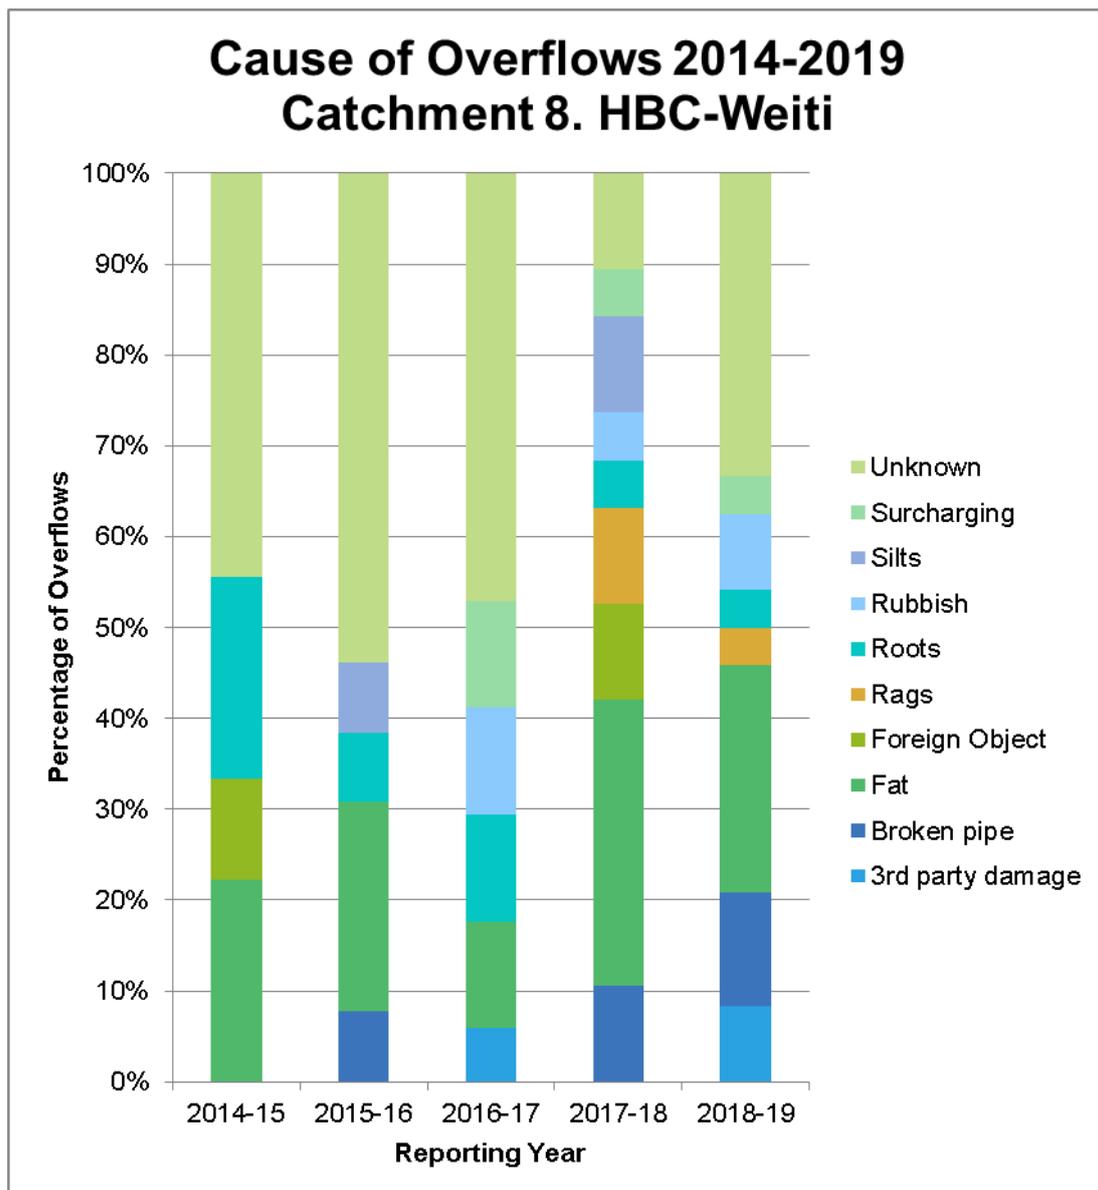
### 2.10.3 Trend analysis of reported incidents

The below graphs reflect the trends distributed along pipe lengths, annual trends, and overflow cause proportions. Trends are displayed over months where overflows occurred.

Trend analysis has been carried out where the cause has been identified.
