## **Section 2**

# **Annual Performance Report Strategic Management Areas & Geographical Catchments**

**1 July 2018 to 30 June 2019**

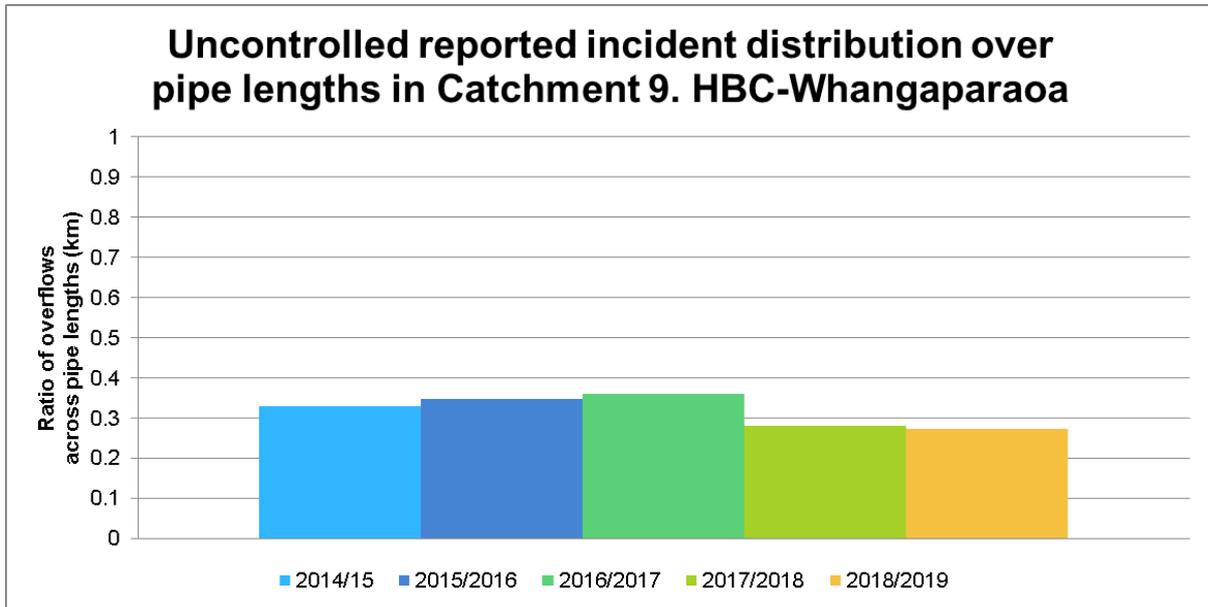
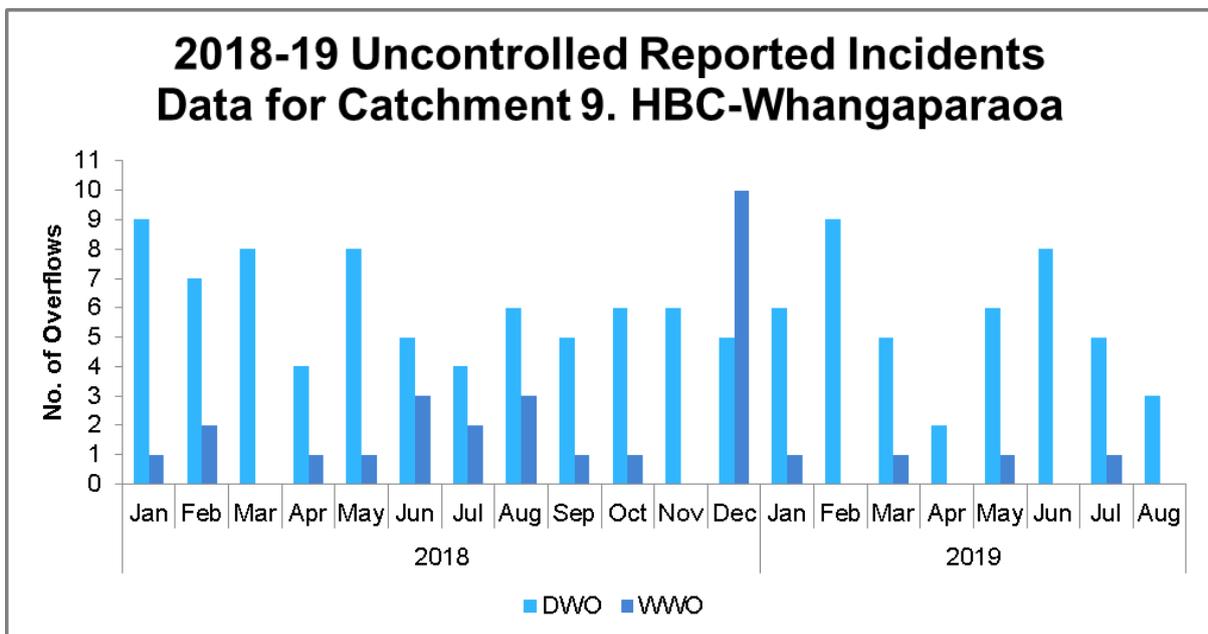
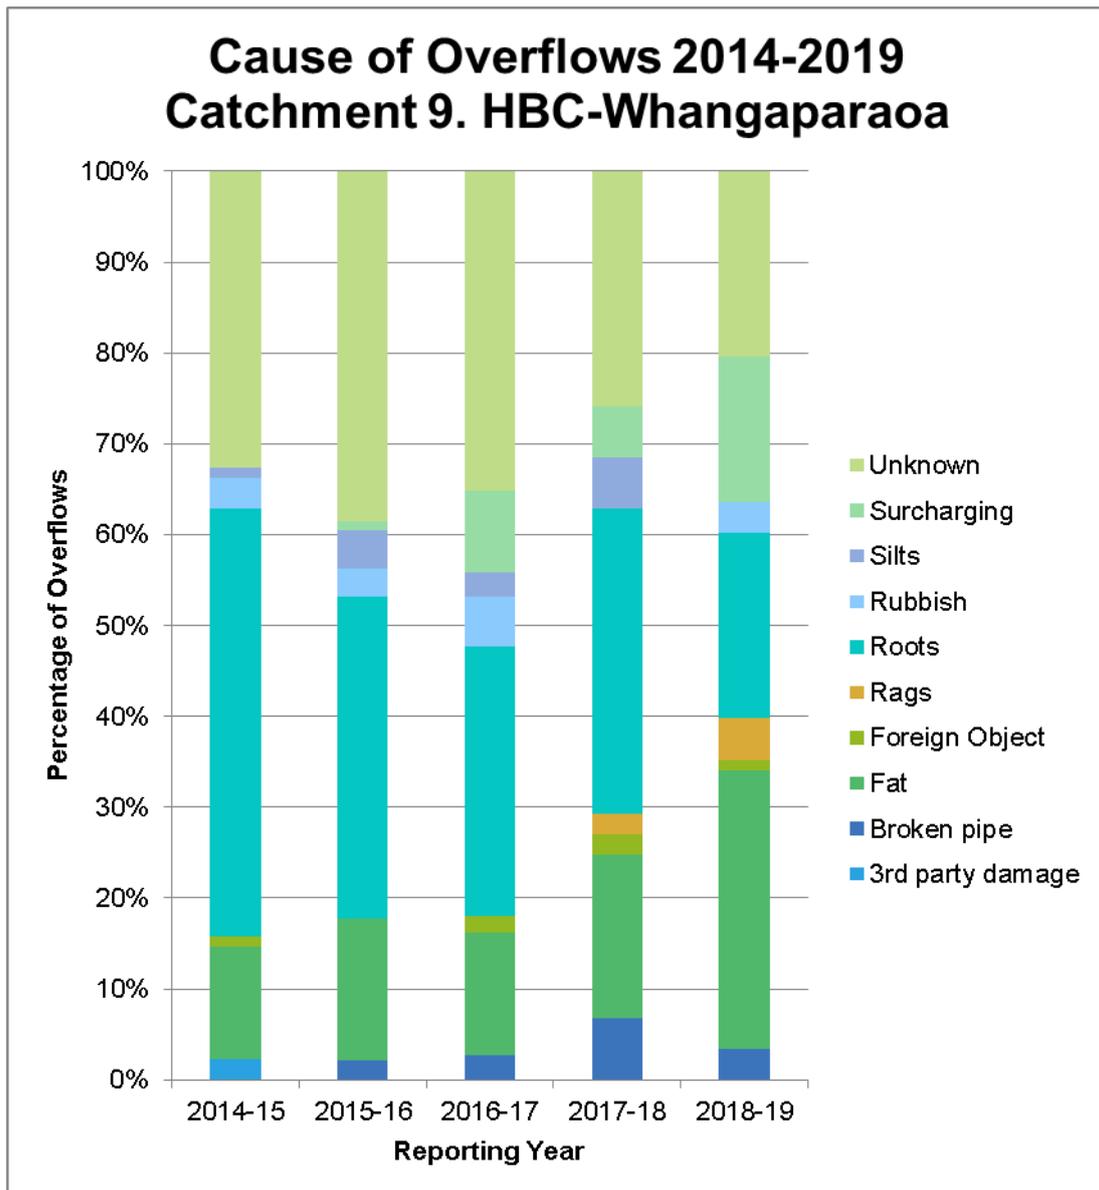
### 2.11.3 Trend analysis of reported incidents

The graphs below reflect the trends distributed along pipe lengths, annual trends, and overflow cause proportions. Trends are displayed over months where overflows occurred.

Trend analysis has been carried out where the cause has been identified.

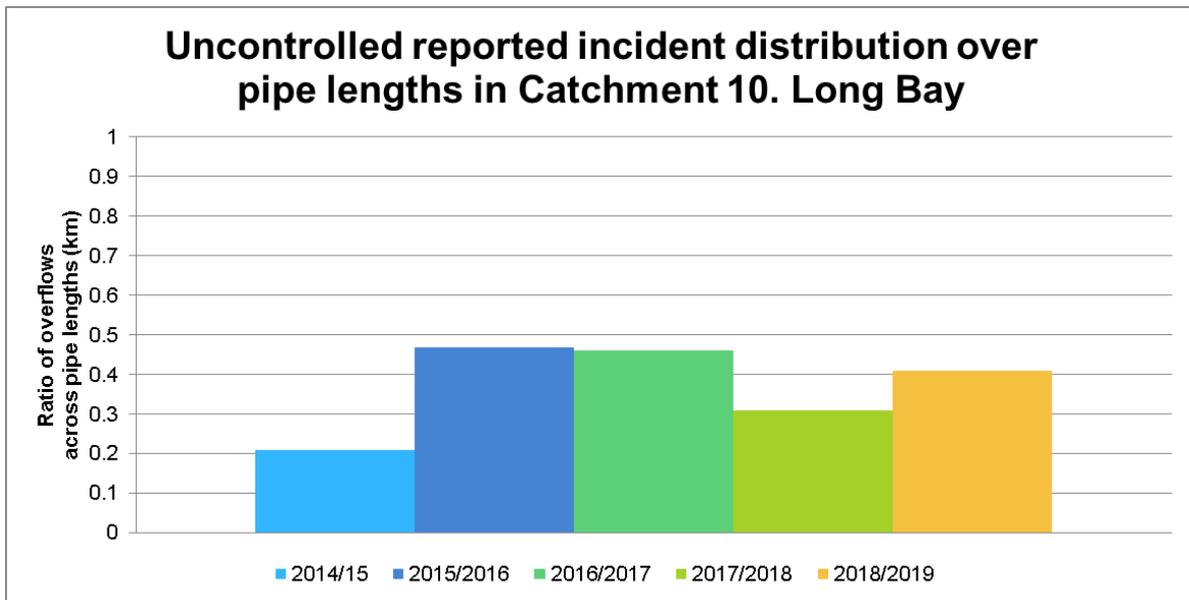
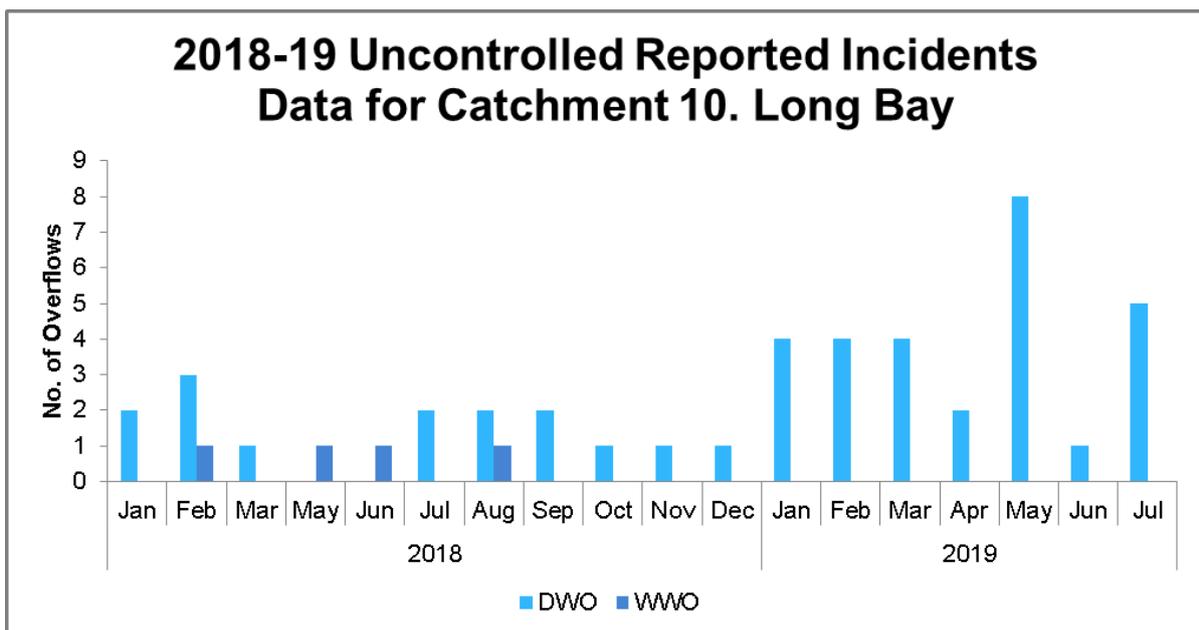
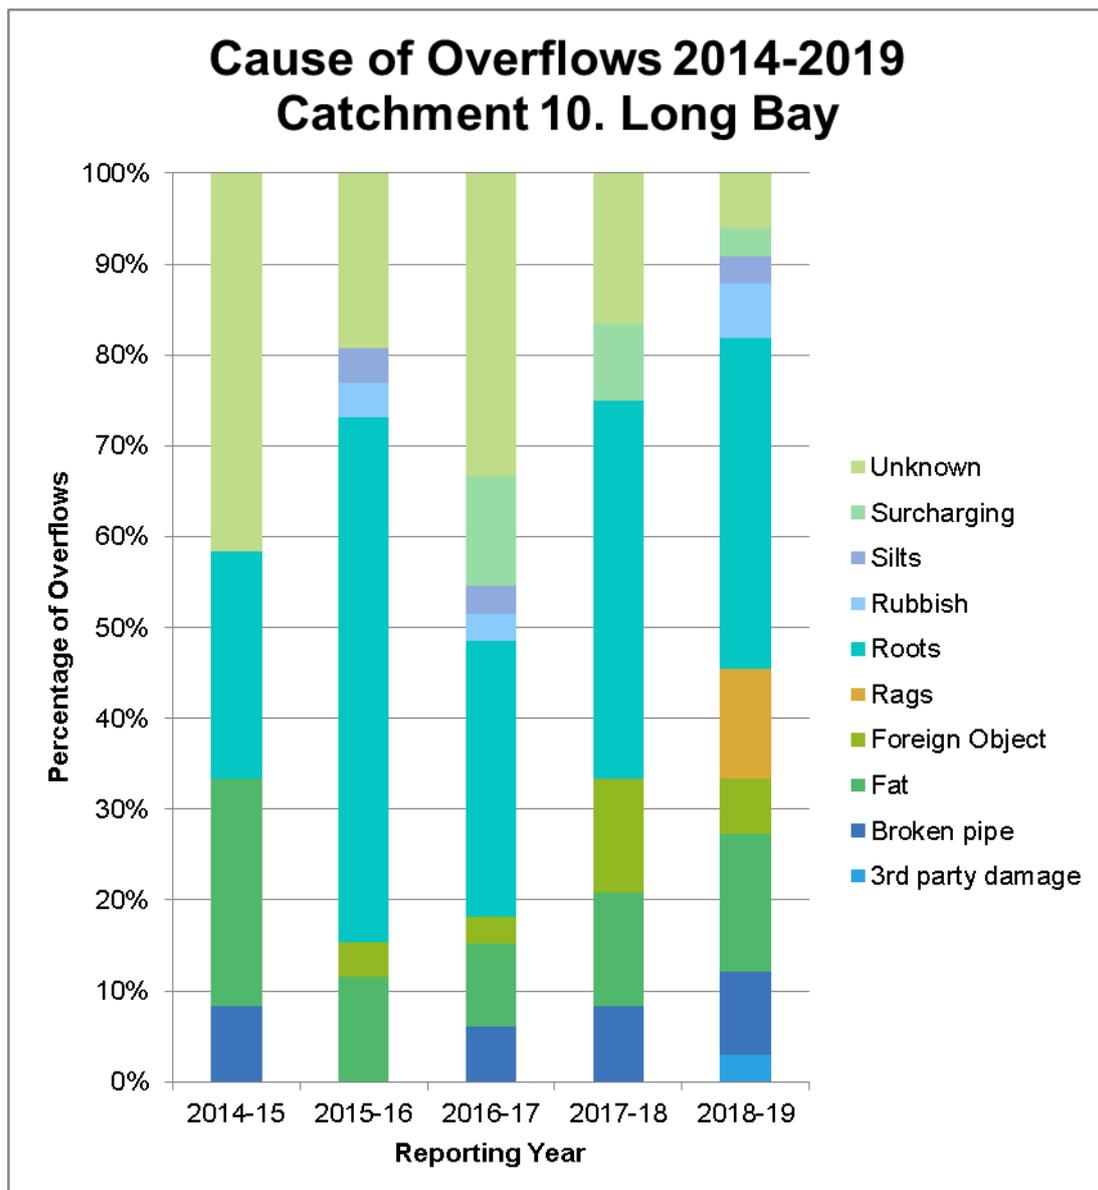
### 2.12.3 Trend analysis of reported incidents

The below graphs reflect the trends distributed along pipe lengths, annual trends, and overflow cause proportions. Trends are displayed over months where overflows occurred.

Trend analysis has been carried out where the cause has been identified.

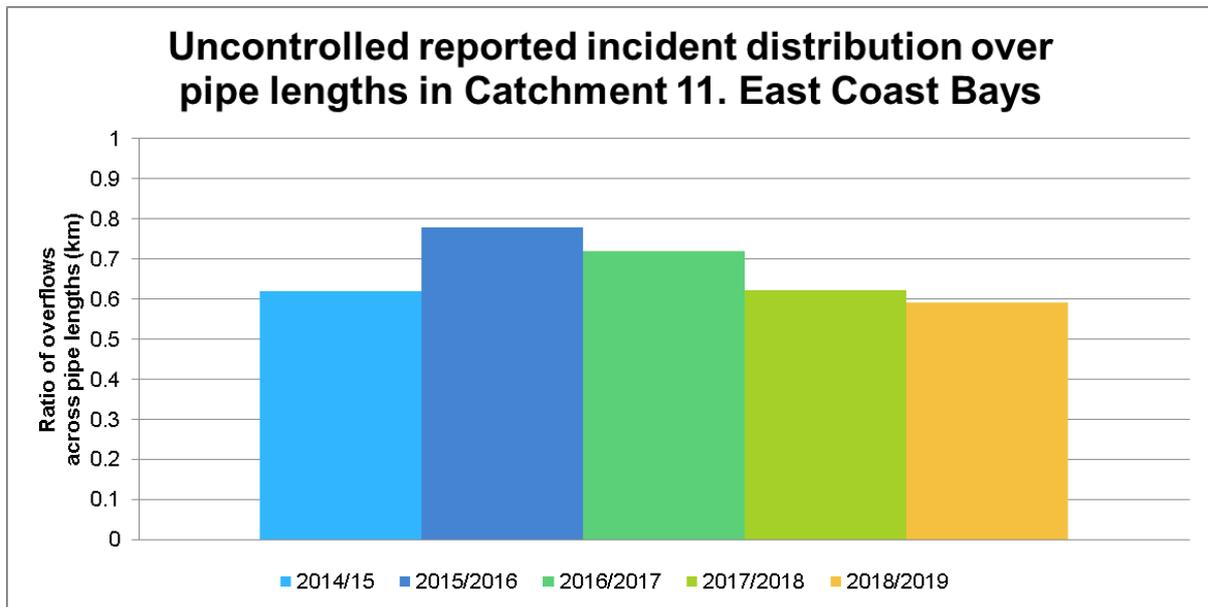
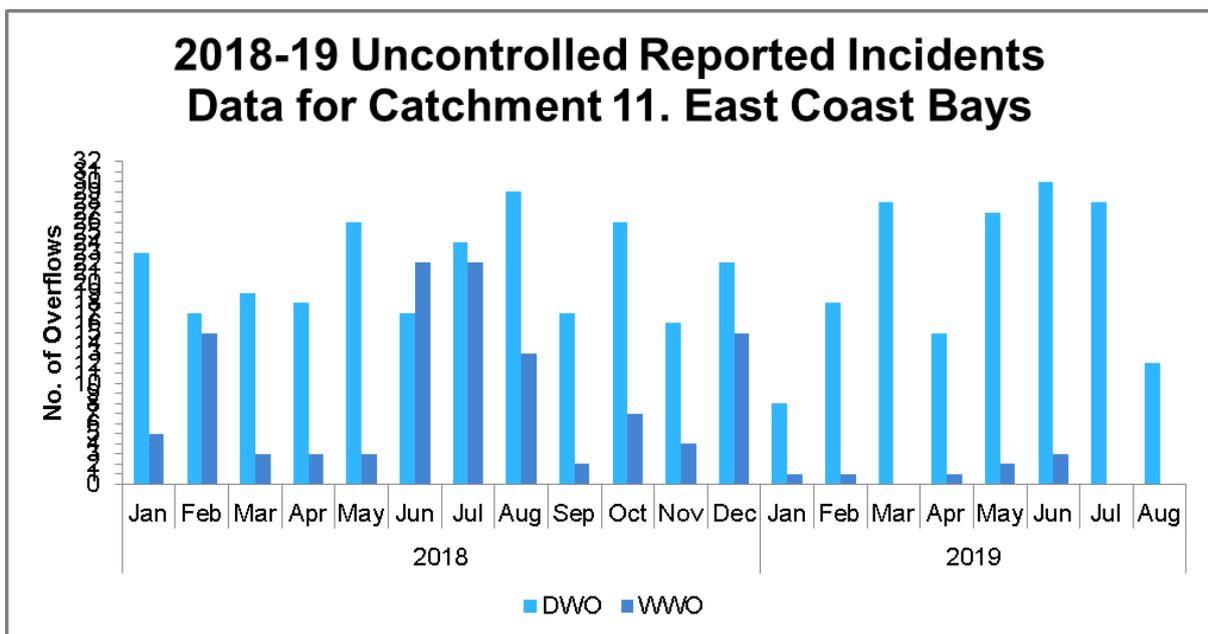
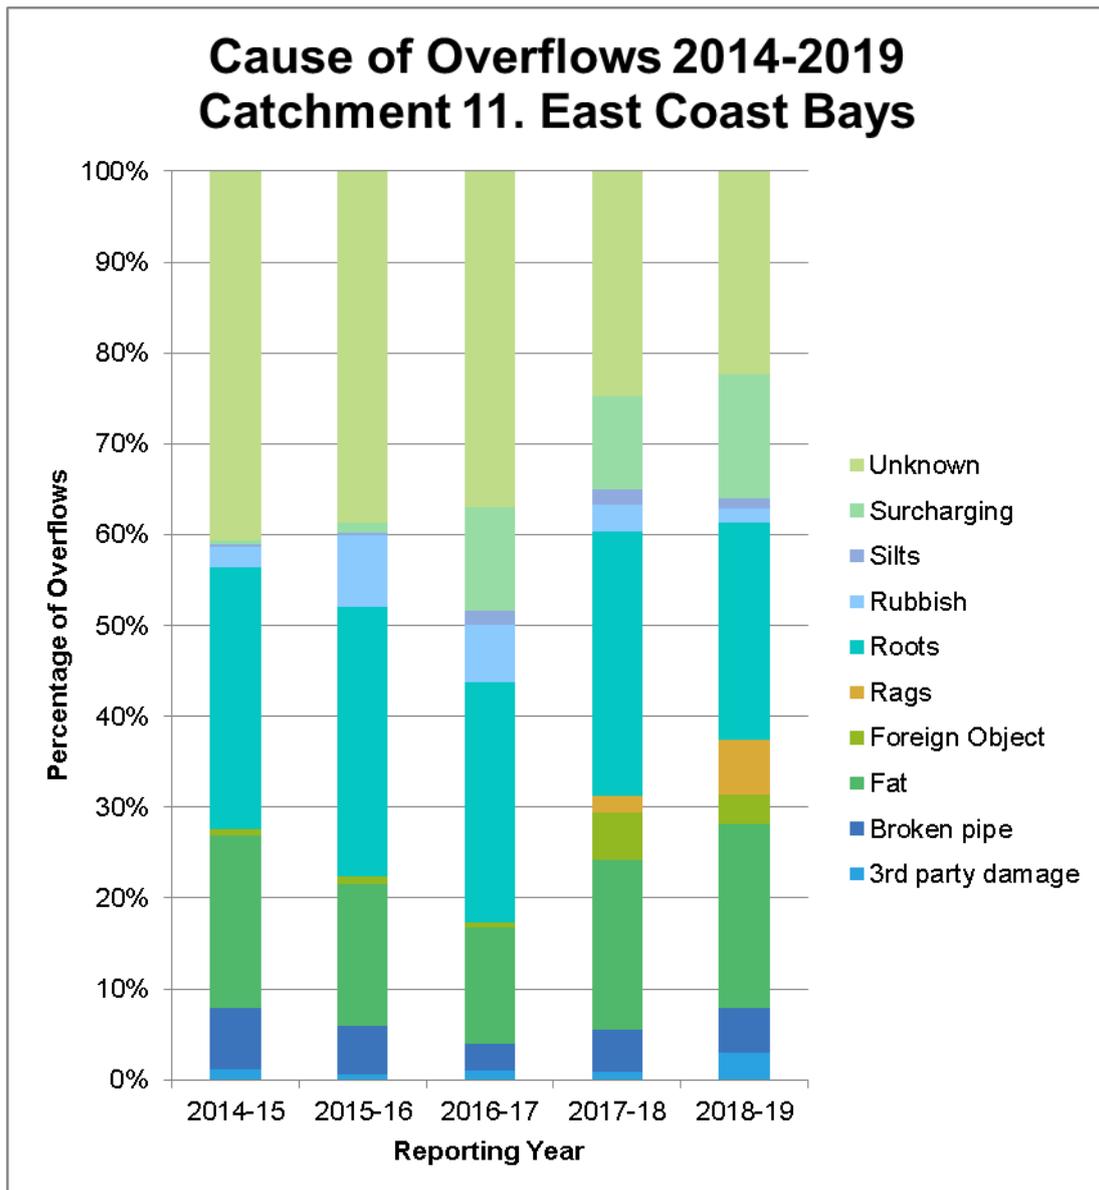
### 2.13.3 Trend analysis of reported incidents

The below graphs reflect the trends distributed along pipe lengths, annual trends, and overflow cause proportions. Trends are displayed over months where overflows occurred.

Trend analysis has been carried out where the cause has been identified.

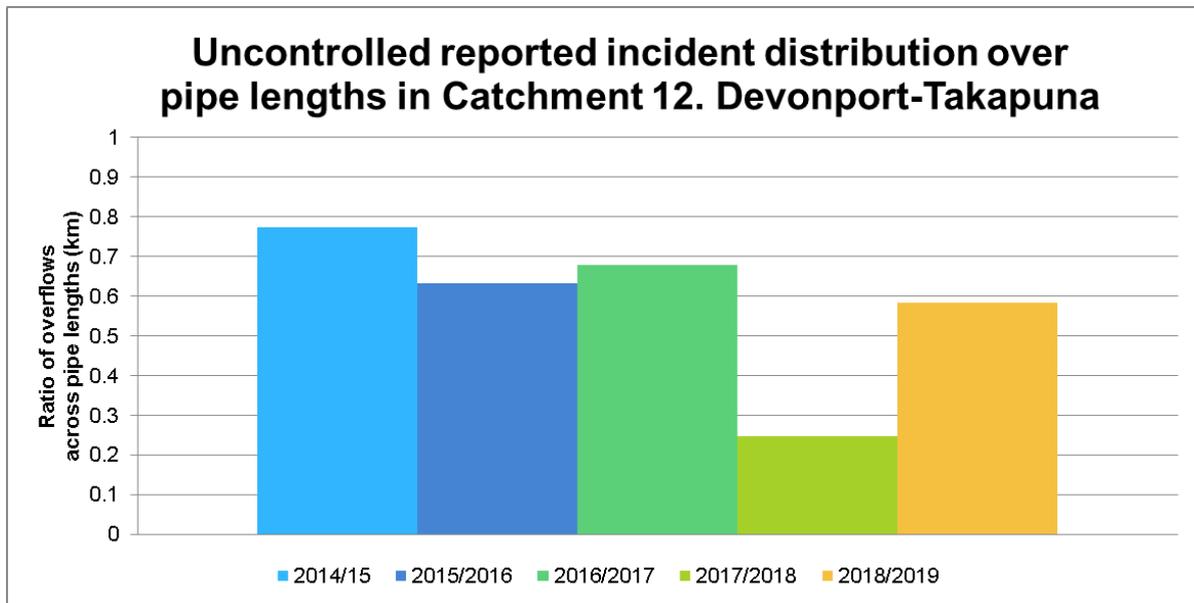
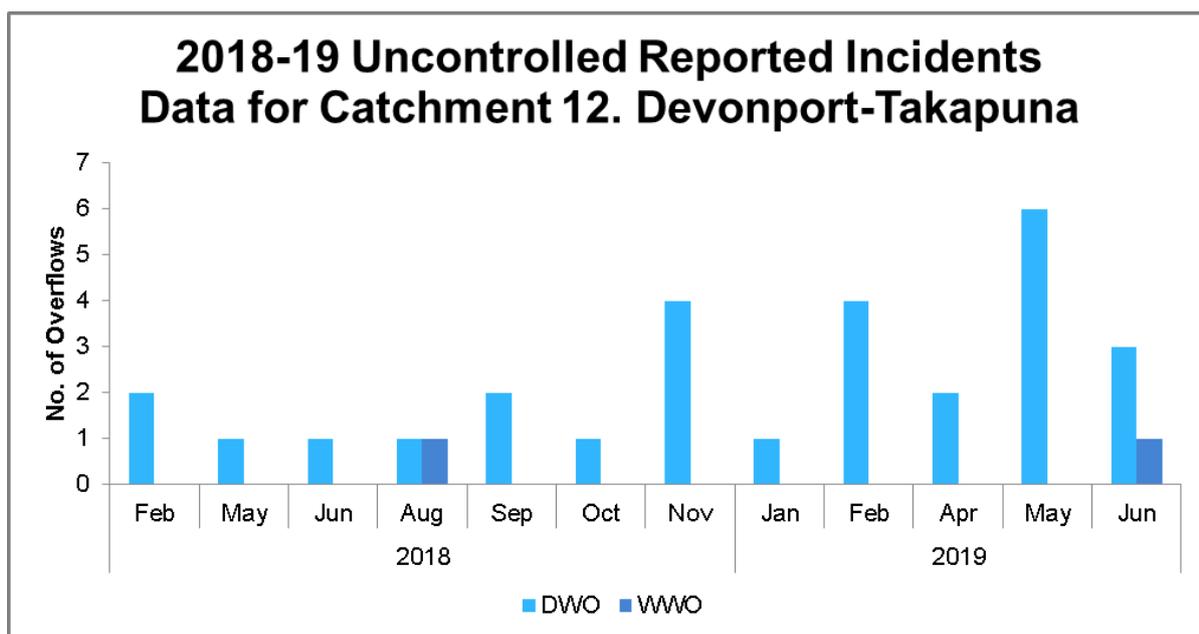
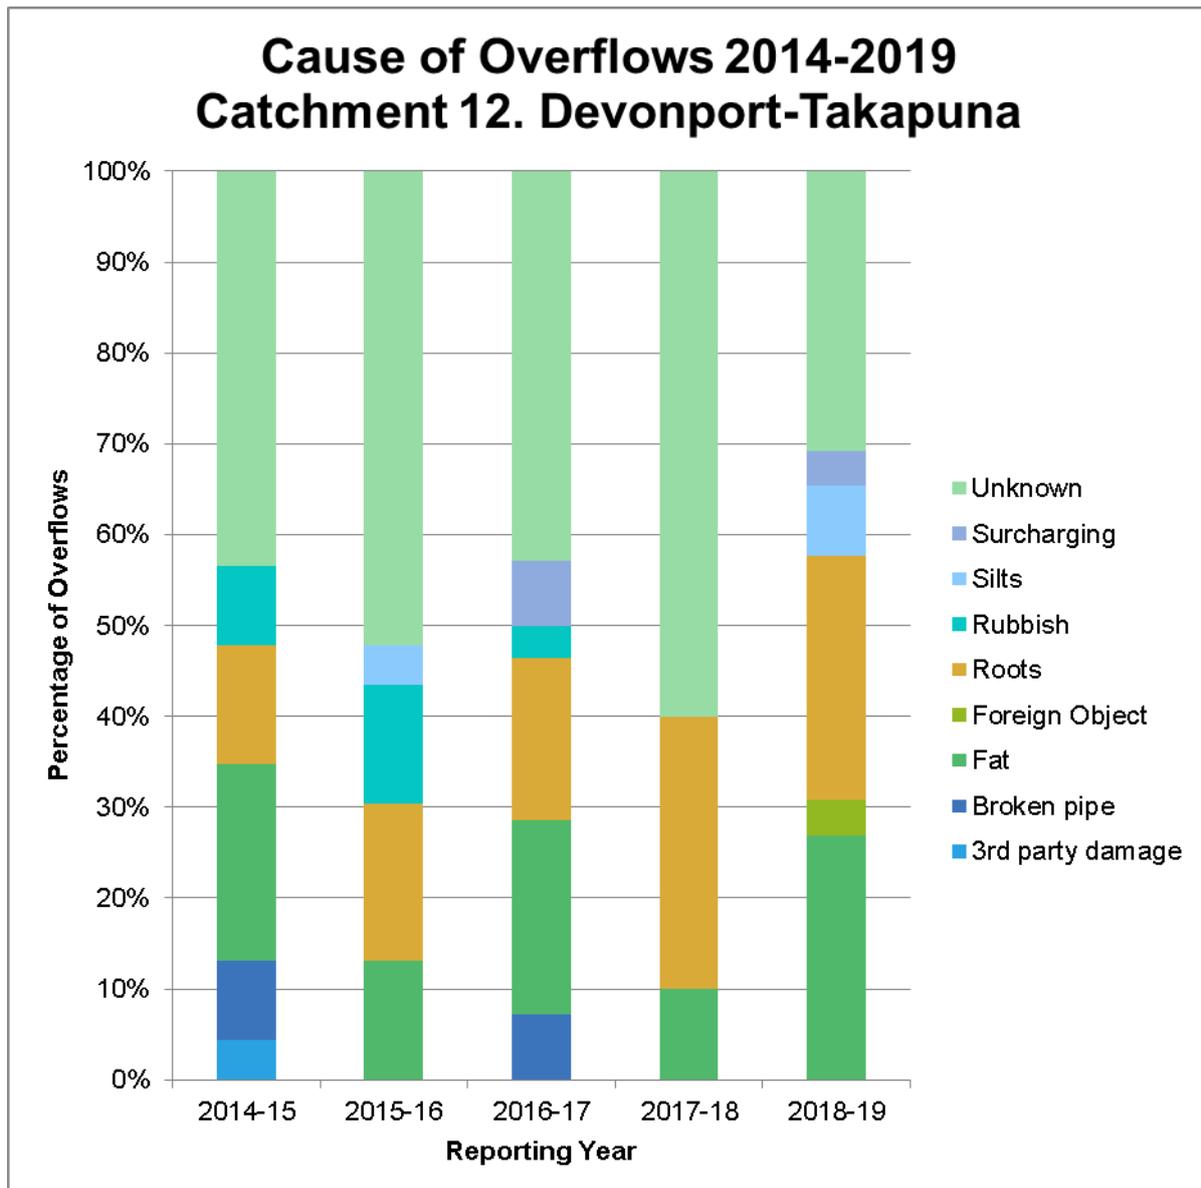
### 2.14.3 Trend analysis of reported incidents

The below graphs reflect the trends distributed along pipe lengths, annual trends, and overflow cause proportions. Trends are displayed over months where overflows occurred.

Trend analysis has been carried out where the cause has been identified.

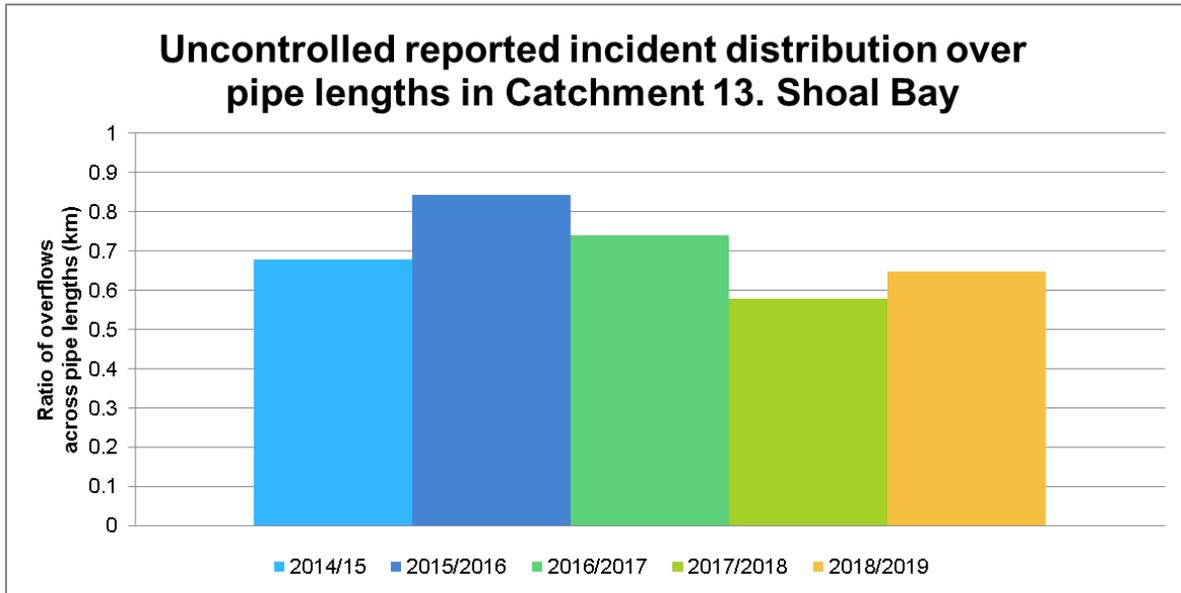
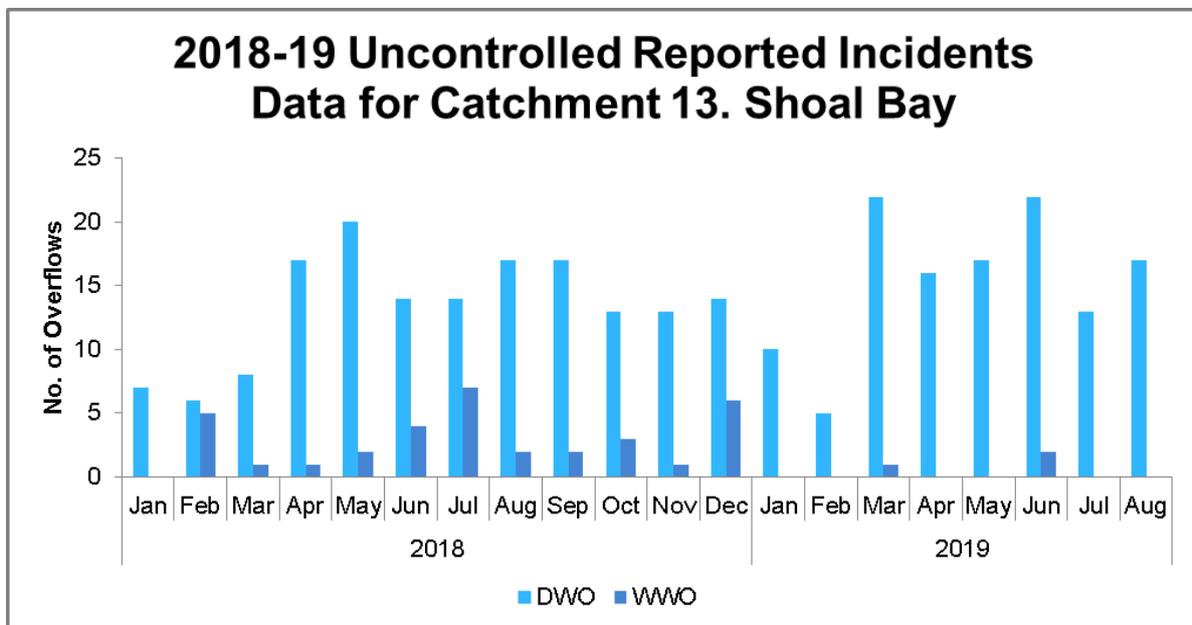
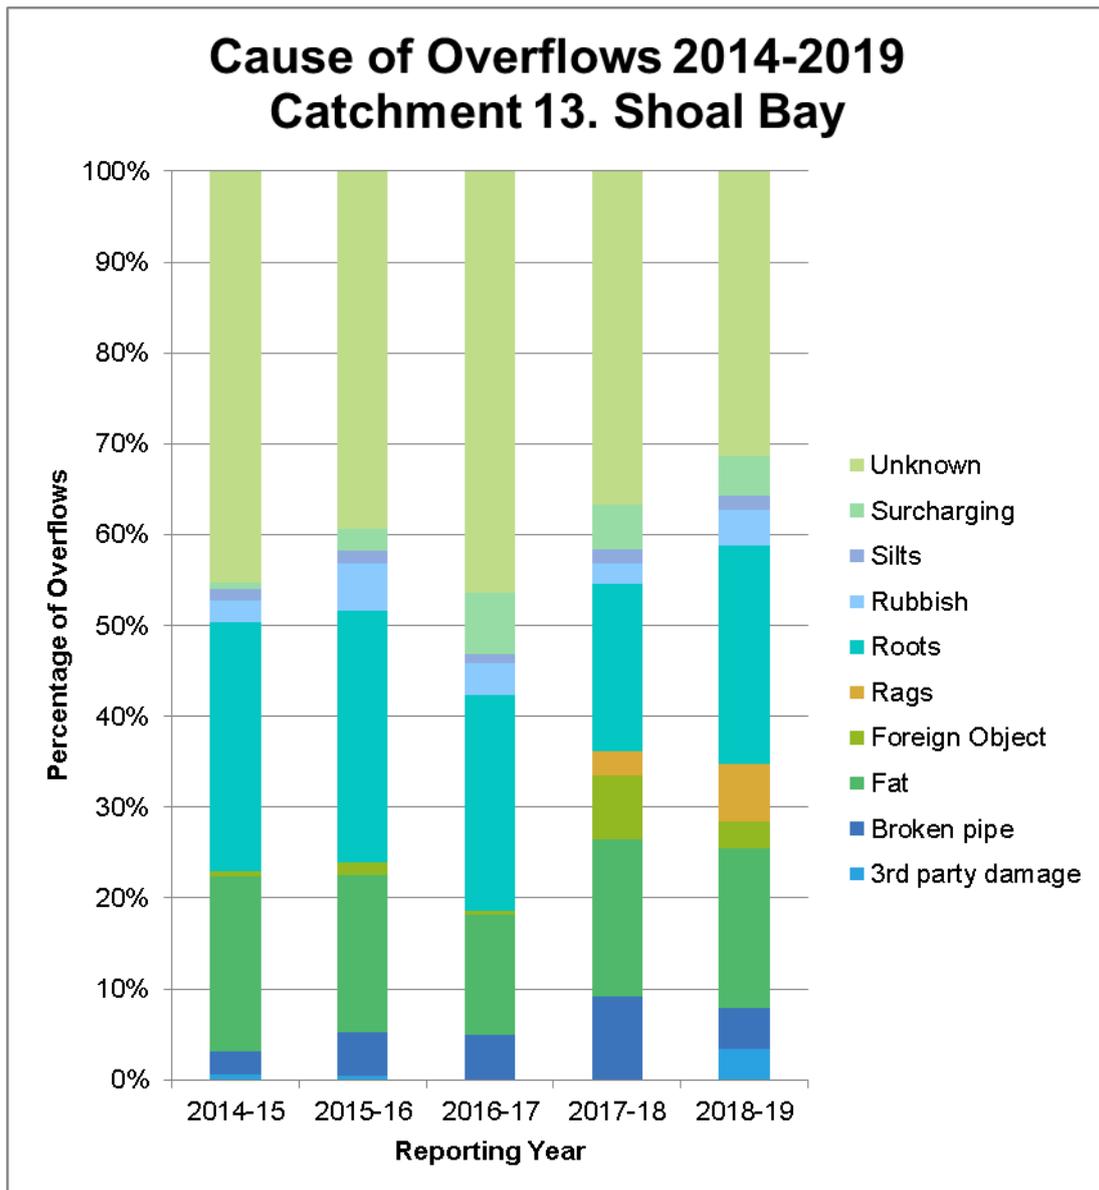
### 2.15.3 Trend analysis of reported incidents

The below graphs reflect the trends distributed along pipe lengths, annual trends, and overflow cause proportions. Trends are displayed over months where overflows occurred.

Trend analysis has been carried out where the cause has been identified.

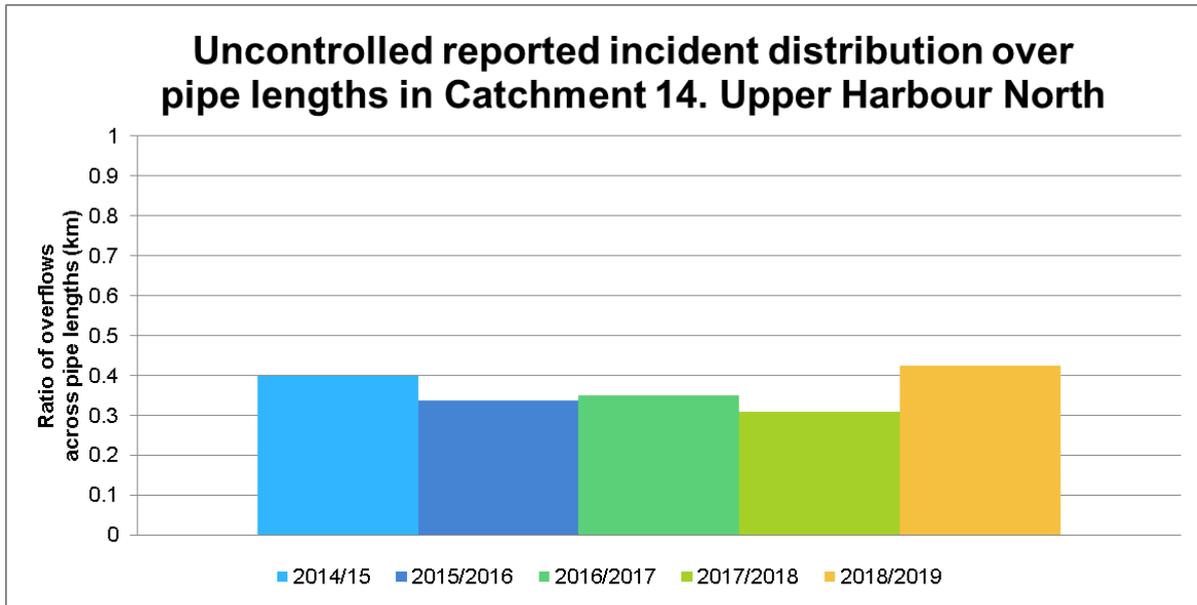
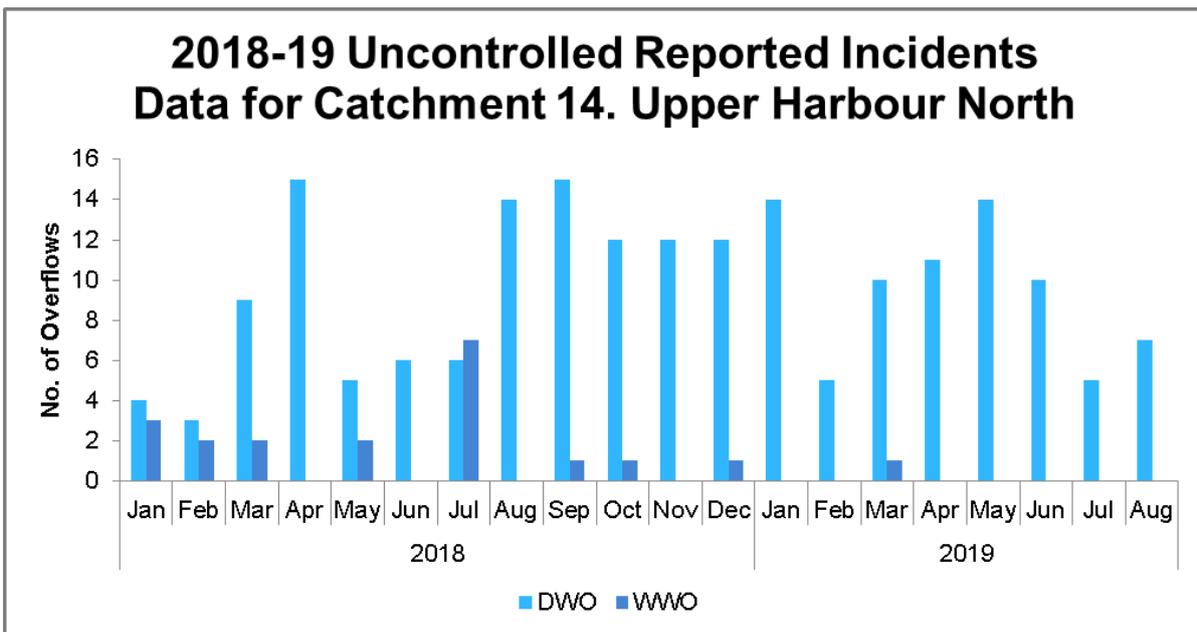
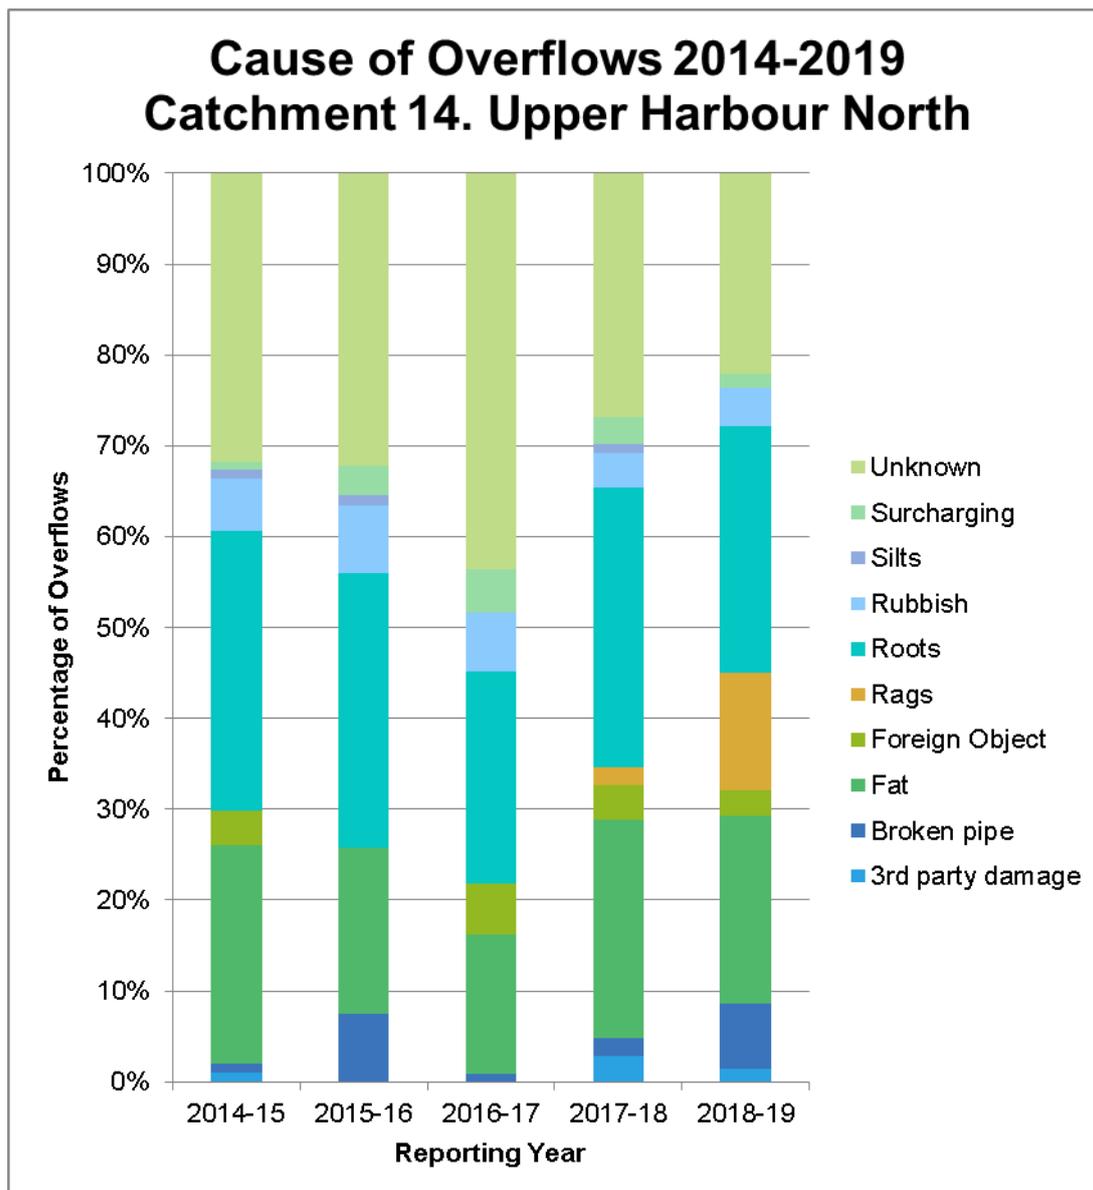
### 2.16.3 Trend analysis of reported incidents

The below graphs reflect the trends distributed along pipe lengths, annual trends, and overflow cause proportions. Trends are displayed over months where overflows occurred.

Trend analysis has been carried out where the cause has been identified.

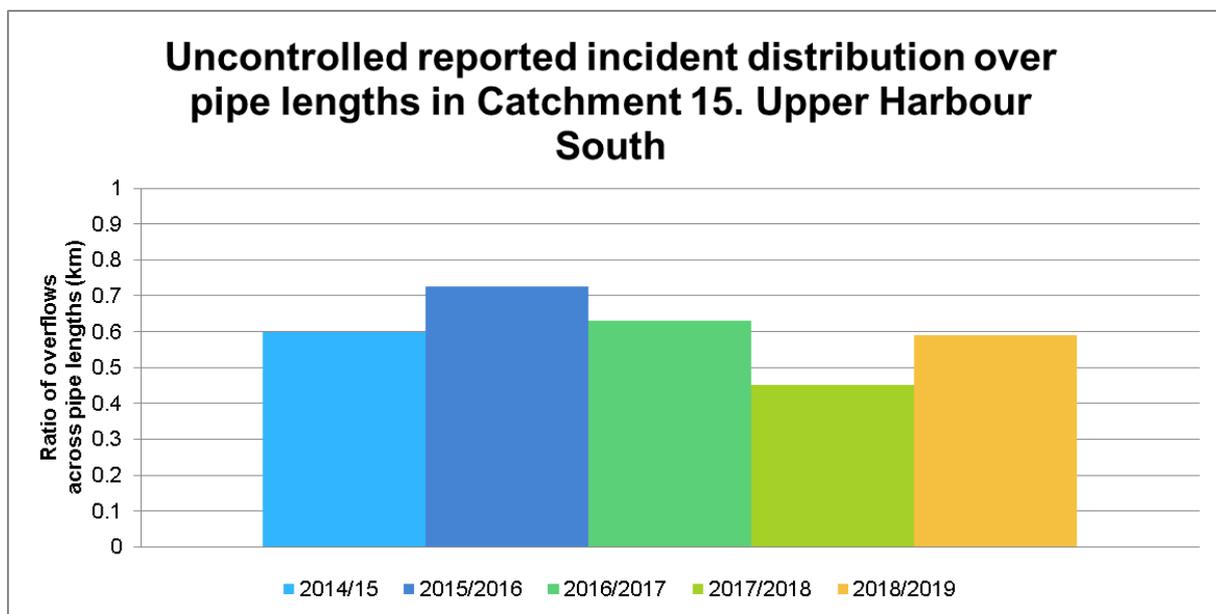
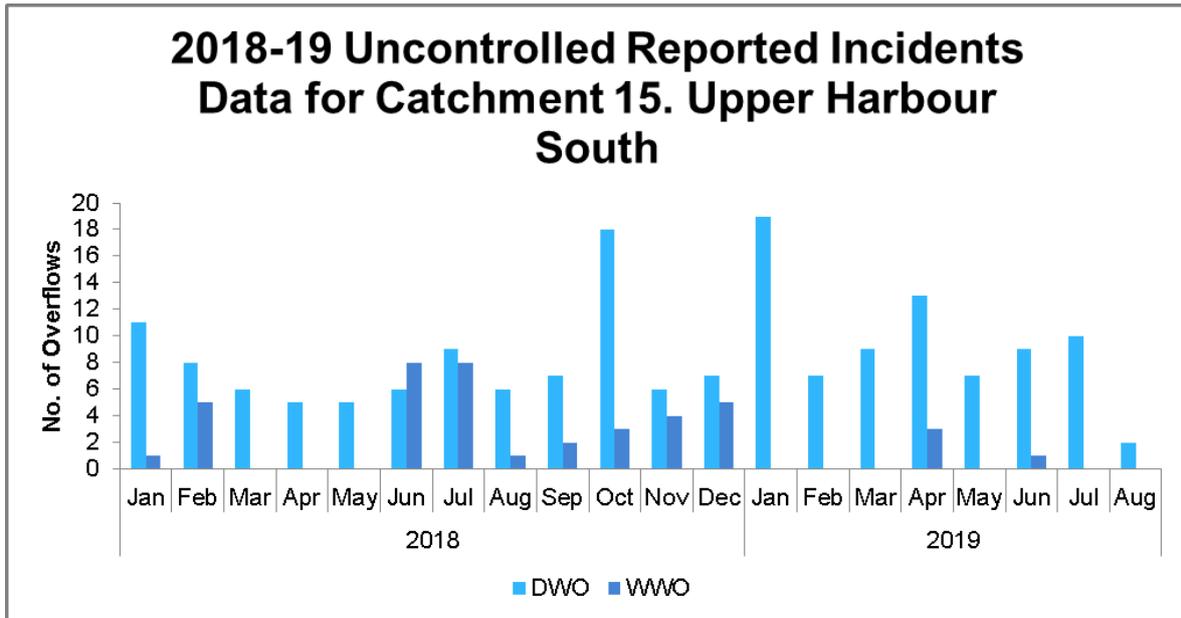
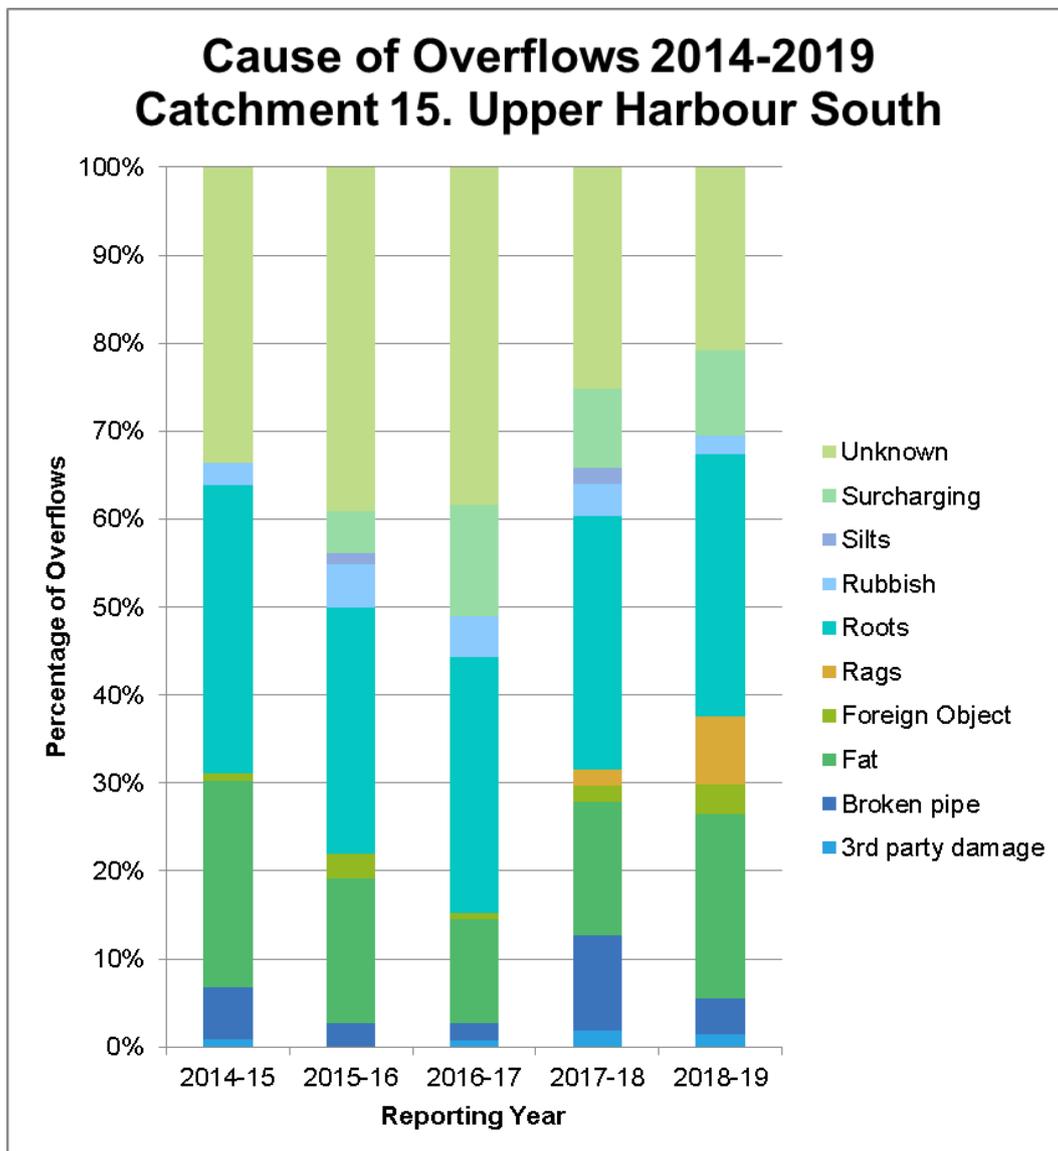
### 2.17.3 Trend analysis of reported incidents

The below graphs reflect the trends distributed along pipe lengths, annual trends, and overflow cause proportions. Trends are displayed over months where overflows occurred.

Trend analysis has been carried out where the cause has been identified.

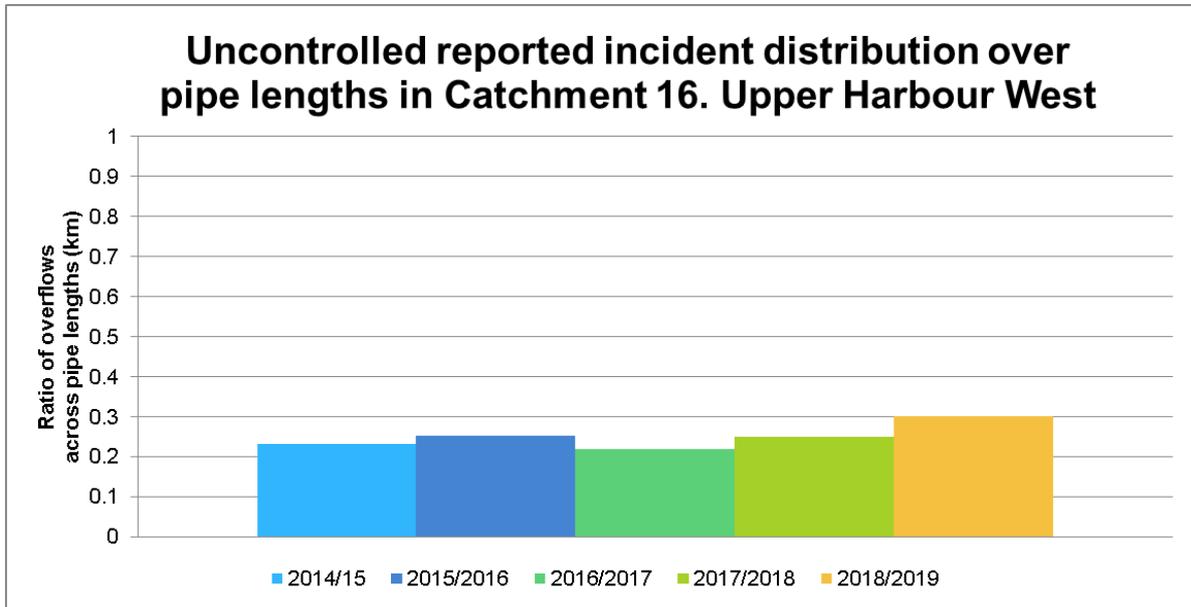
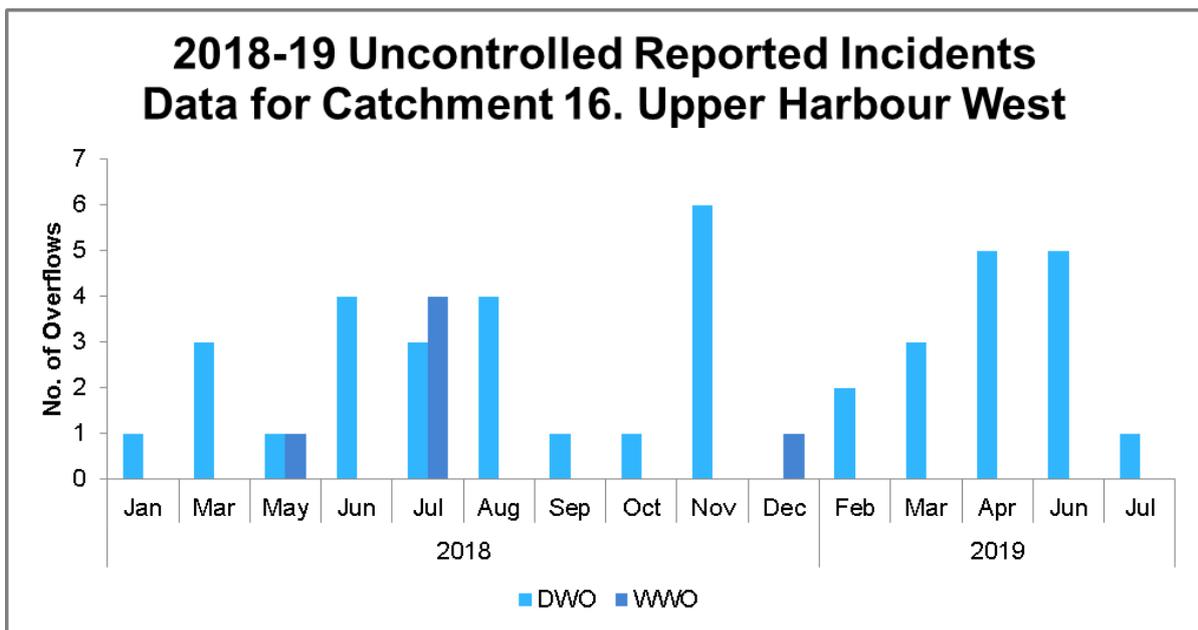
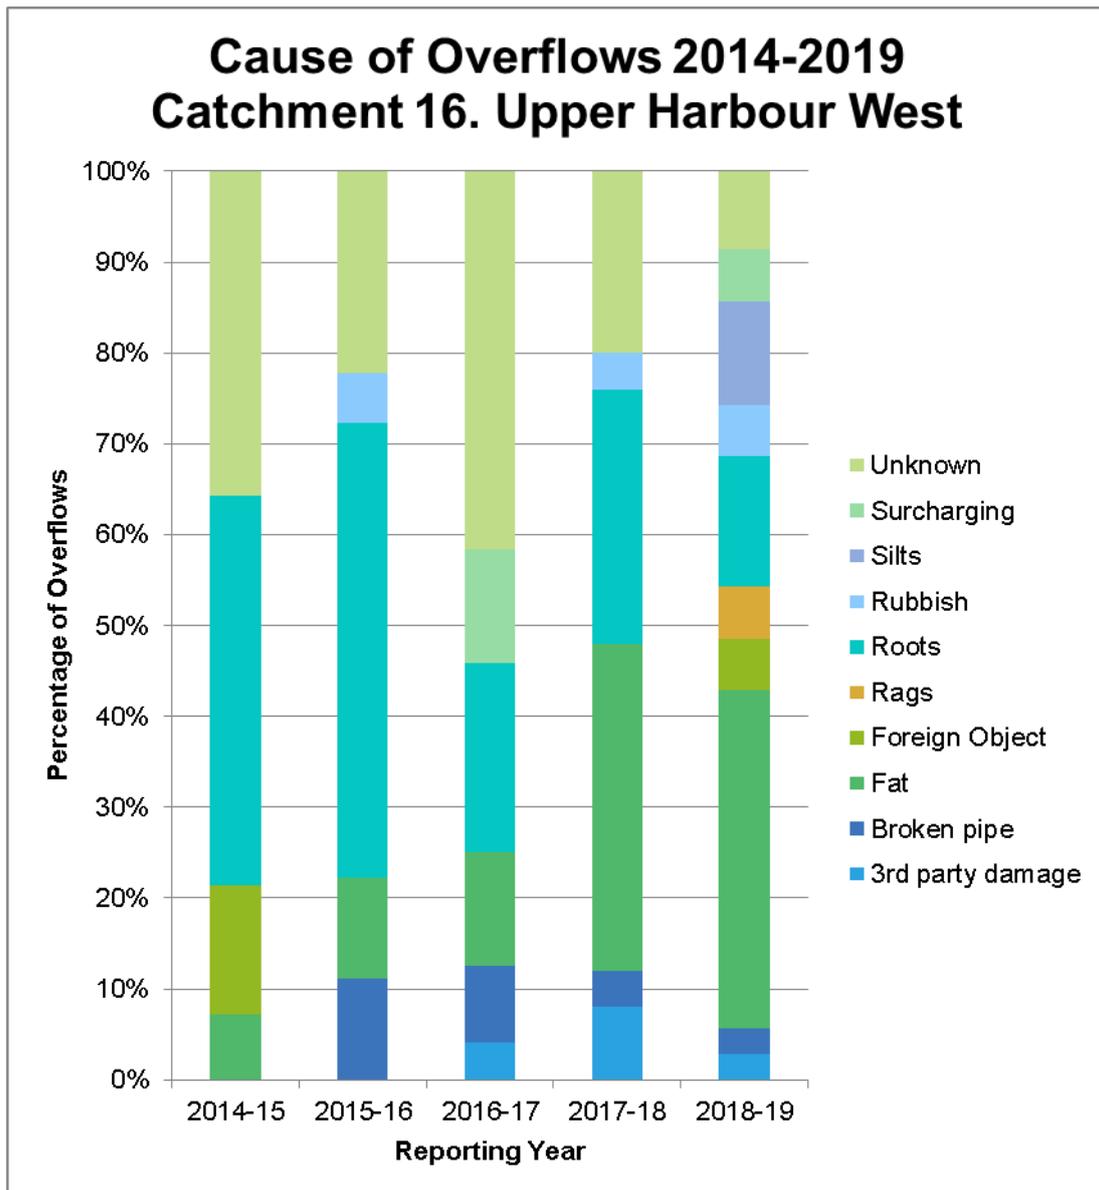
### 2.18.3 Trend analysis of reported incidents

The below graphs reflect the trends distributed along pipe lengths, annual trends, and overflow cause proportions. Trends are displayed over months where overflows occurred.

Trend analysis has been carried out where the cause has been identified.
