## **Section 2**

# **Annual Performance Report Strategic Management Areas & Geographical Catchments**

**1 July 2018 to 30 June 2019**

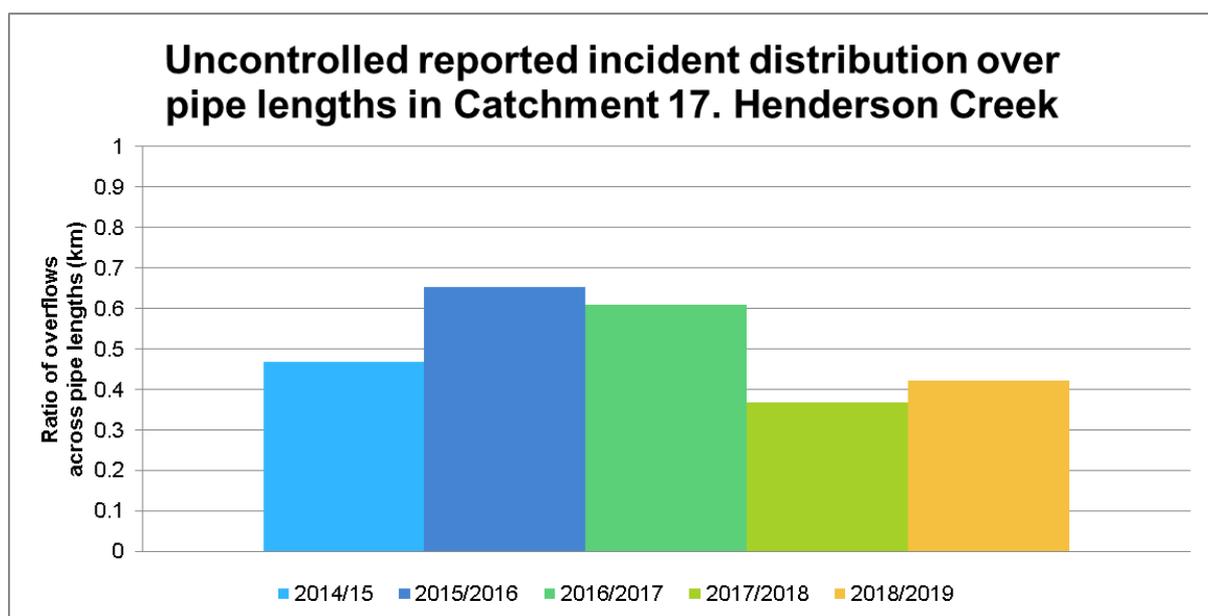
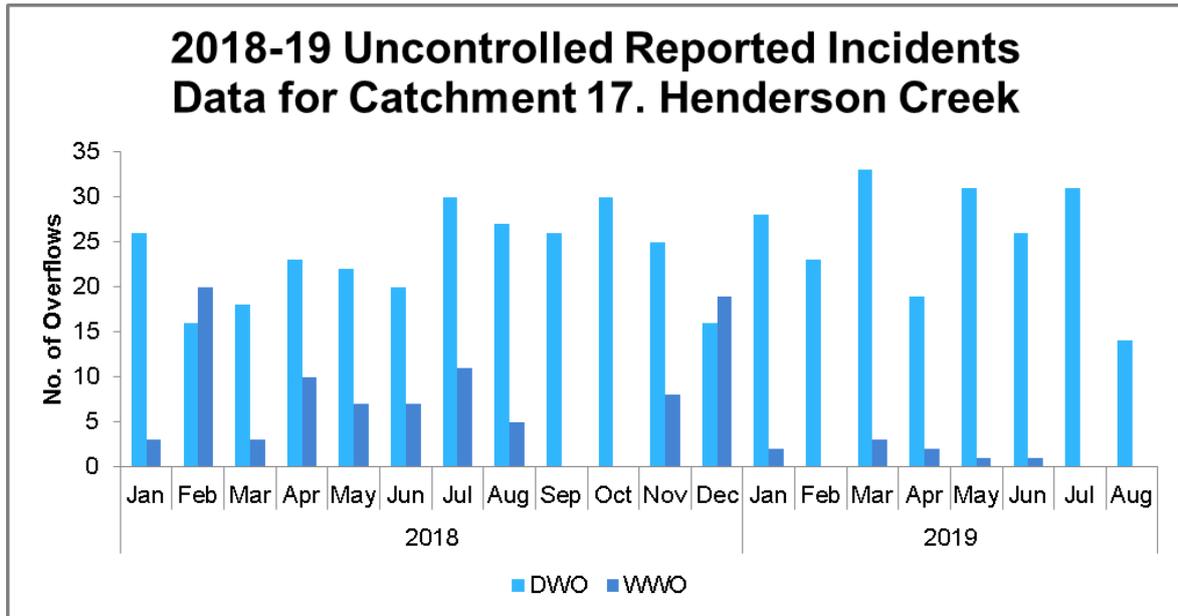
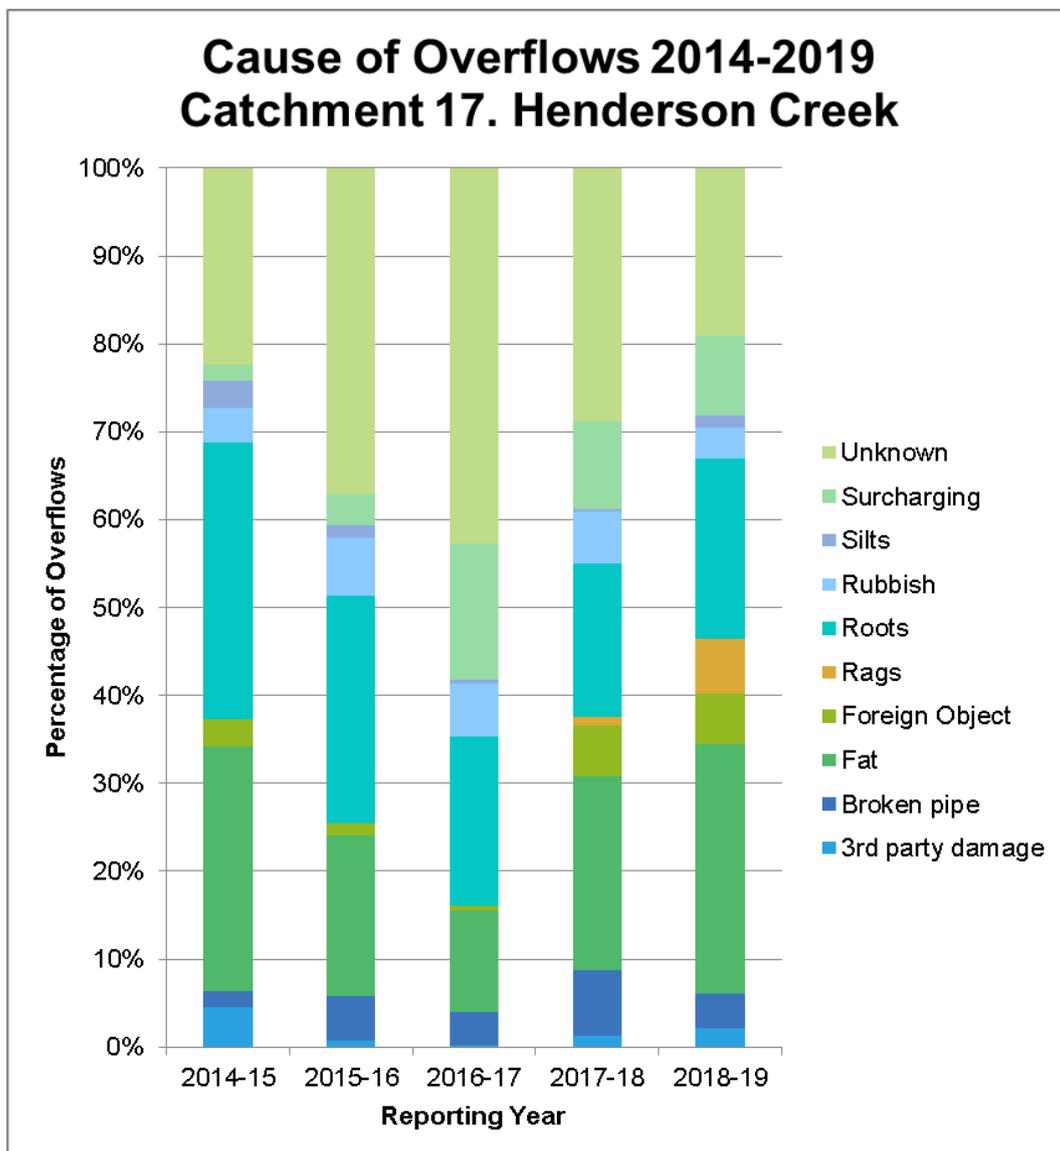
### 2.19.3 Trend analysis of reported incidents

The below graphs reflect the trends distributed along pipe lengths, annual trends, and overflow cause proportions. Trends are displayed over months where overflows occurred.

Trend analysis has been carried out where the cause has been identified.

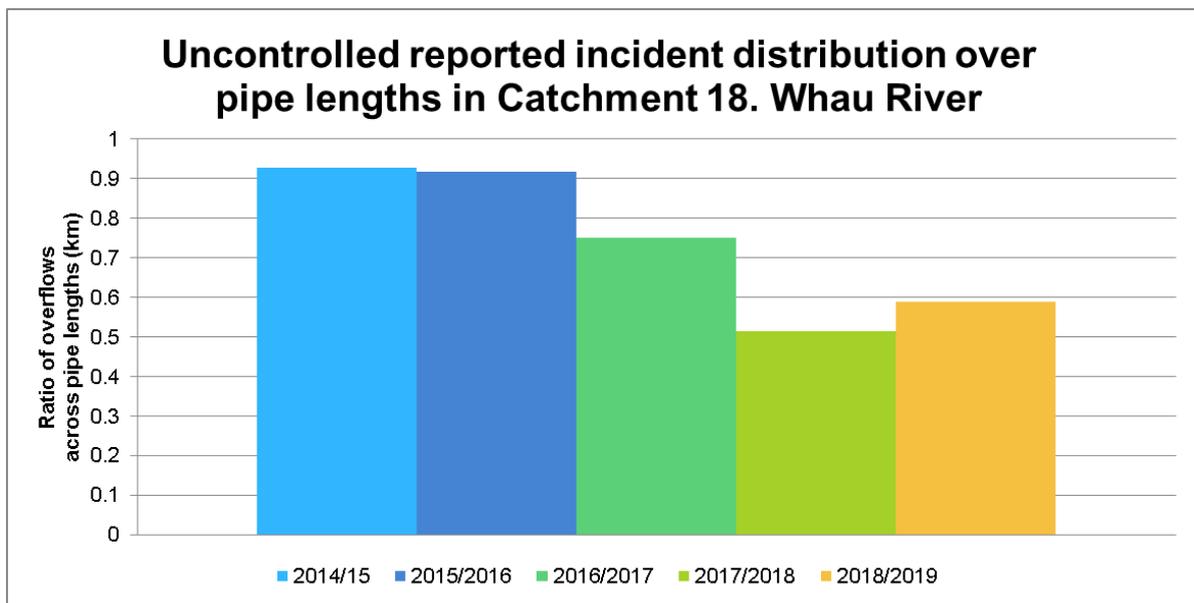
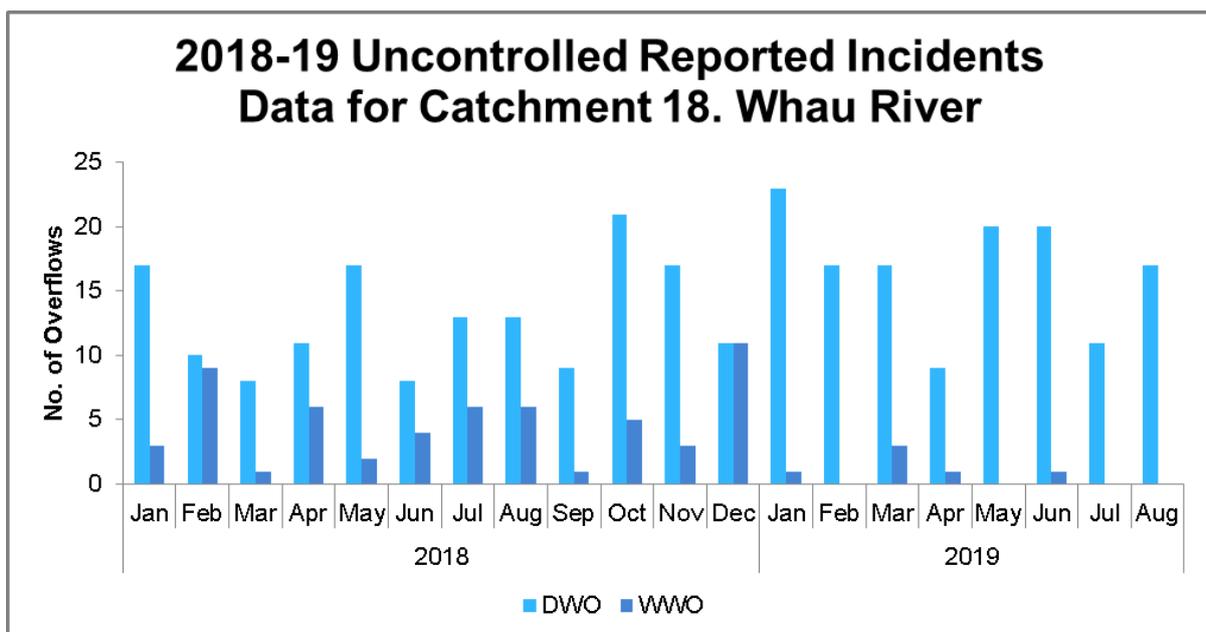
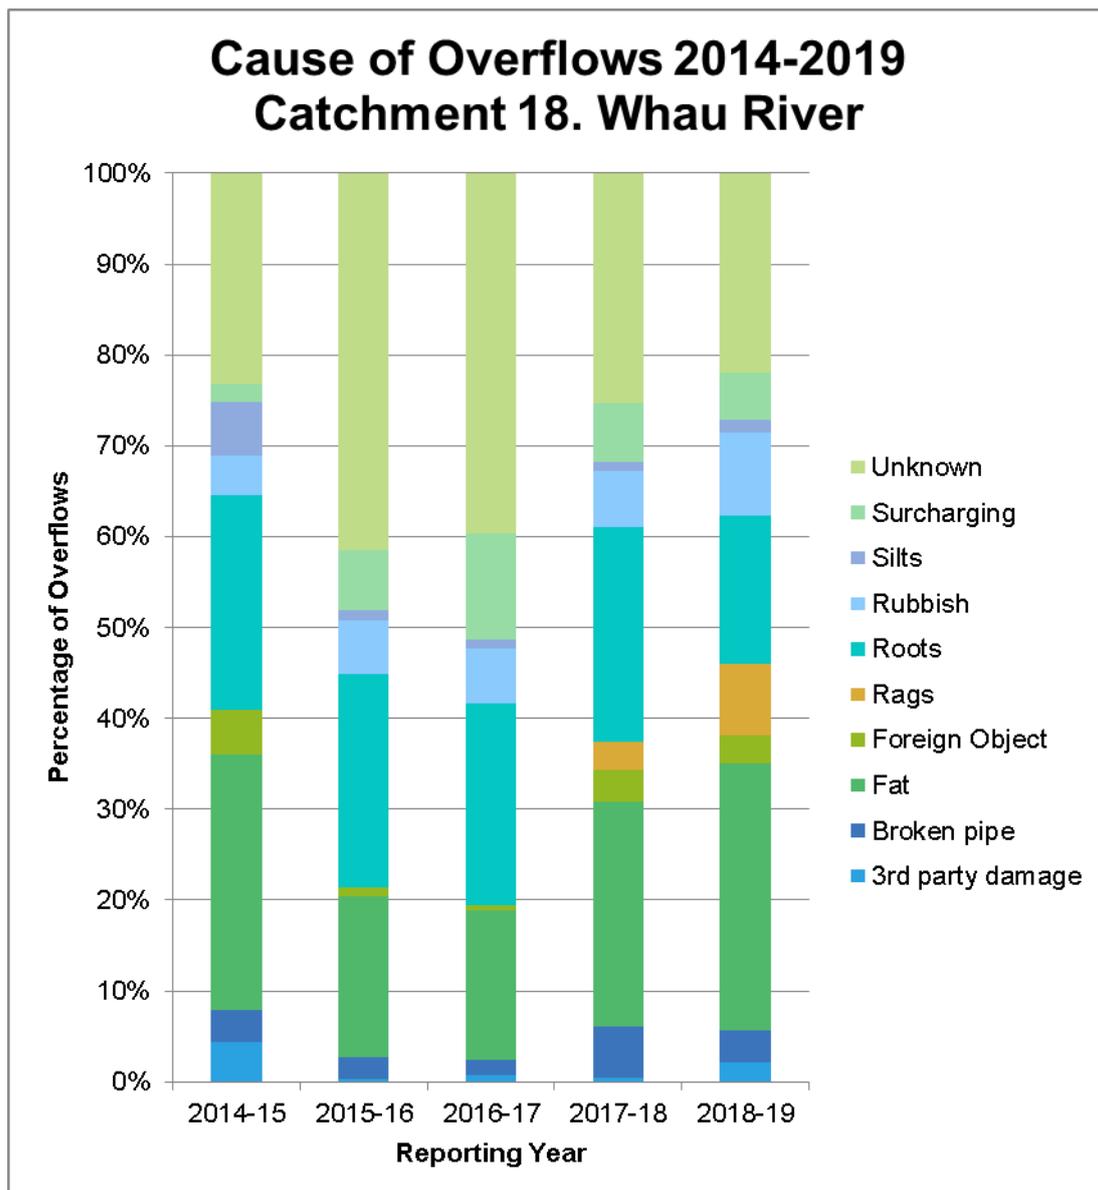
### 2.20.3 Trend analysis of reported incidents

The below graphs reflect the trends distributed along pipe lengths, annual trends, and overflow cause proportions. Trends are displayed over months where overflows occurred.

Trend analysis has been carried out where root cause has been identified.

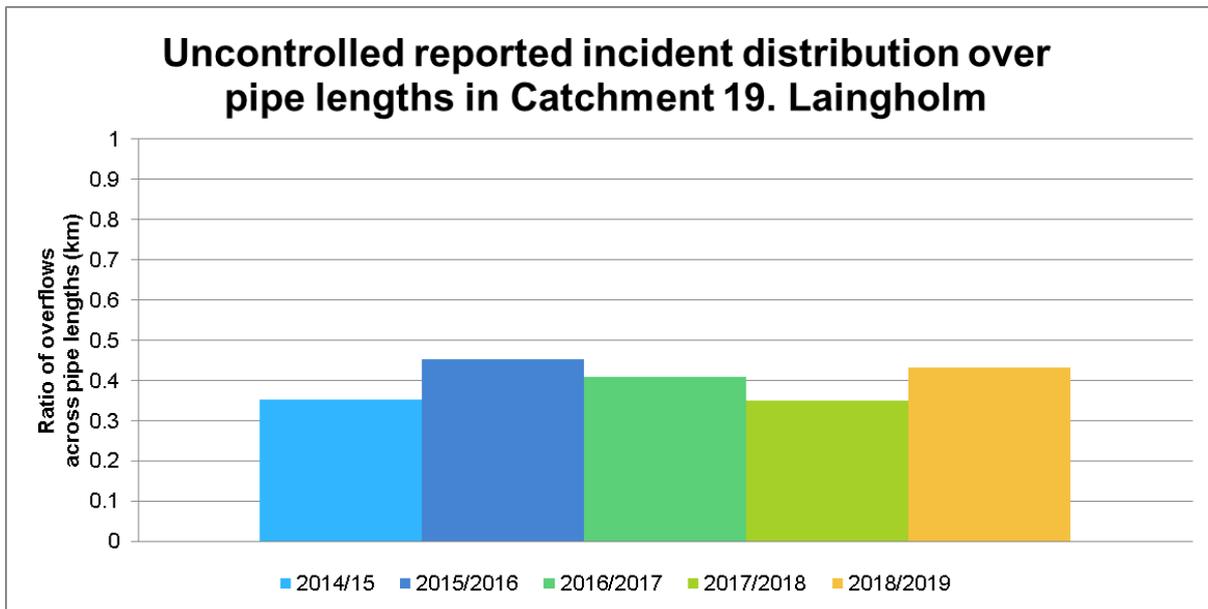
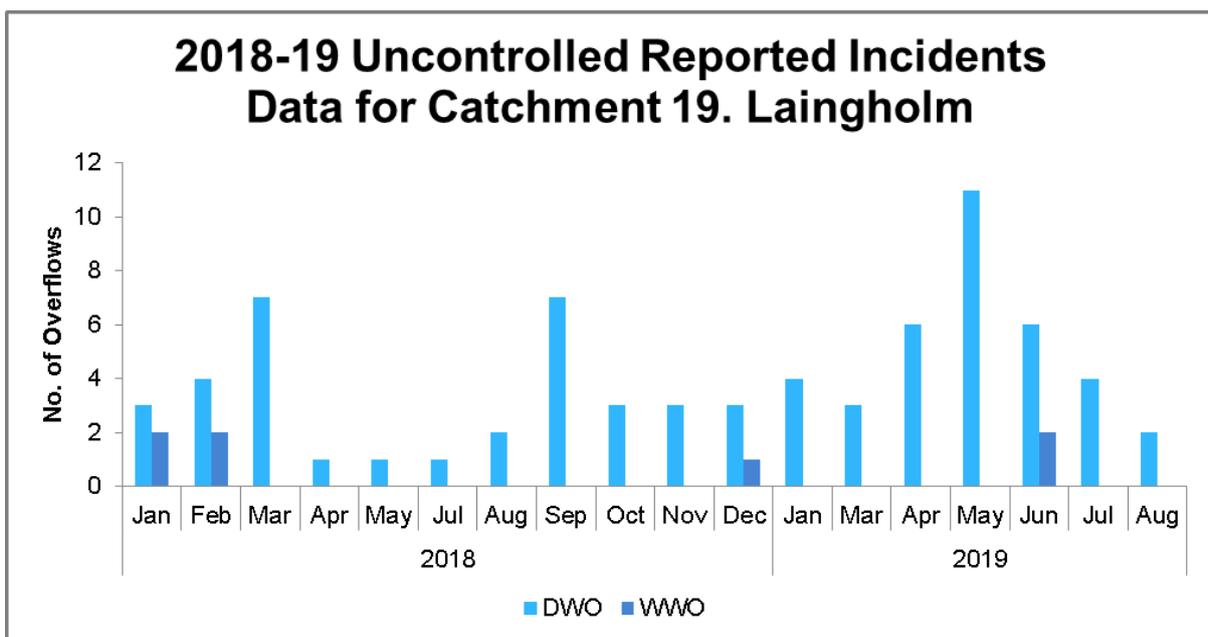
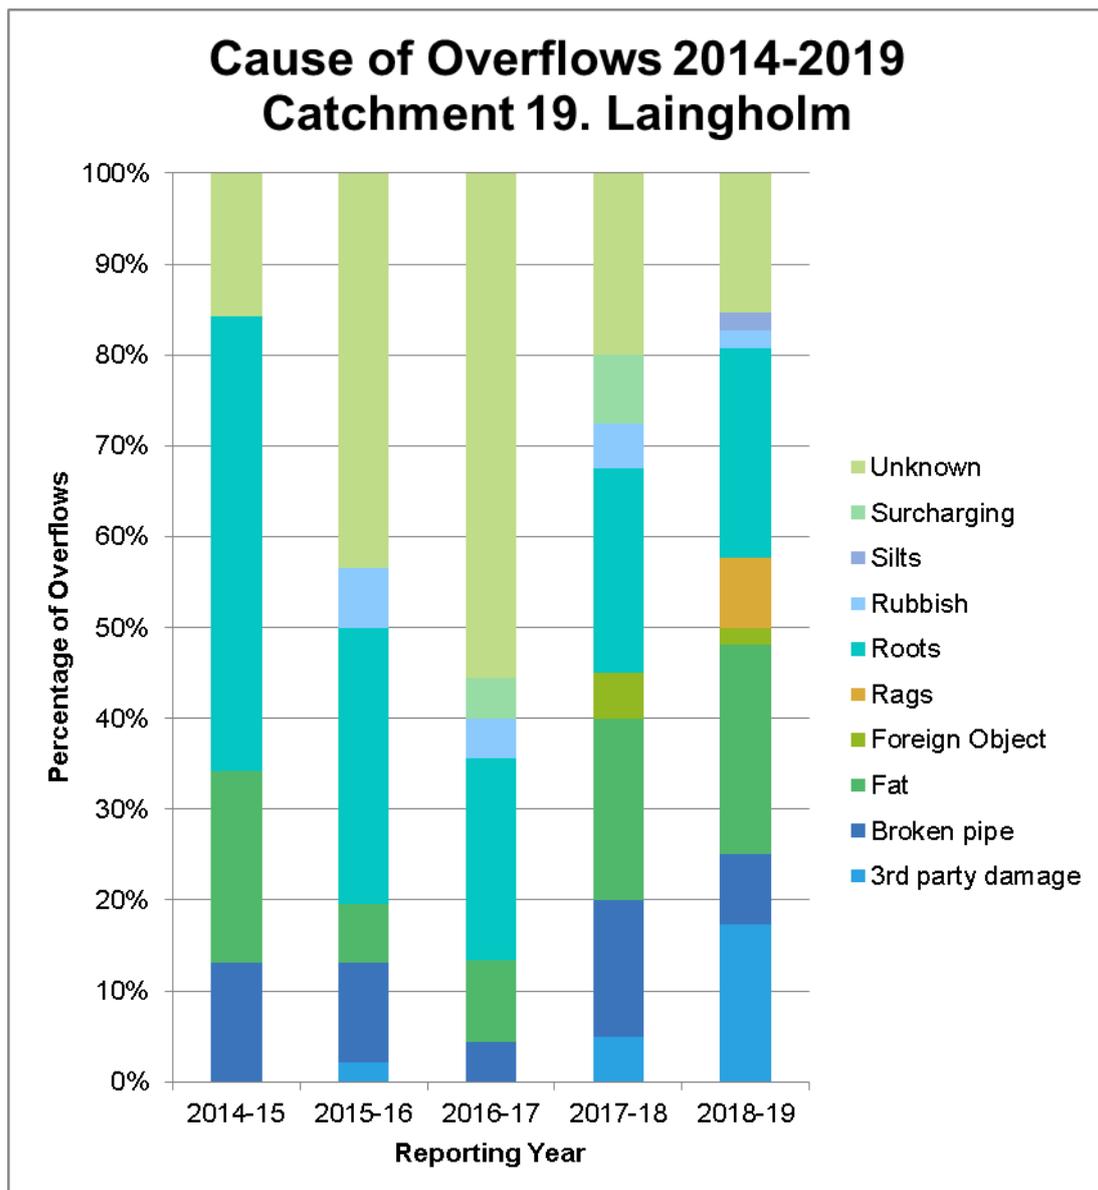
### 2.21.3 Trend analysis of reported incidents

The below graphs reflect the trends distributed along pipe lengths, annual trends, and overflow cause proportions. Trends are displayed over months where overflows occurred.

Trend analysis has been carried out where the cause has been identified.

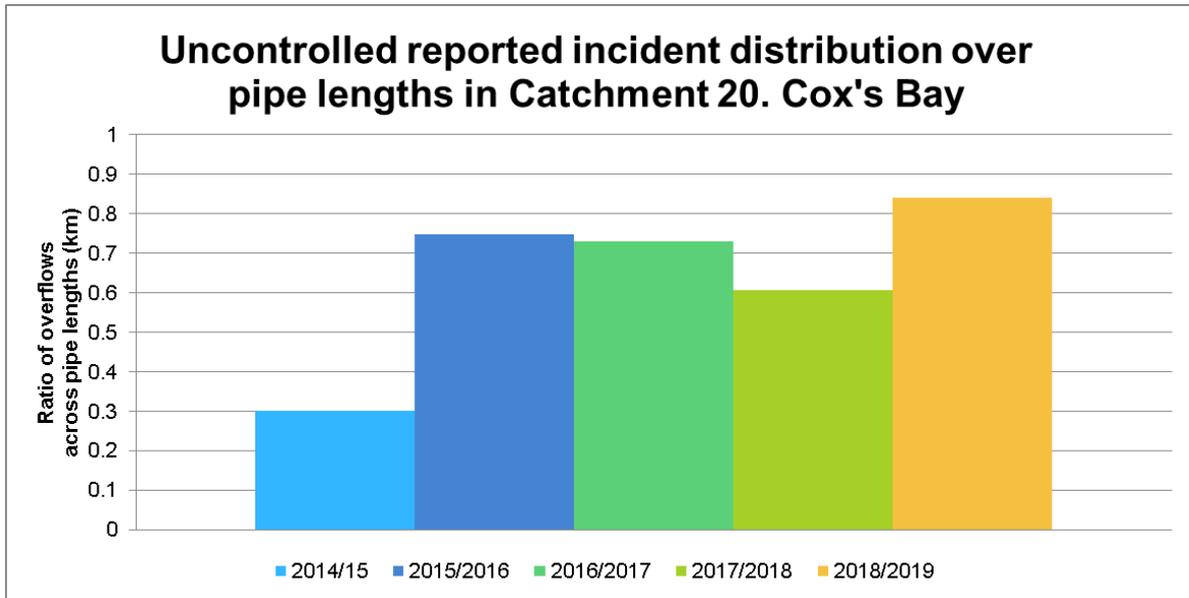
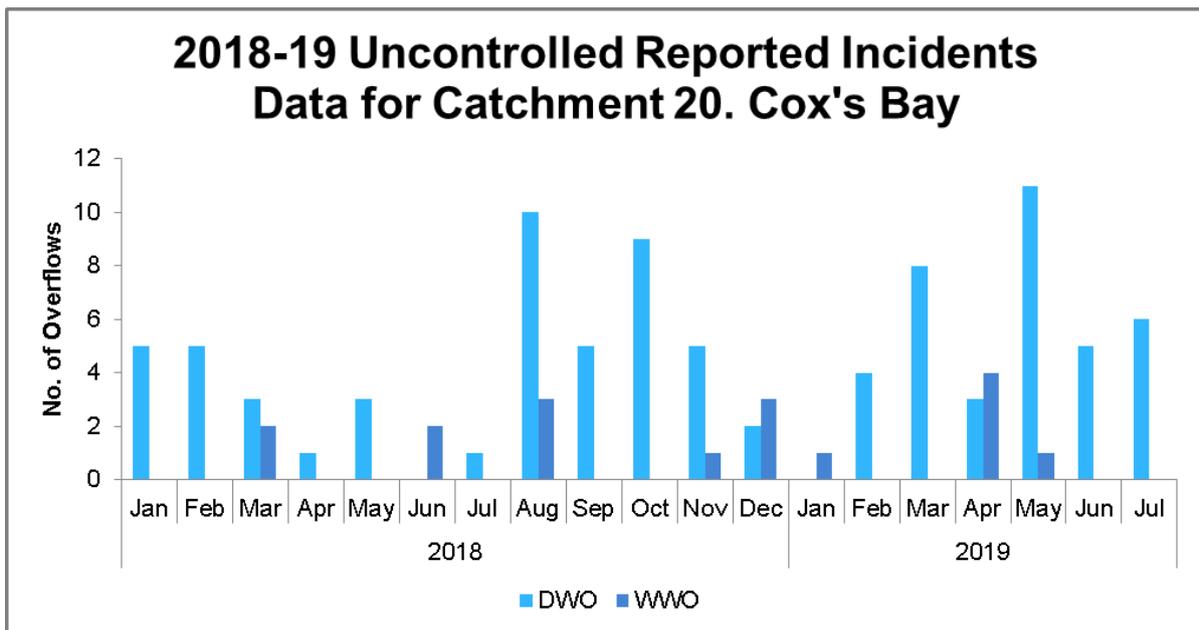
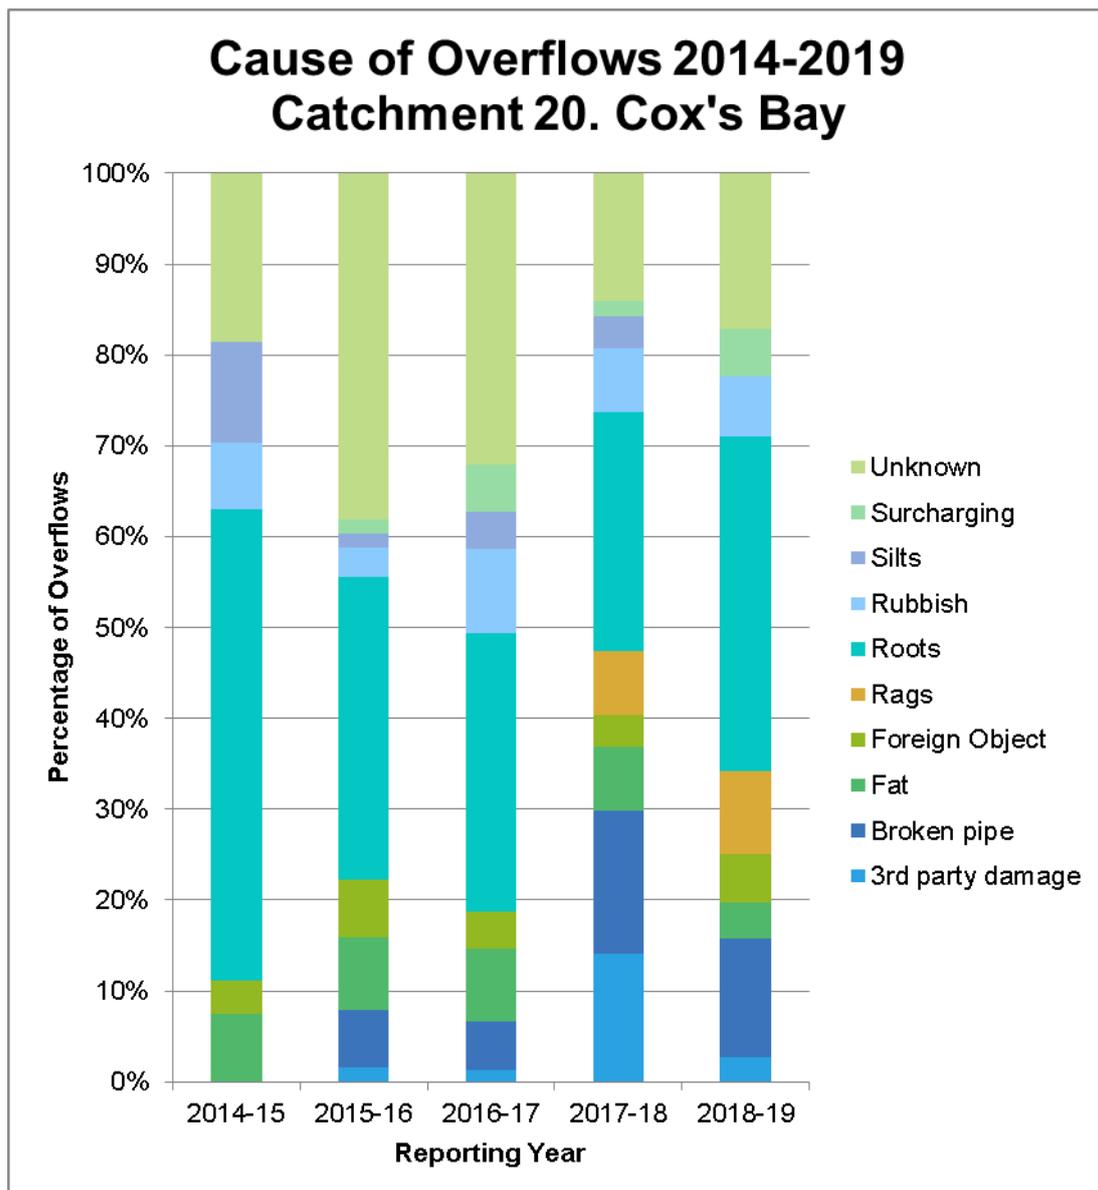
### 2.22.3 Trend analysis of reported incidents

The below graphs reflect the trends distributed along pipe lengths, annual trends, and overflow cause proportions. Trends are displayed over months where overflows occurred.

Trend analysis has been carried out where the cause has been identified.

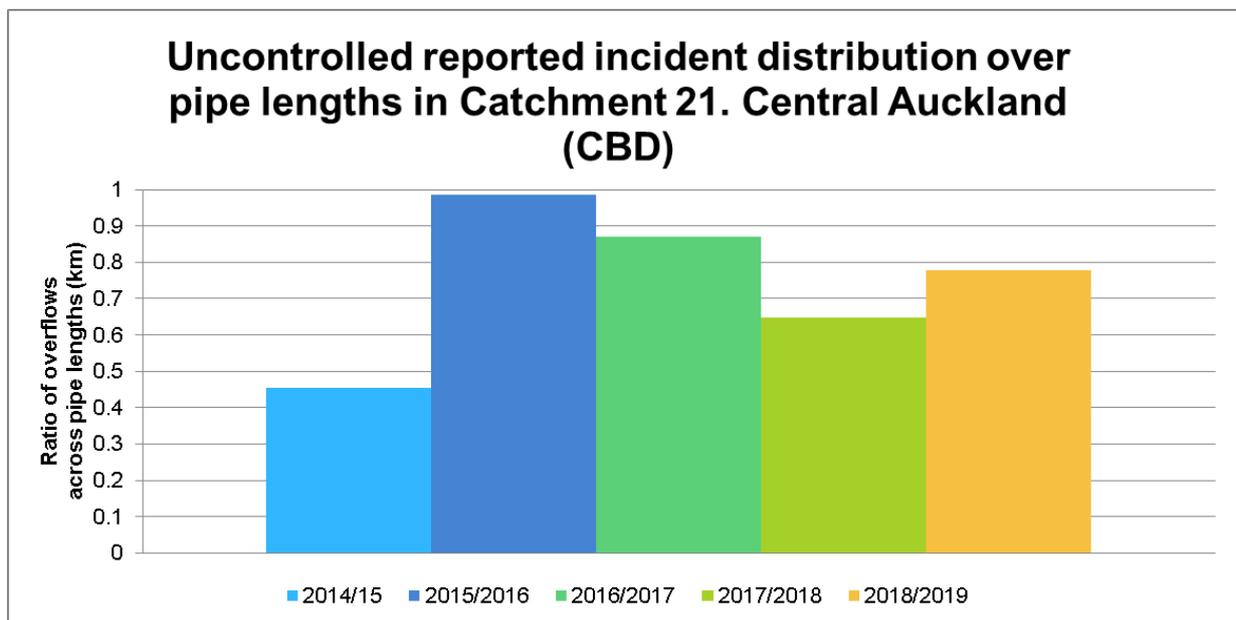
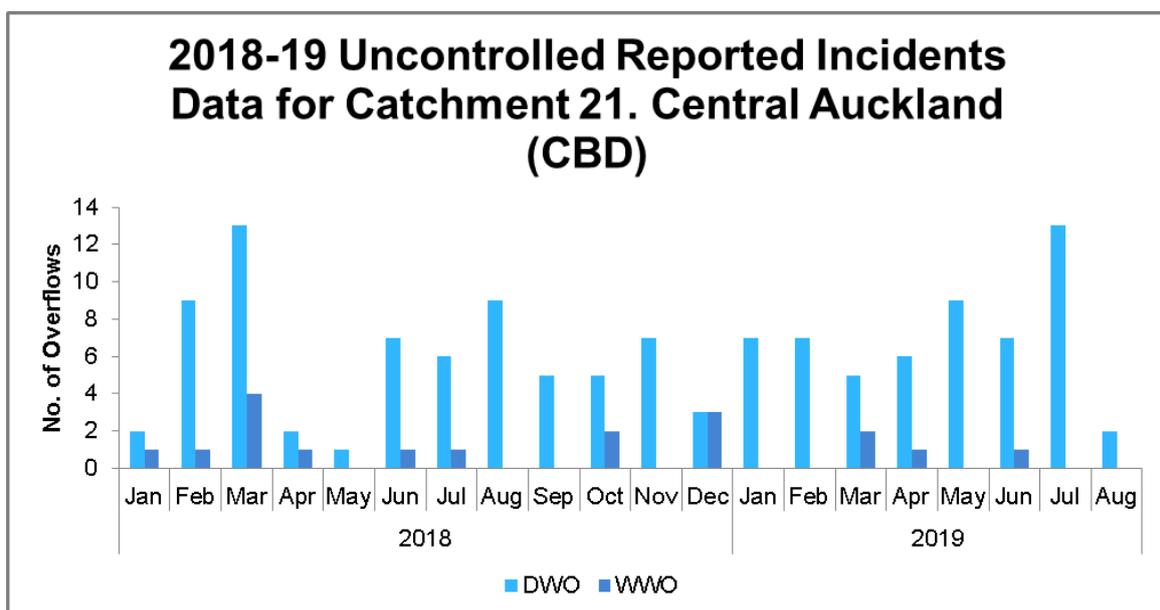
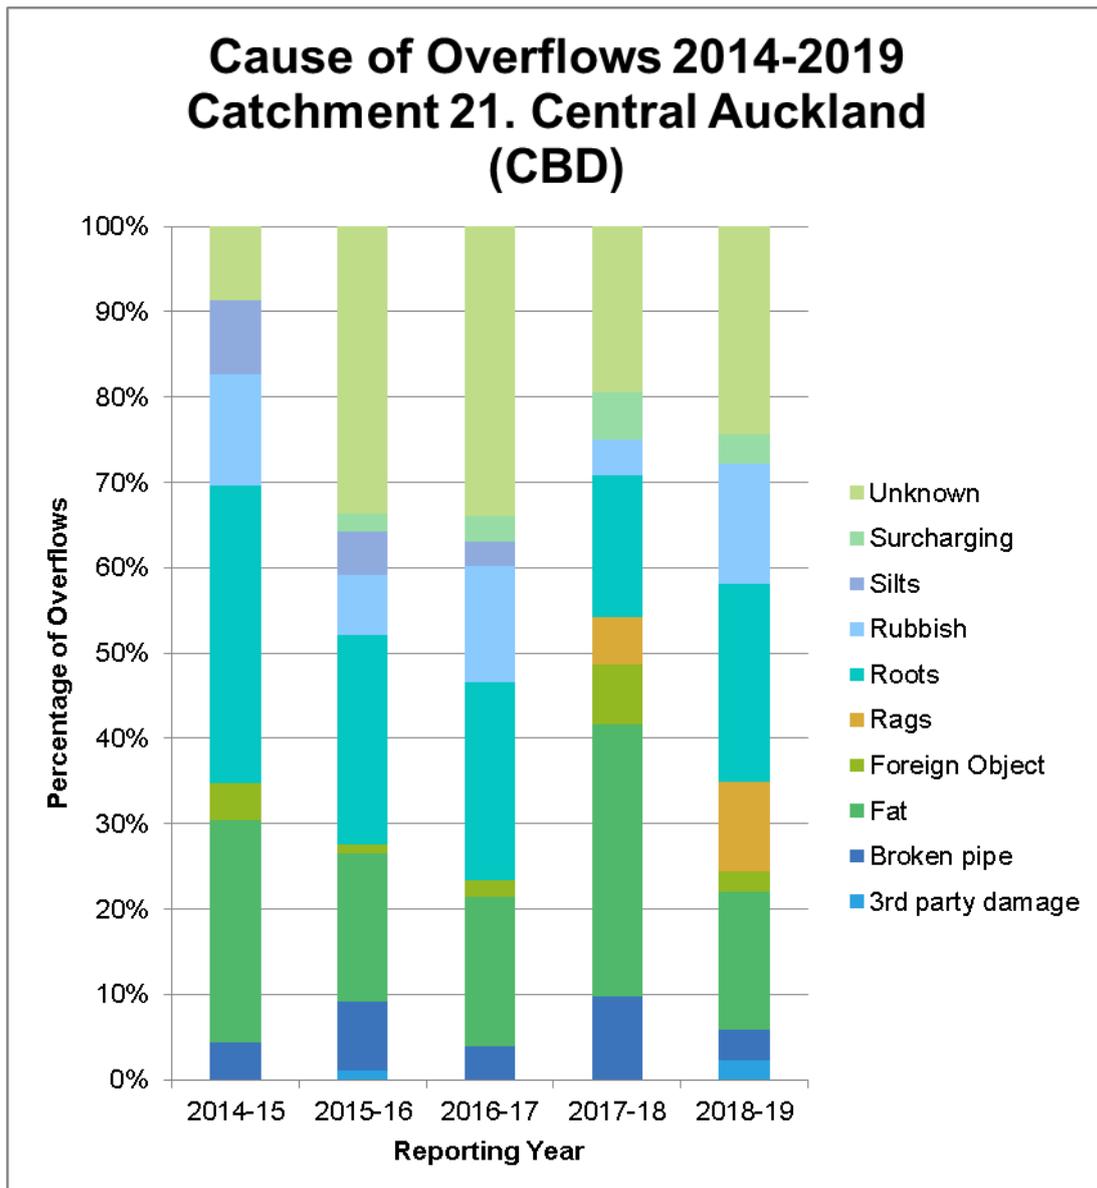
### 2.23.3 Trend analysis of reported incidents

The below graphs reflect the trends distributed along pipe lengths, annual trends, and overflow cause proportions. Trends are displayed over months where overflows occurred.

Trend analysis has been carried out where the cause has been identified.

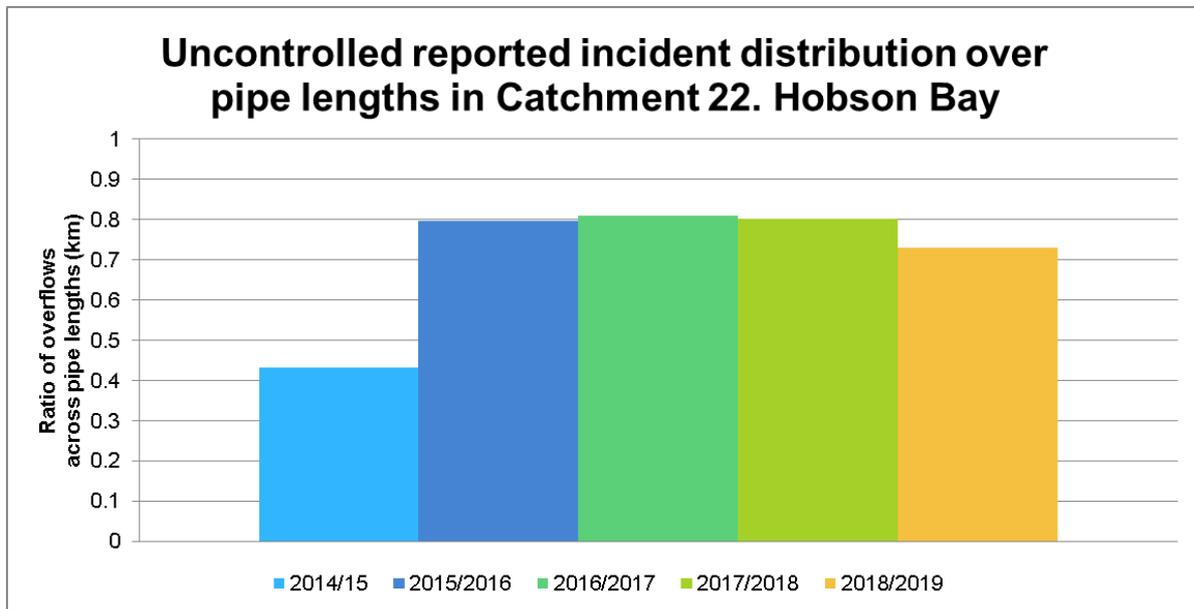
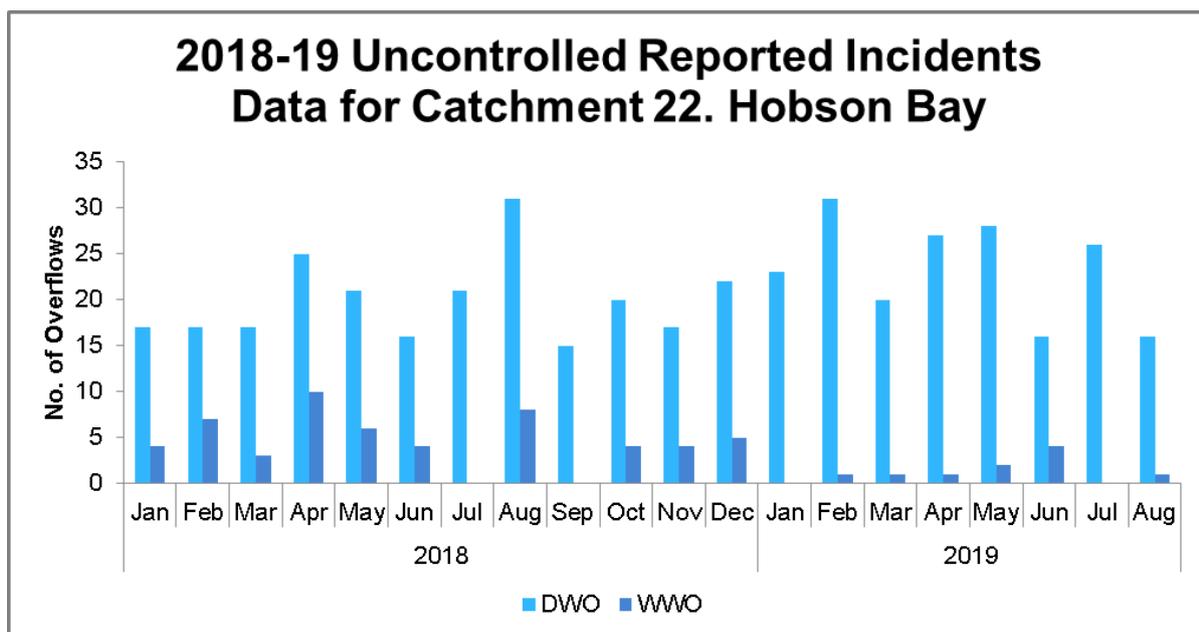
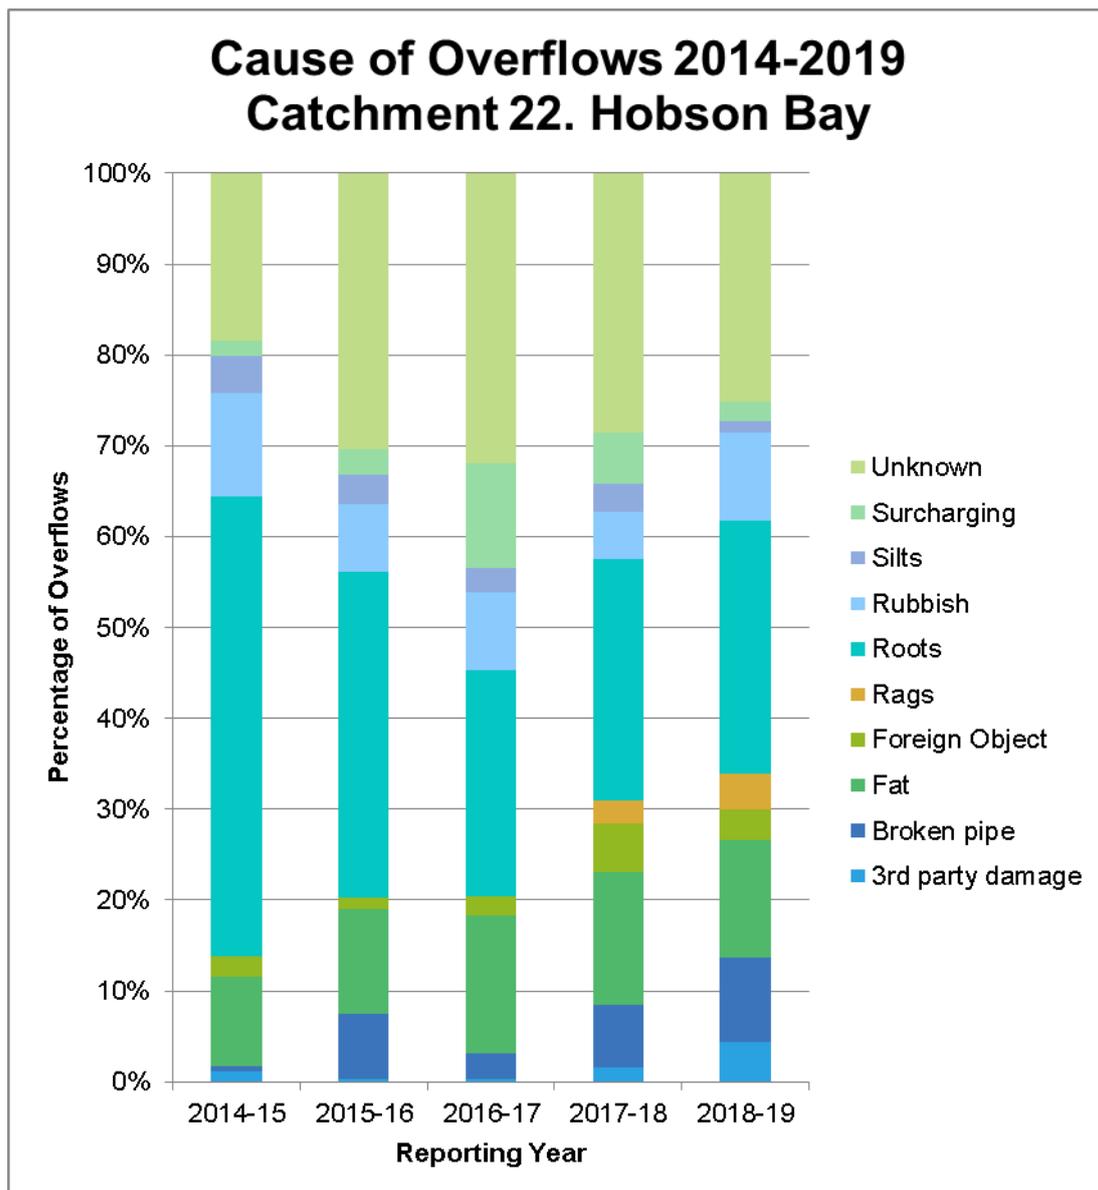
### 2.24.3 Trend analysis of reported incidents

The below graphs reflect the trends distributed along pipe lengths, annual trends, and overflow cause proportions. Trends are displayed over months where overflows occurred.

Trend analysis has been carried out where the cause has been identified.

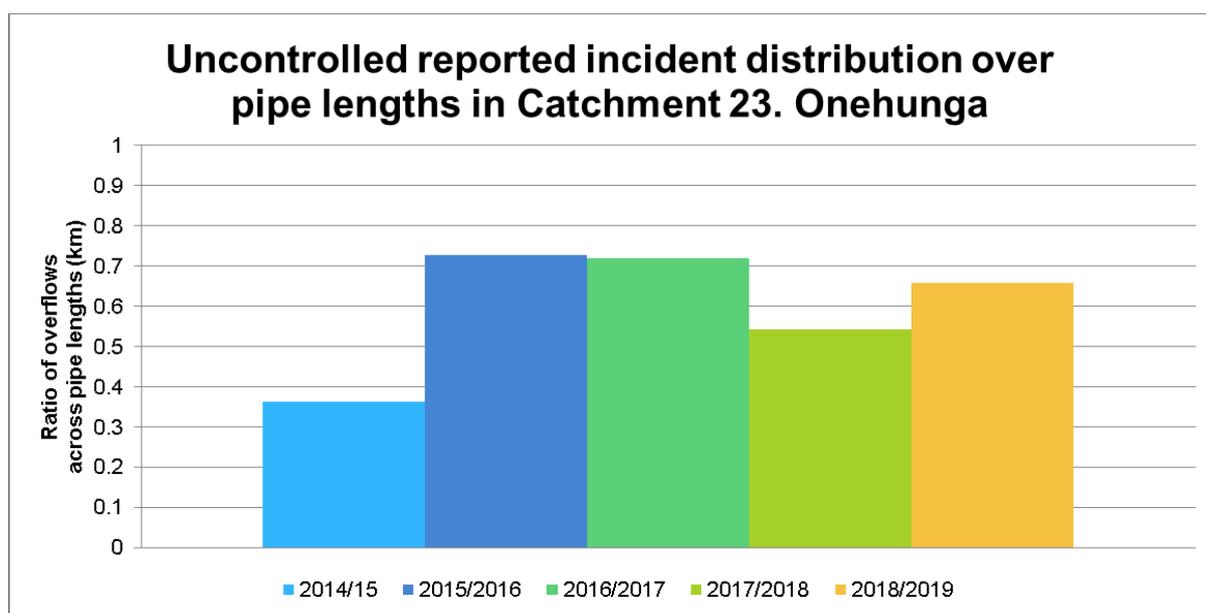
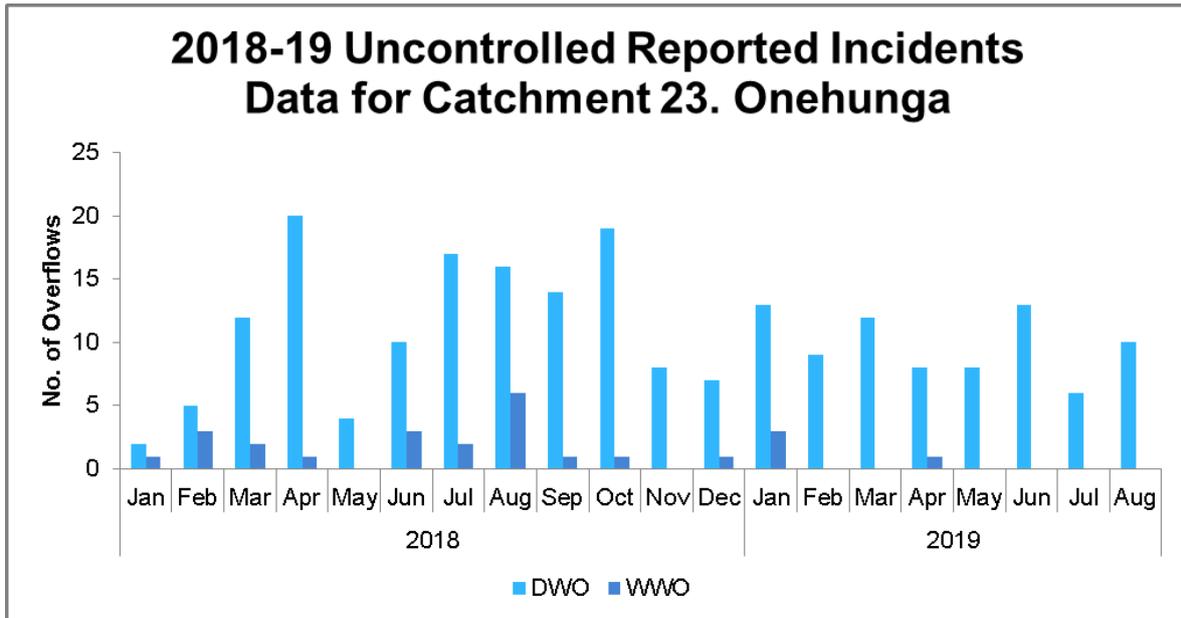
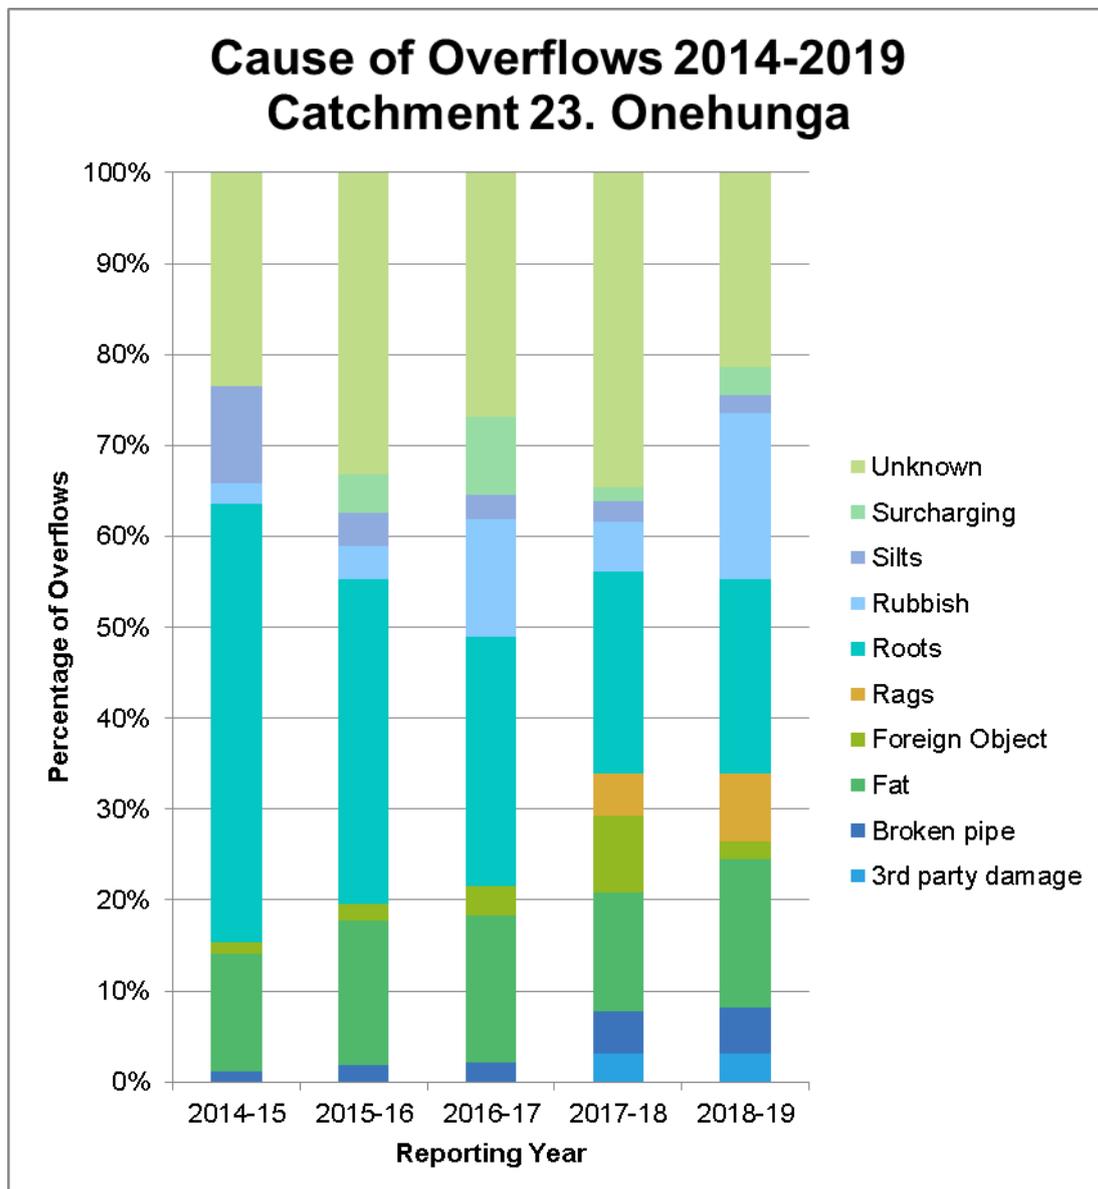
### 2.25.3 Trend analysis of reported incidents

The below graphs reflect the trends distributed along pipe lengths, annual trends, and overflow cause proportions. Trends are displayed over months where overflows occurred.

Trend analysis has been carried out where the cause has been identified.

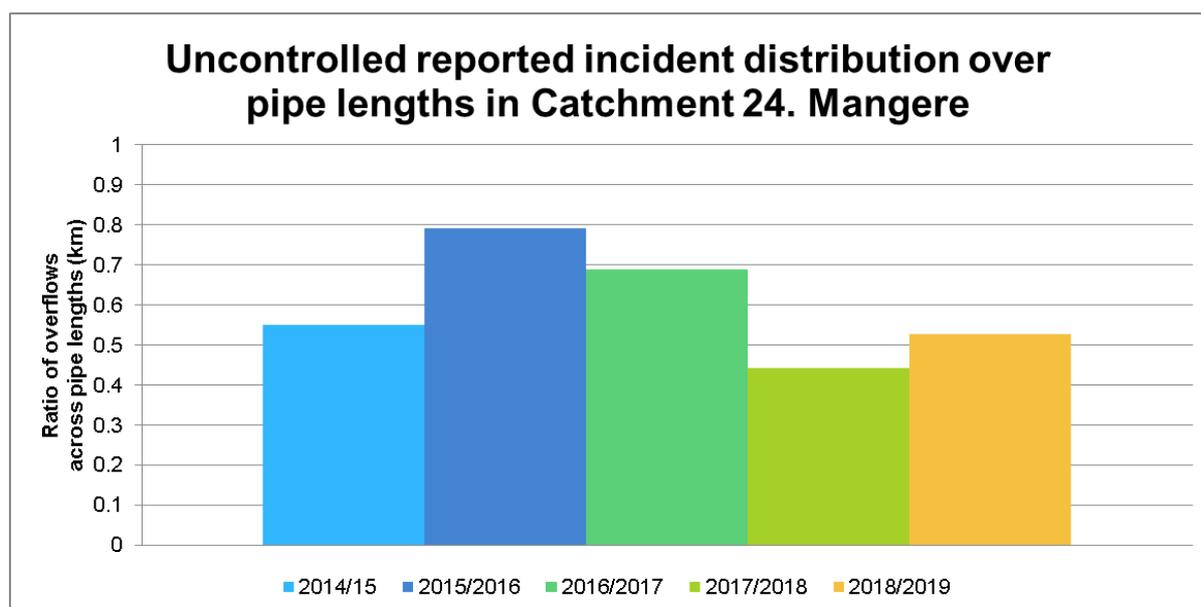
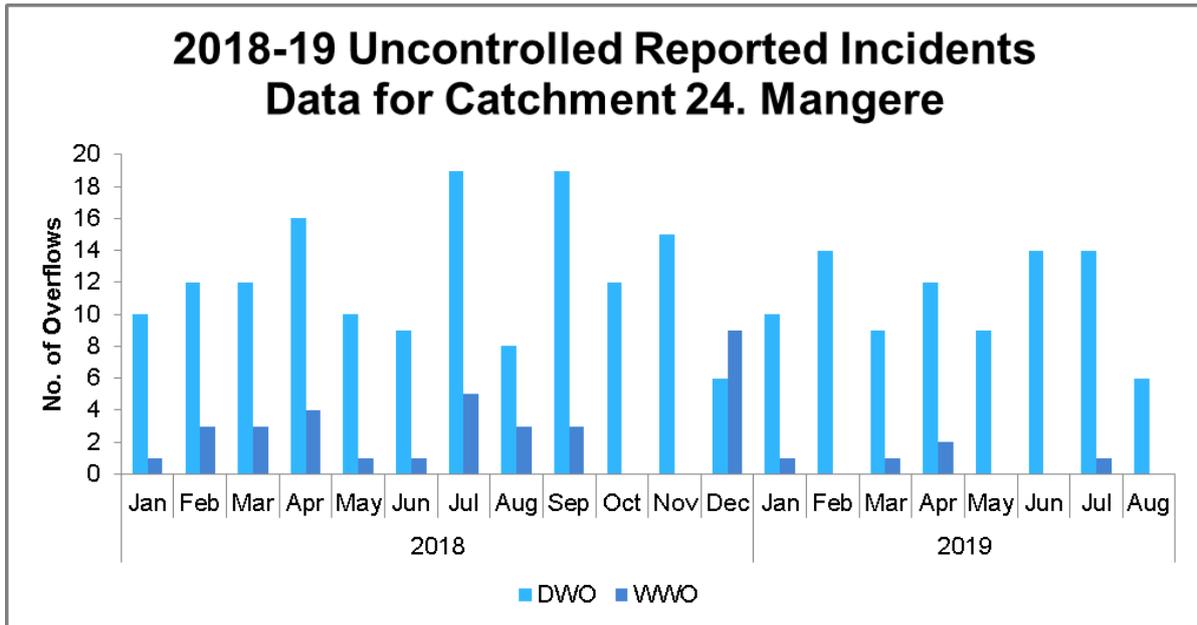
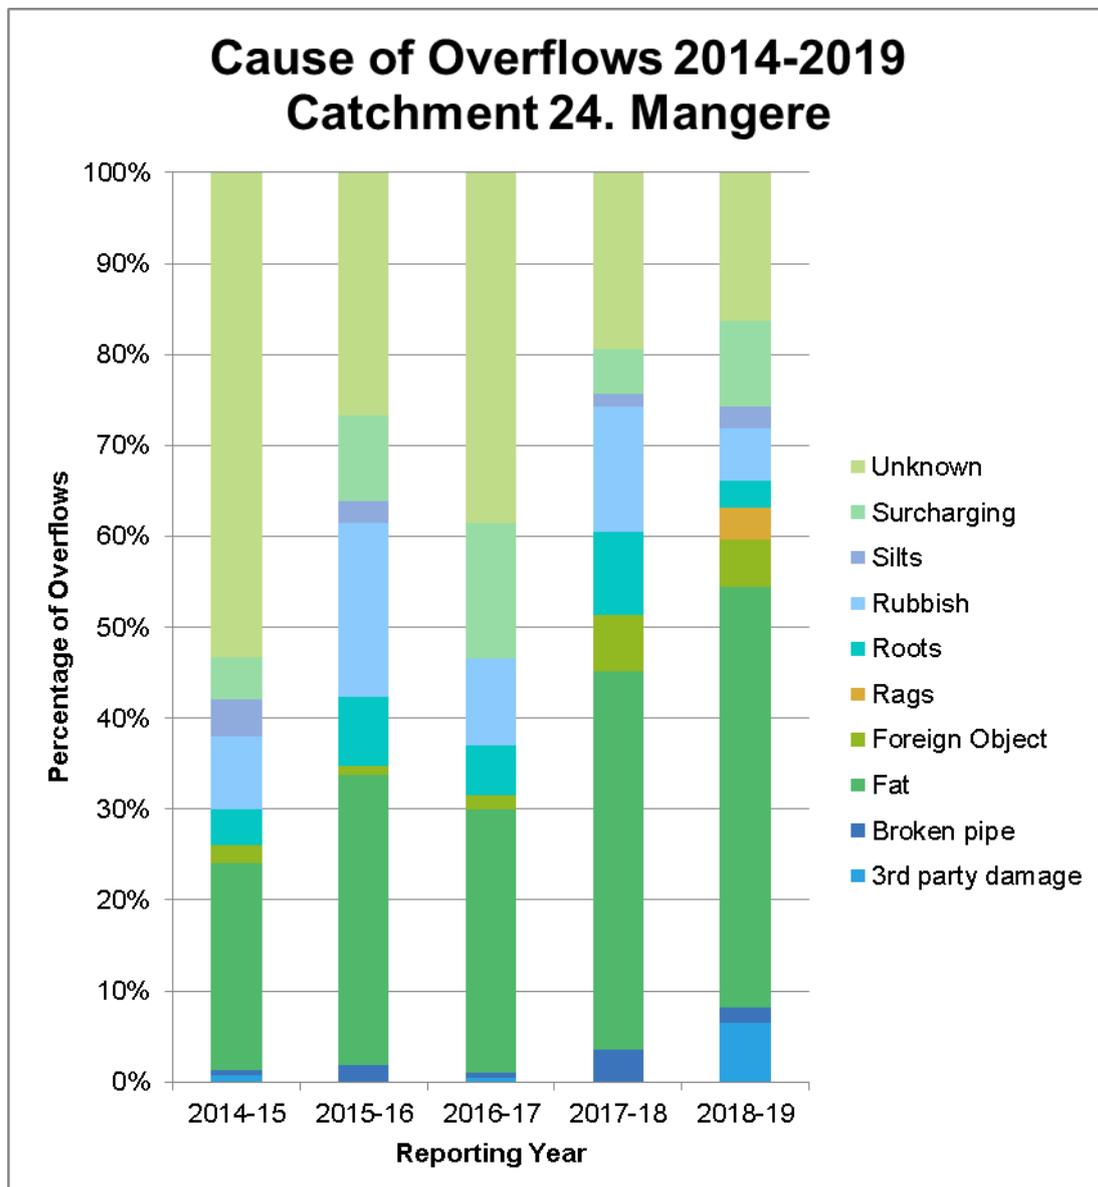
### 2.26.3 Trend analysis of reported incidents

The below graphs reflect the trends distributed along pipe lengths, annual trends, and overflow cause proportions. Trends are displayed over months where overflows occurred.

Trend analysis has been carried out where root cause has been identified.
