## **Section 2**

# **Annual Performance Report Strategic Management Areas & Geographical Catchments**

**1 July 2018 to 30 June 2019**

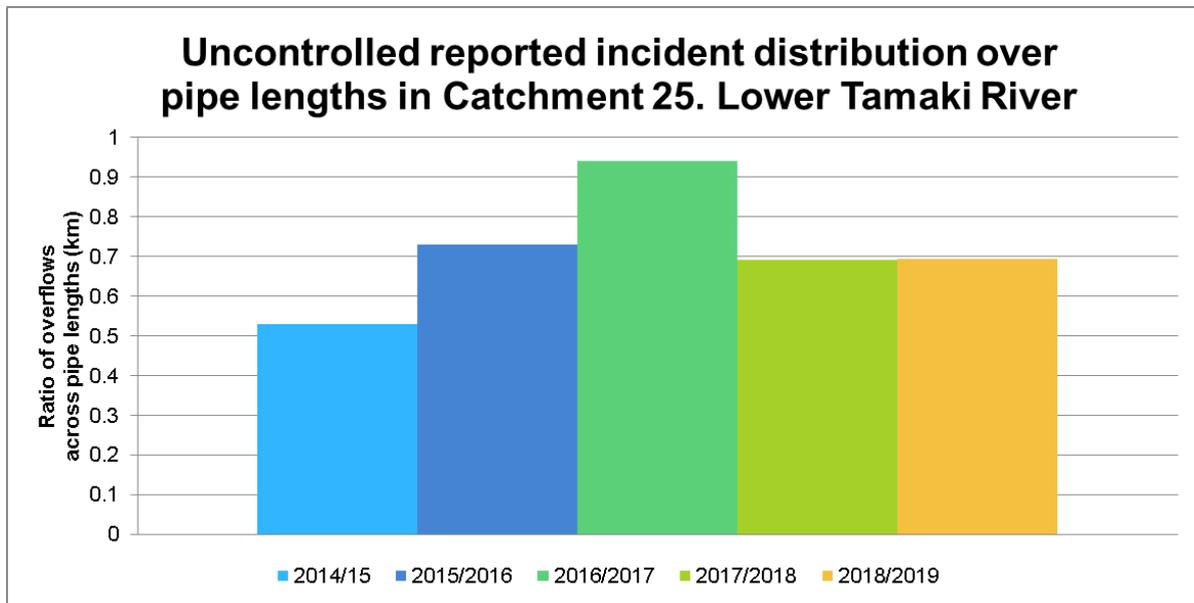
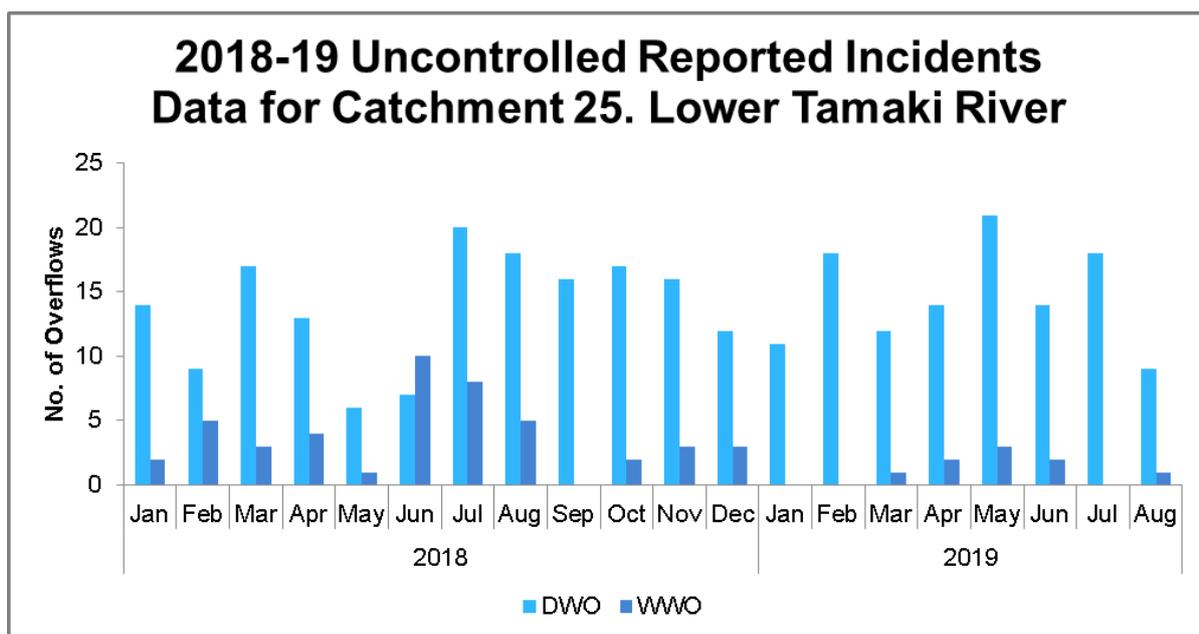
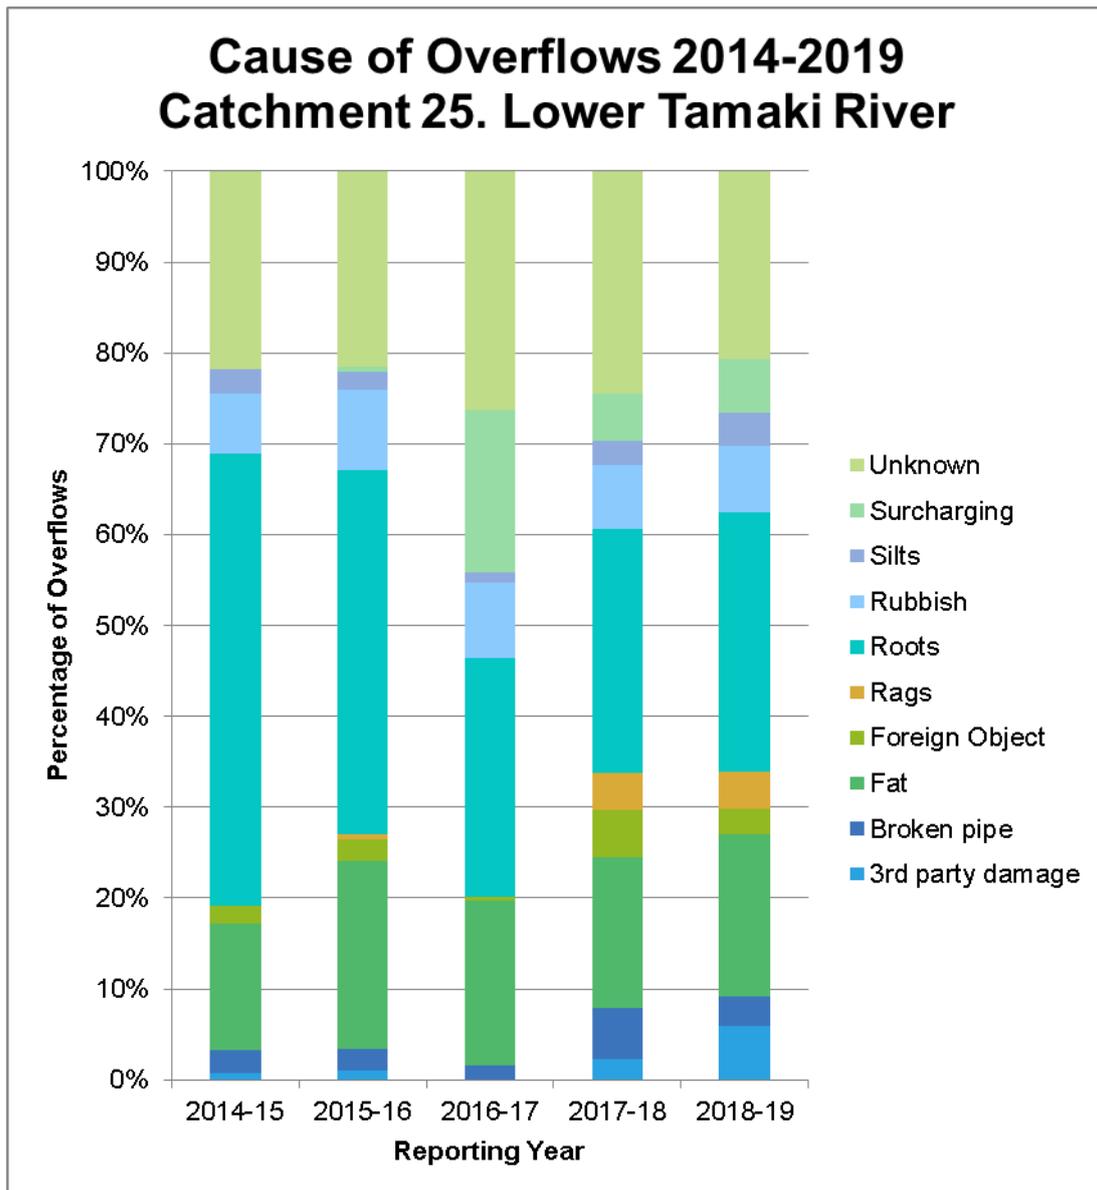
### 2.27.3 Trend analysis of Uncontrolled Overflows

The below graphs reflect the trends distributed along pipe lengths, annual trends, and overflow cause proportions. Trends are displayed over months where overflows occurred.

Trend analysis has been carried out where root cause has been identified.

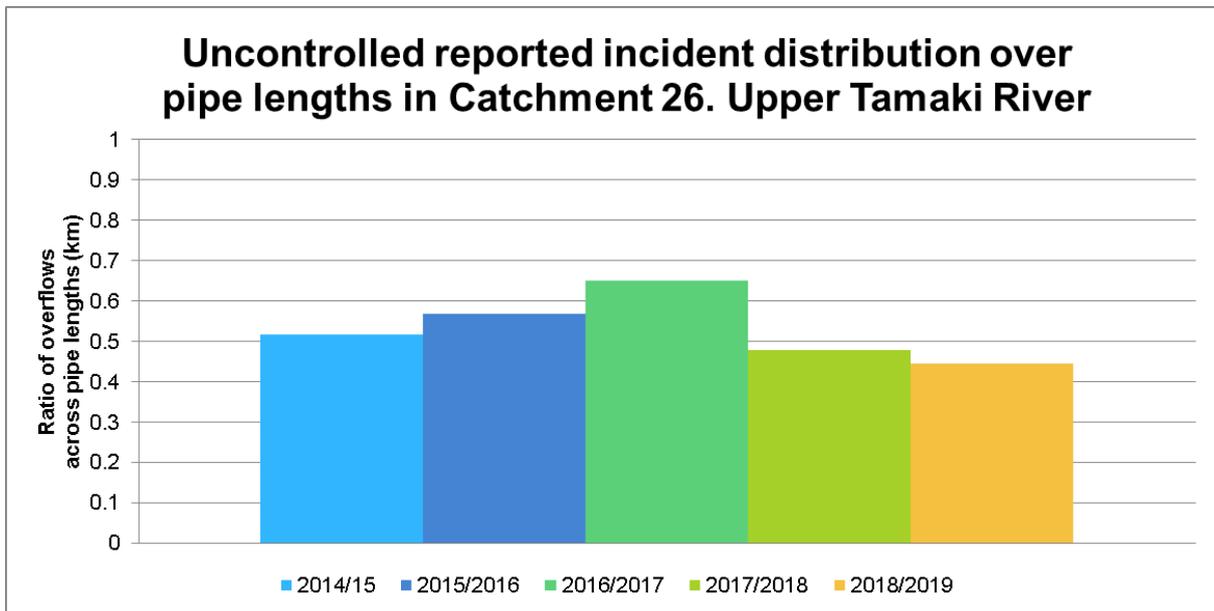
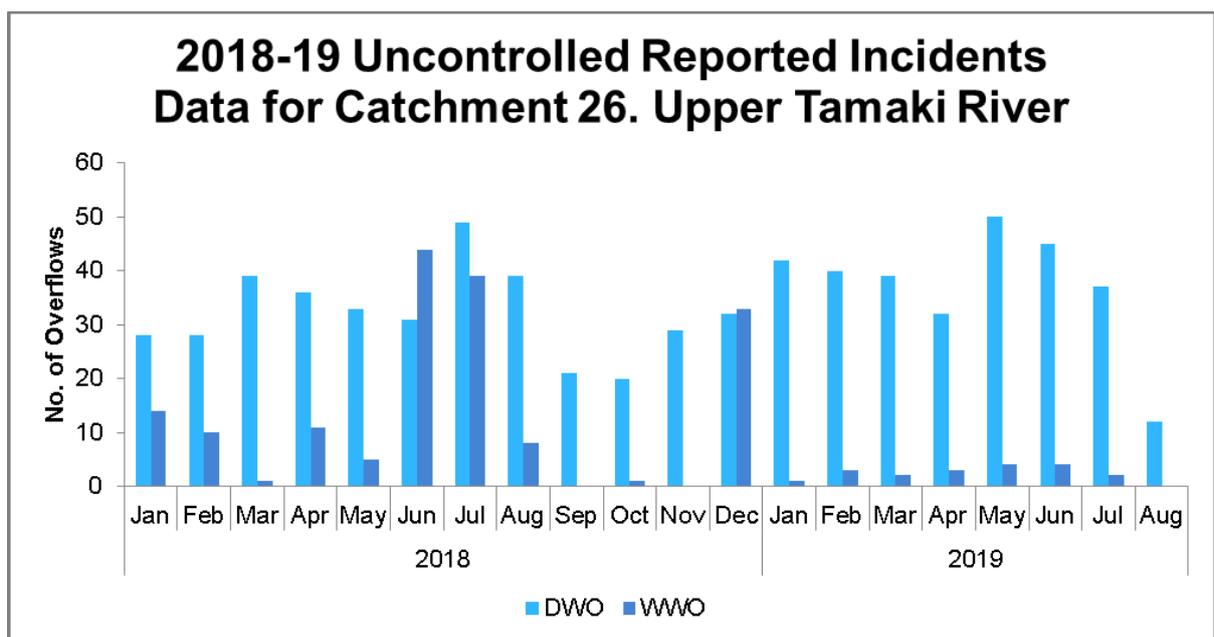
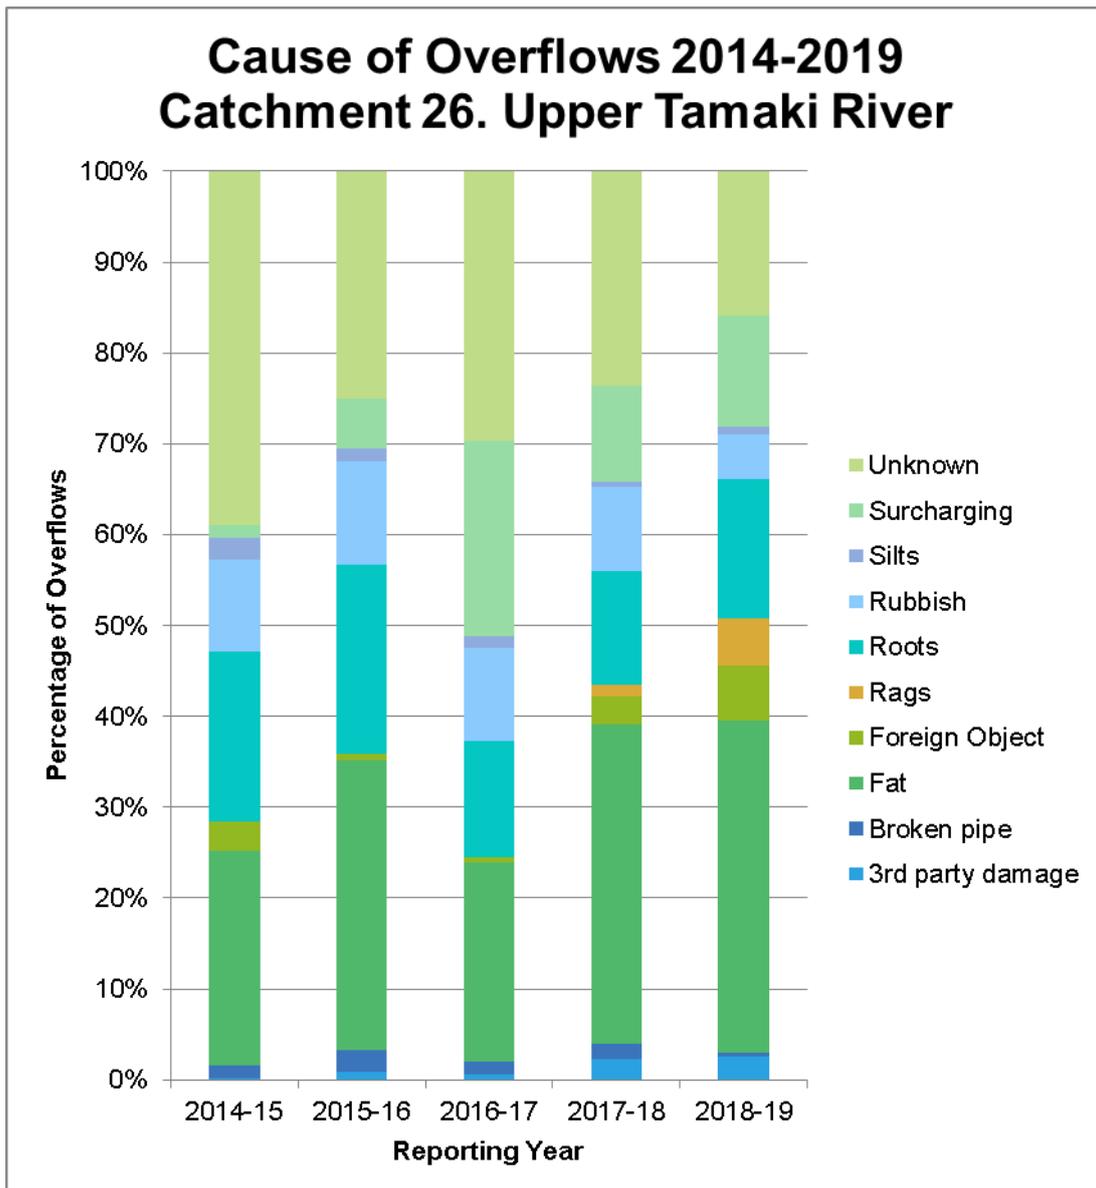
### 2.28.3 Trend analysis of reported incidents

The below graphs reflect the trends distributed along pipe lengths, annual trends, and overflow cause proportions. Trends are displayed over months where overflows occurred.

Trend analysis has been carried out where the cause has been identified.

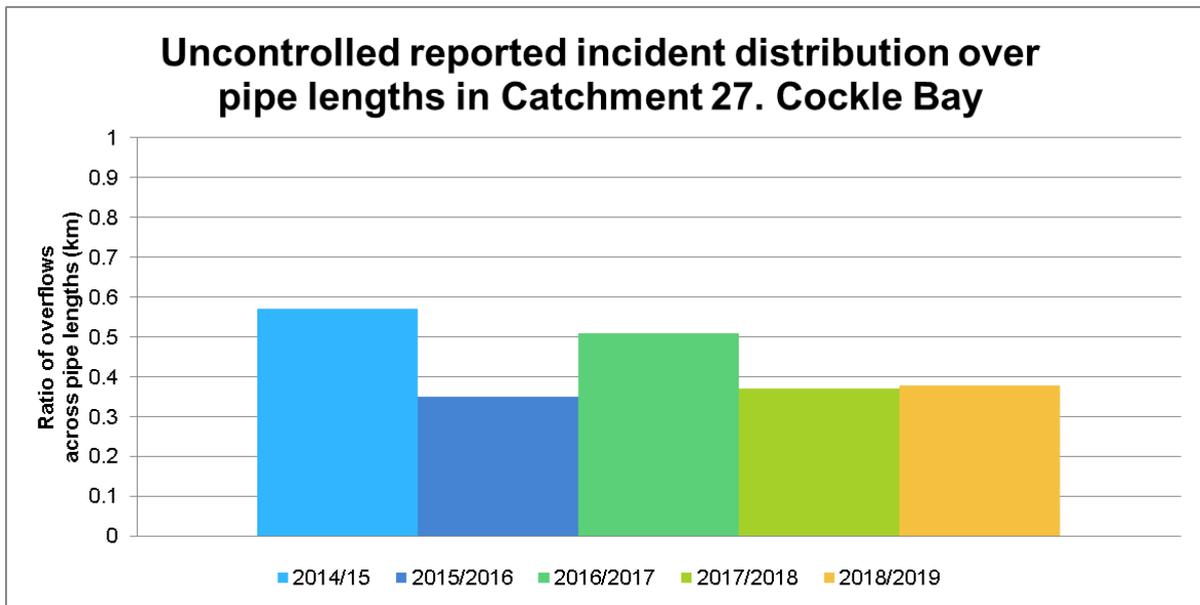
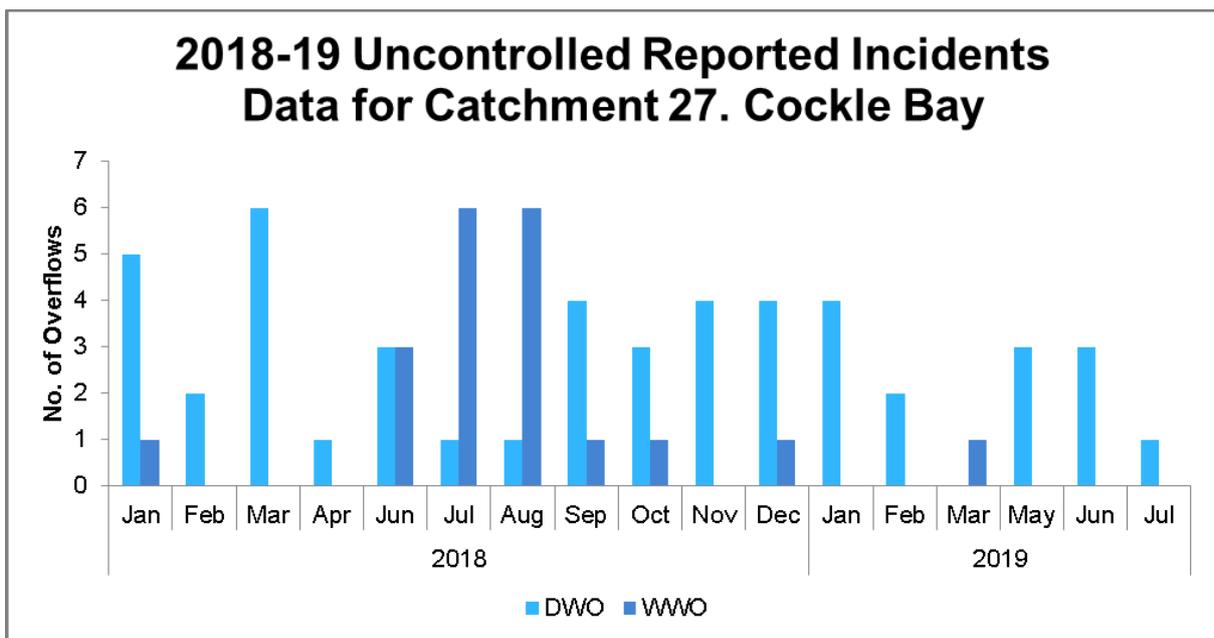
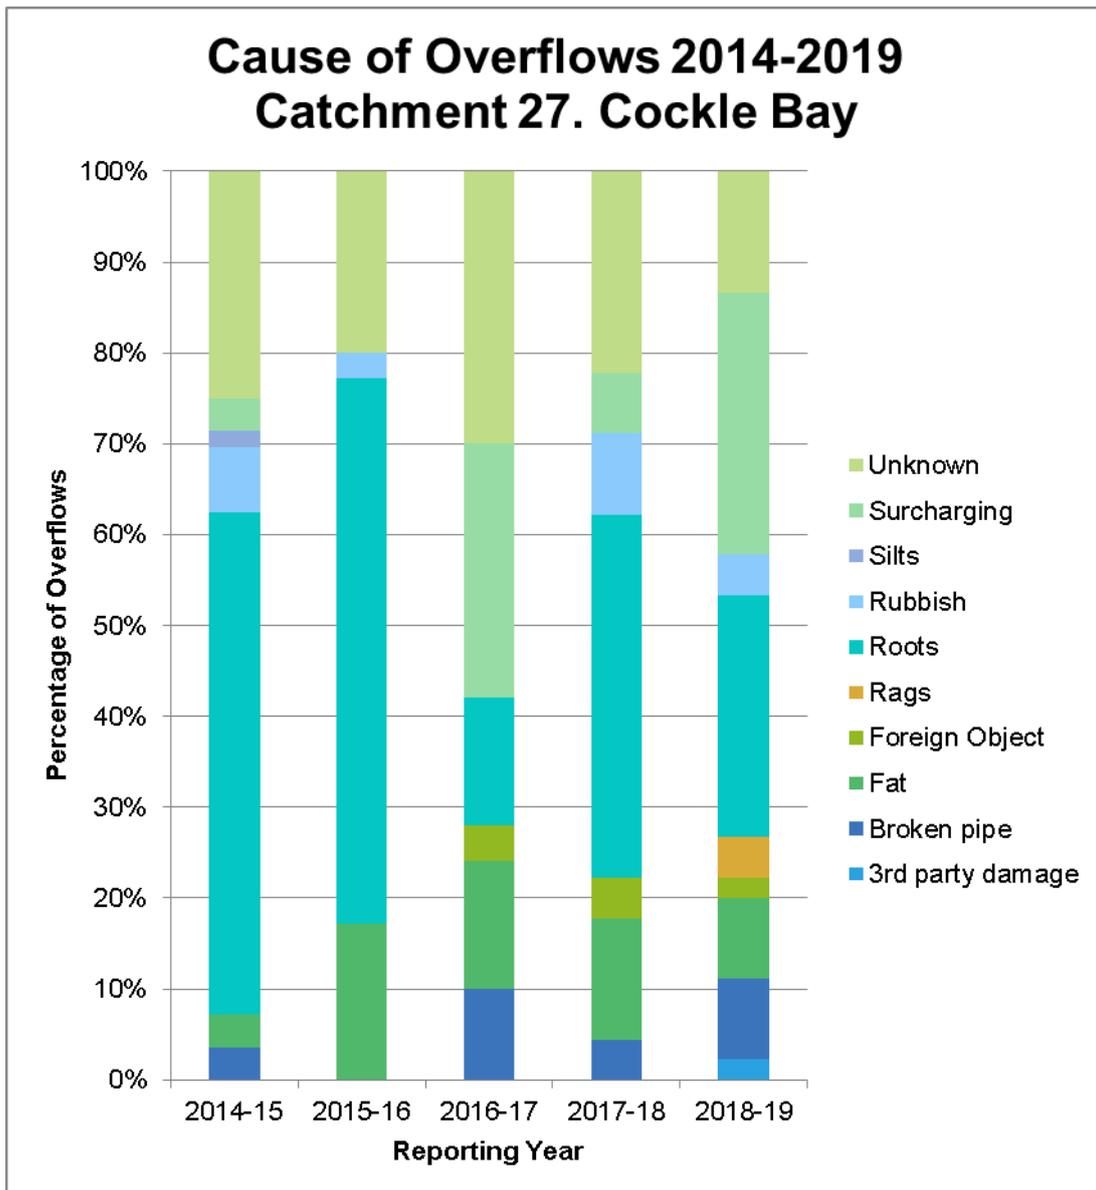
### 2.29.3 Trend analysis of reported incidents

The below graphs reflect the trends distributed along pipe lengths, annual trends, and overflow cause proportions. Trends are displayed over months where overflows occurred.

Trend analysis has been carried out where root cause has been identified.

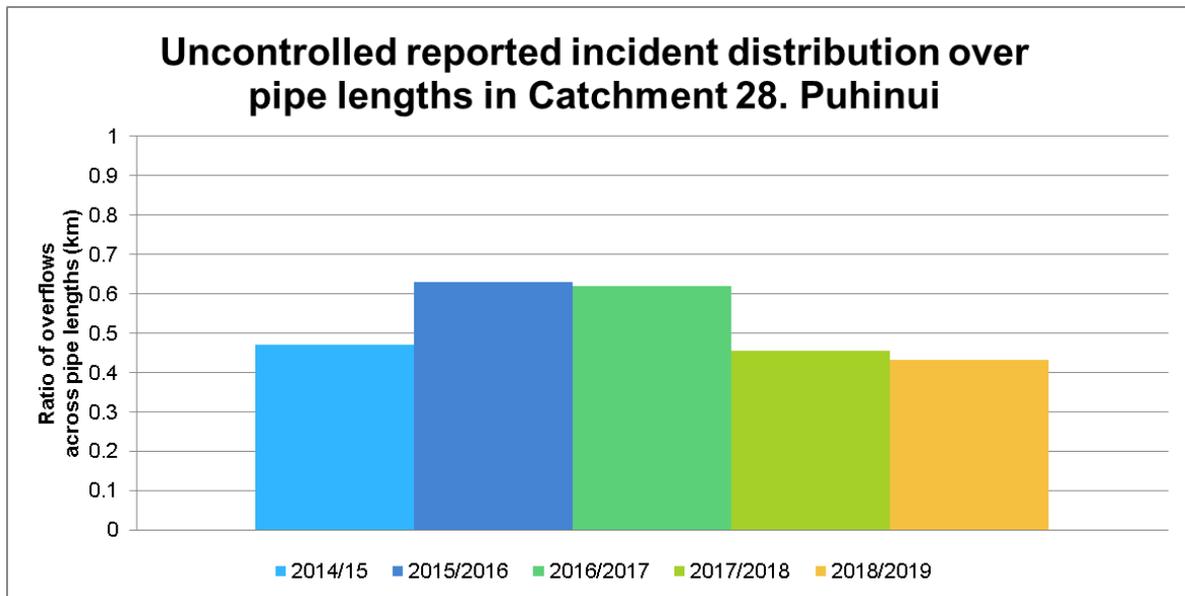
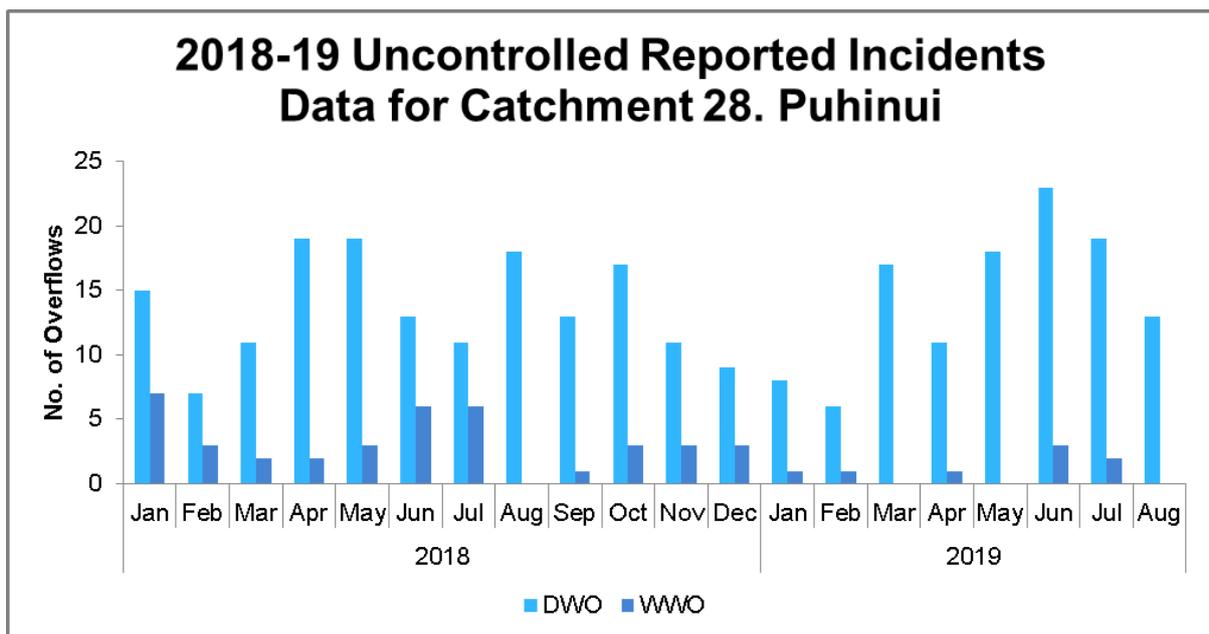
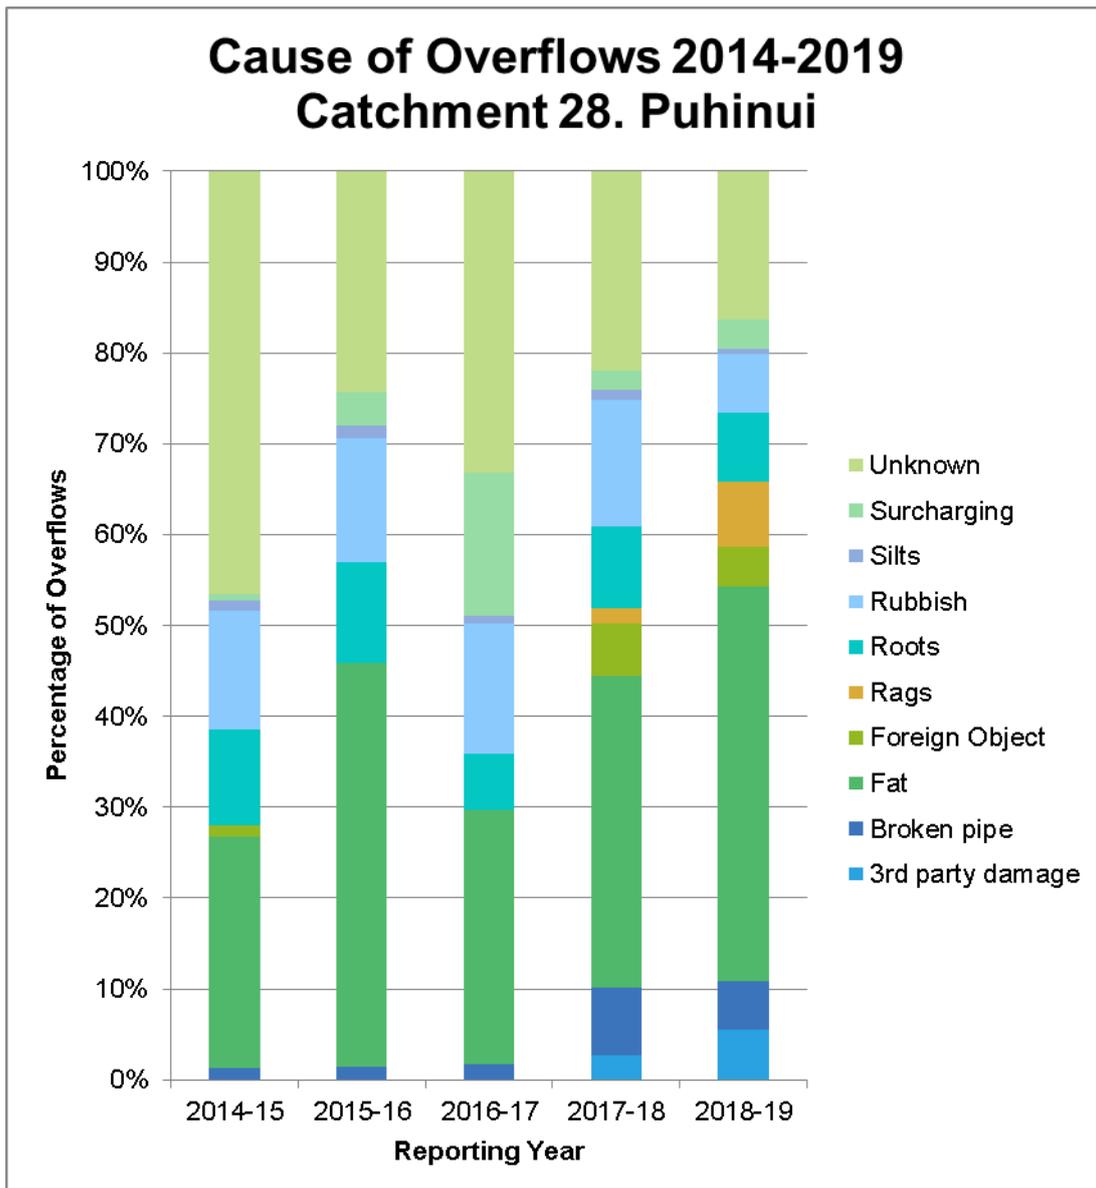
### 2.30.3 Trend analysis of reported incidents

The below graphs reflect the trends distributed along pipe lengths, annual trends, and overflow cause proportions. Trends are displayed over months where overflows occurred.

Trend analysis has been carried out where root cause has been identified.

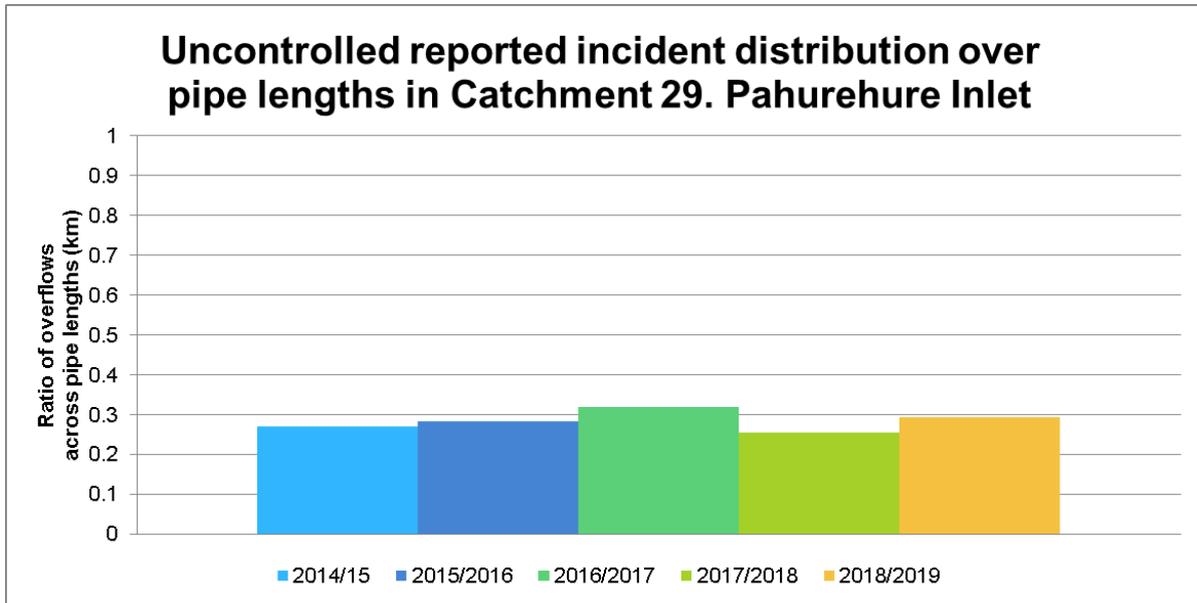
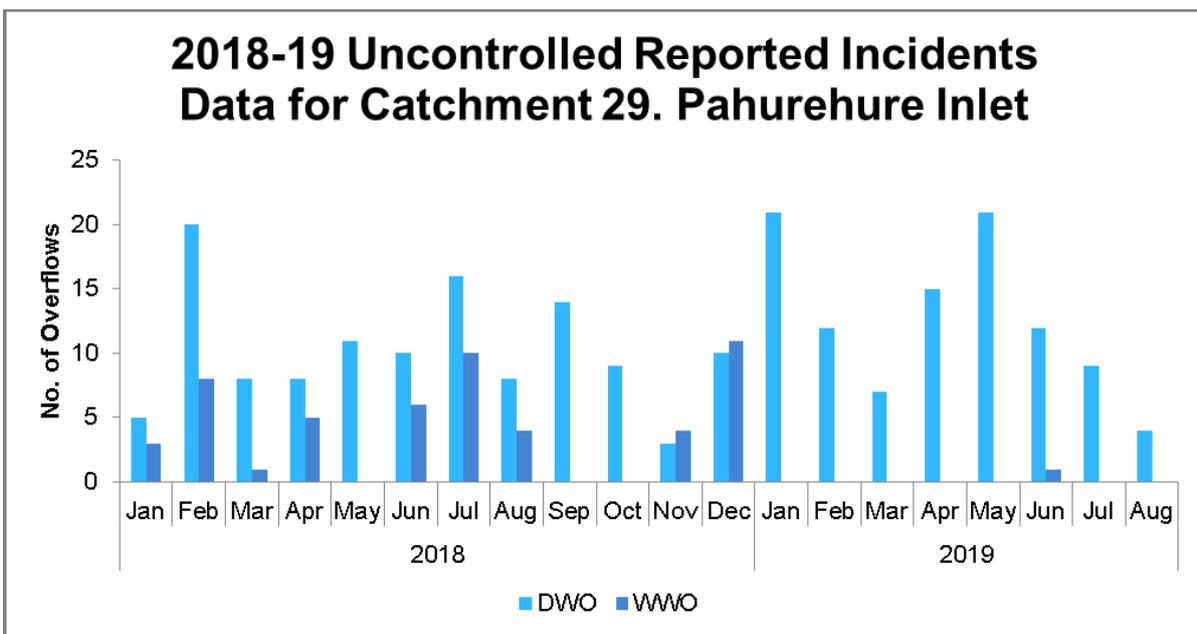
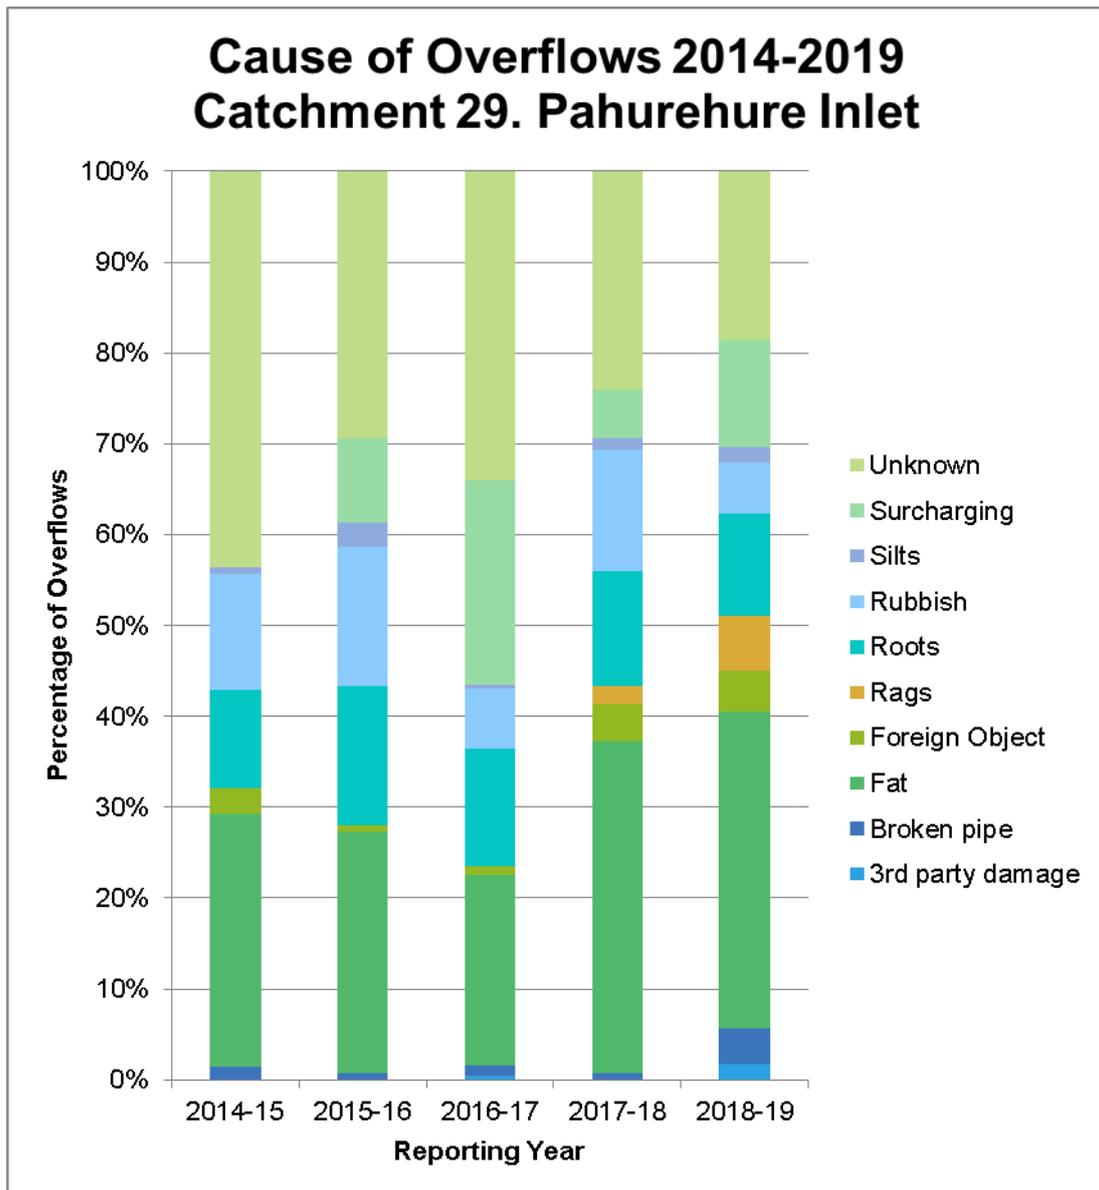
### 2.31.3 Trend analysis of reported incidents

The below graphs reflect the trends distributed along pipe lengths, annual trends, and overflow cause proportions. Trends are displayed over months where overflows occurred.

Trend analysis has been carried out where root cause has been identified.

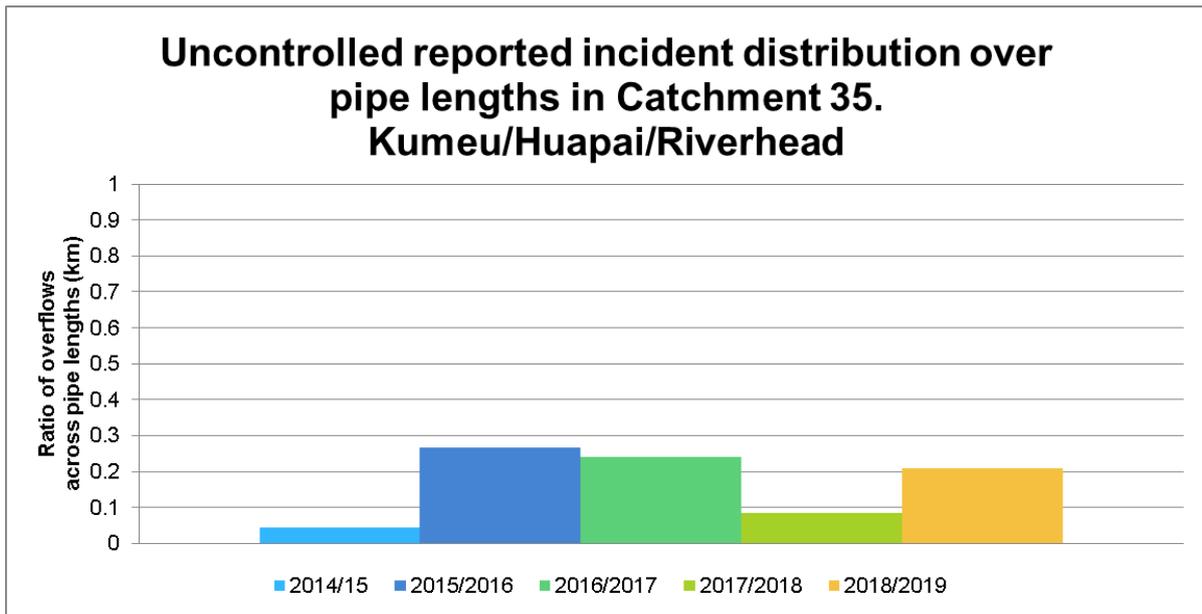
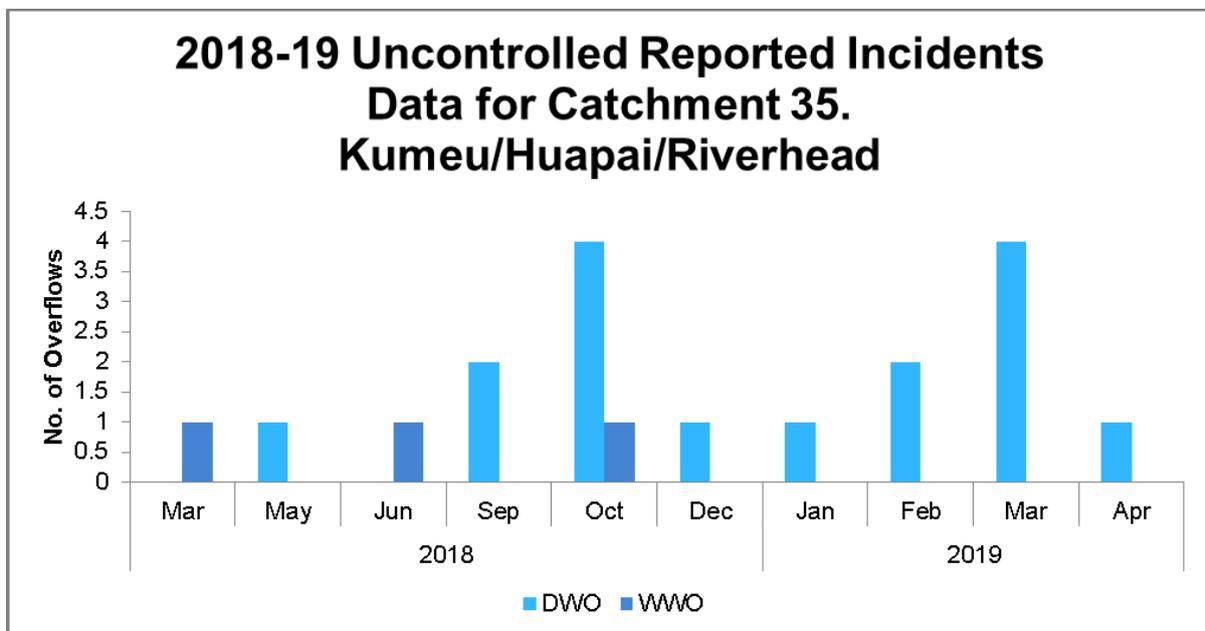
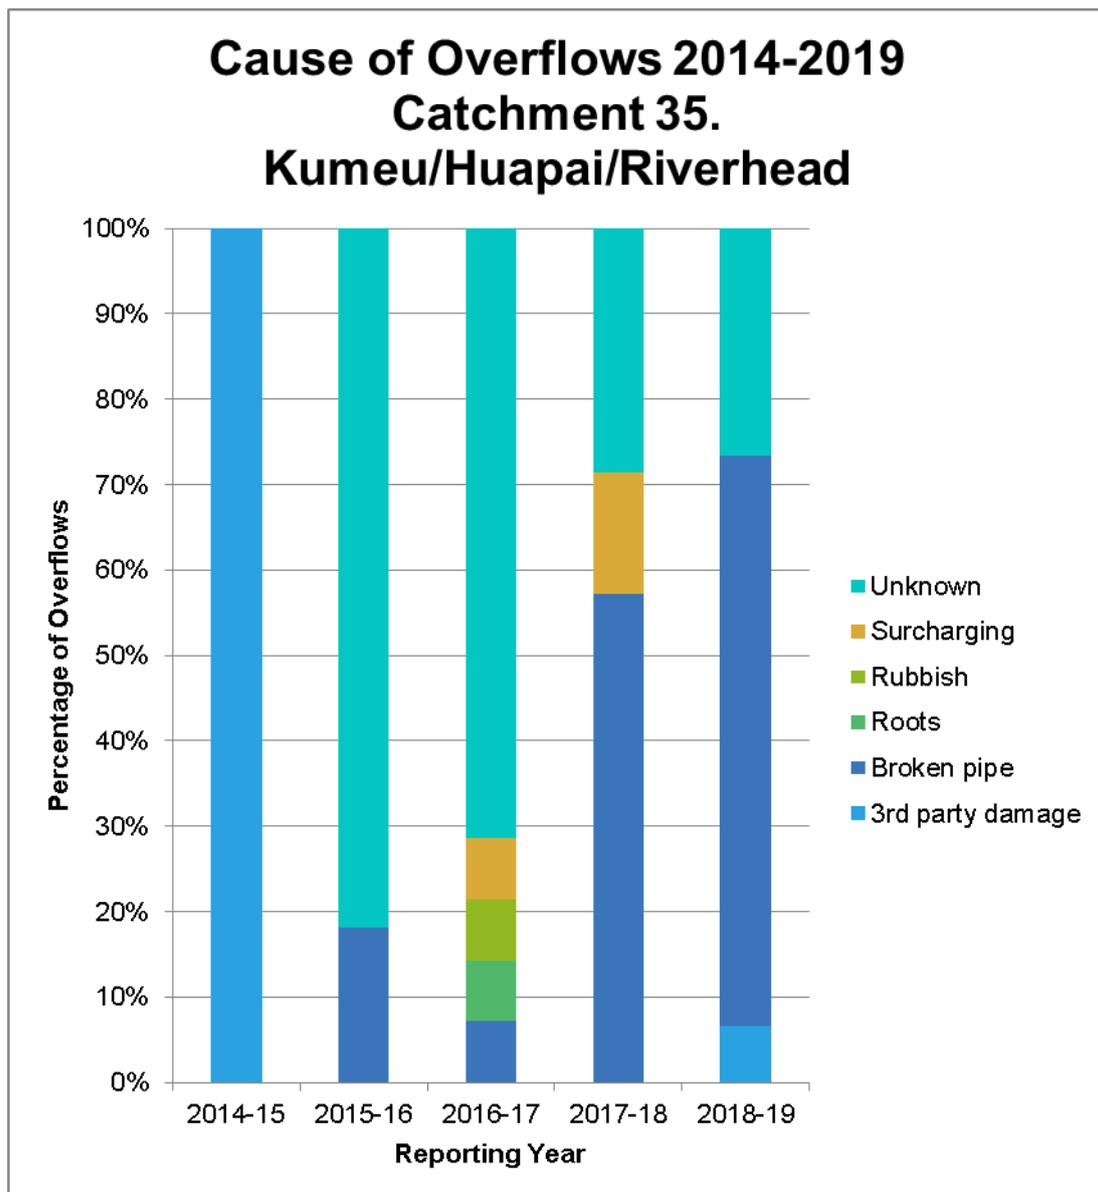
### 2.32.3 Trend analysis of reported incidents

The below graphs reflect the trends distributed along pipe lengths, annual trends, and overflow cause proportions. Trends are displayed over months where overflows occurred.

Trend analysis has been carried out where root cause has been identified.

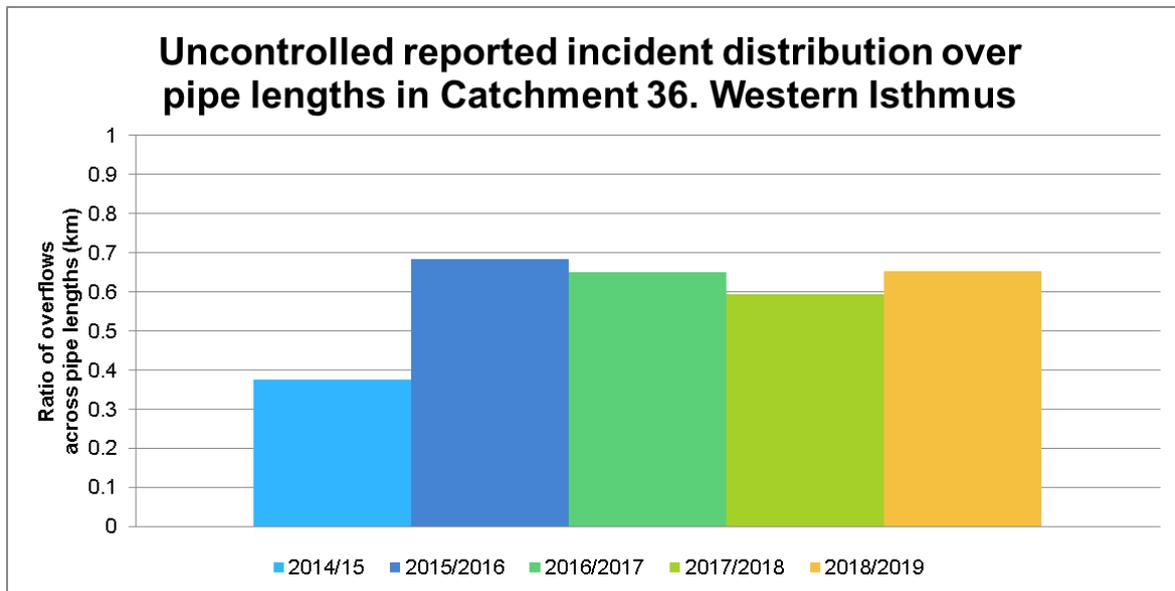
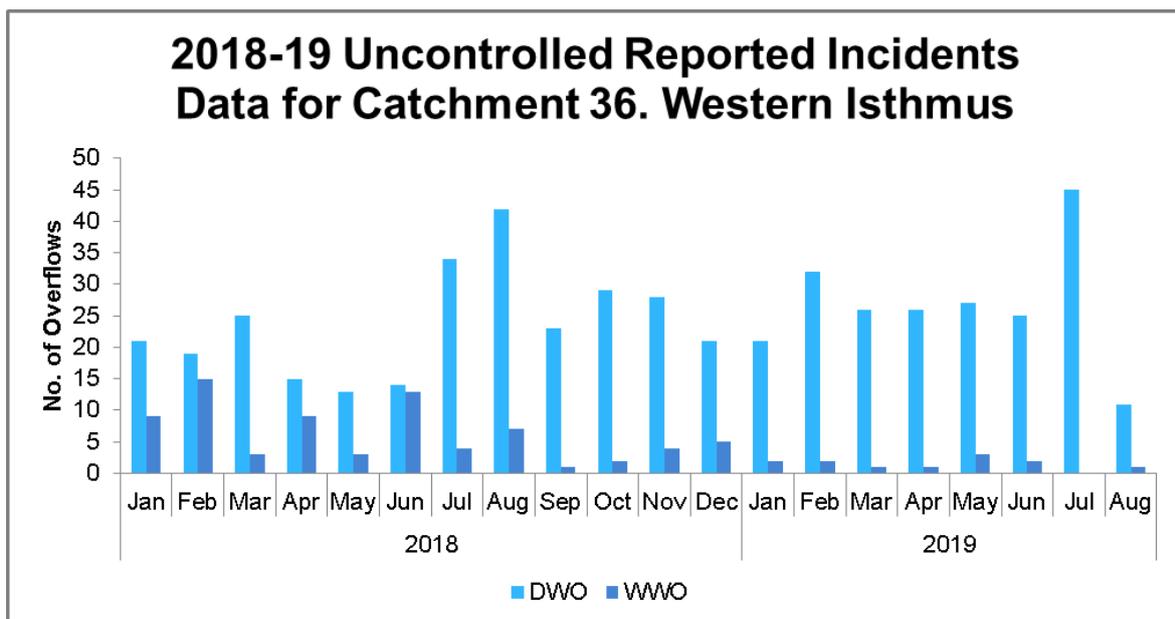
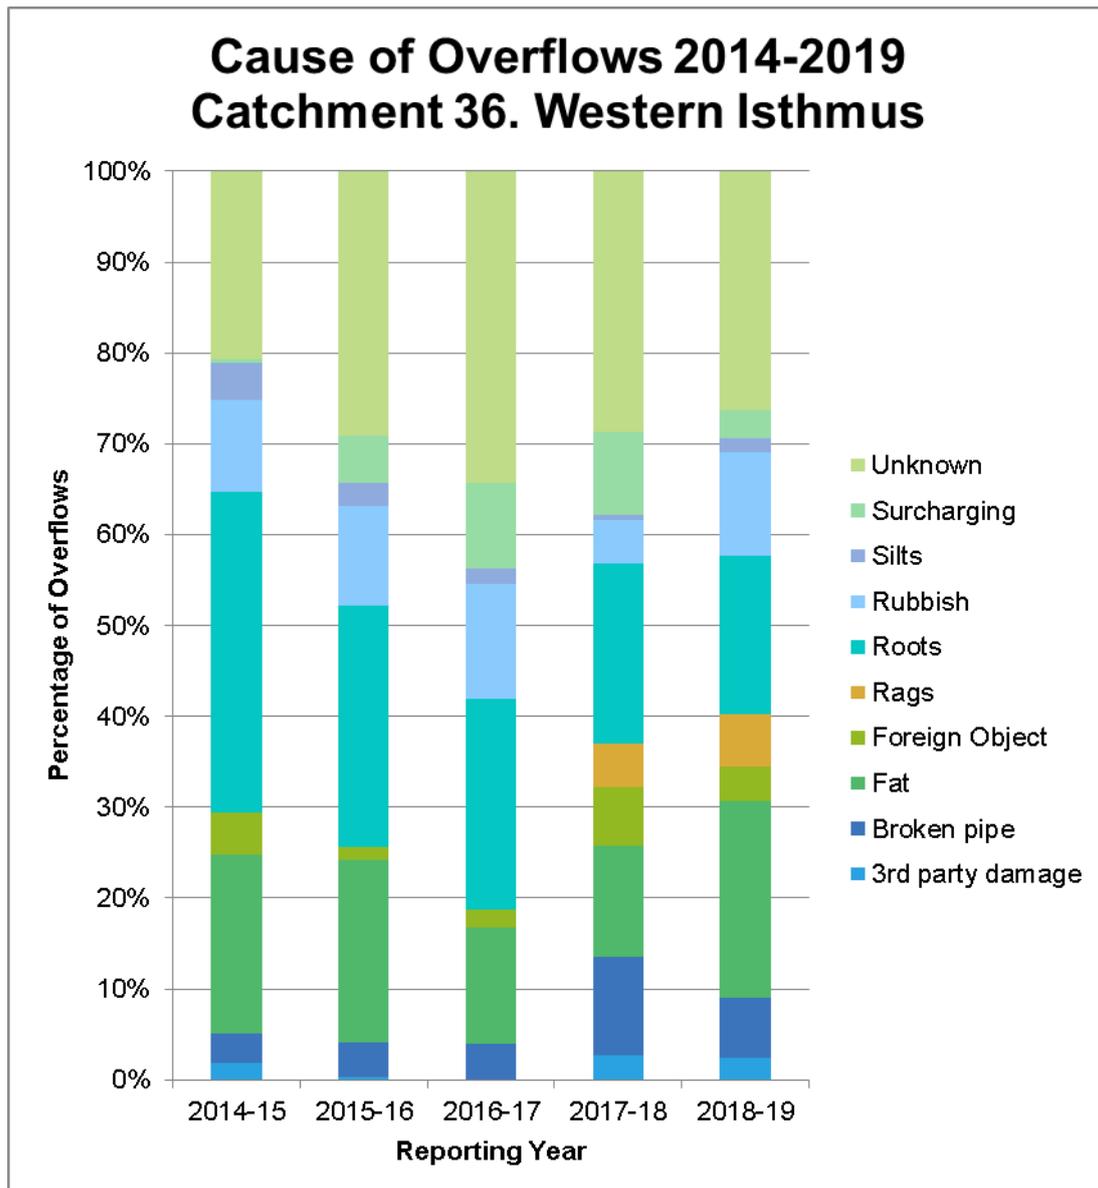
### 2.33.4 Trend analysis of reported incidents

The below graphs reflect the trends distributed along pipe lengths, annual trends, and overflow cause proportions. Trends are displayed over months where overflows occurred.

Trend analysis has been carried out where root cause has been identified.

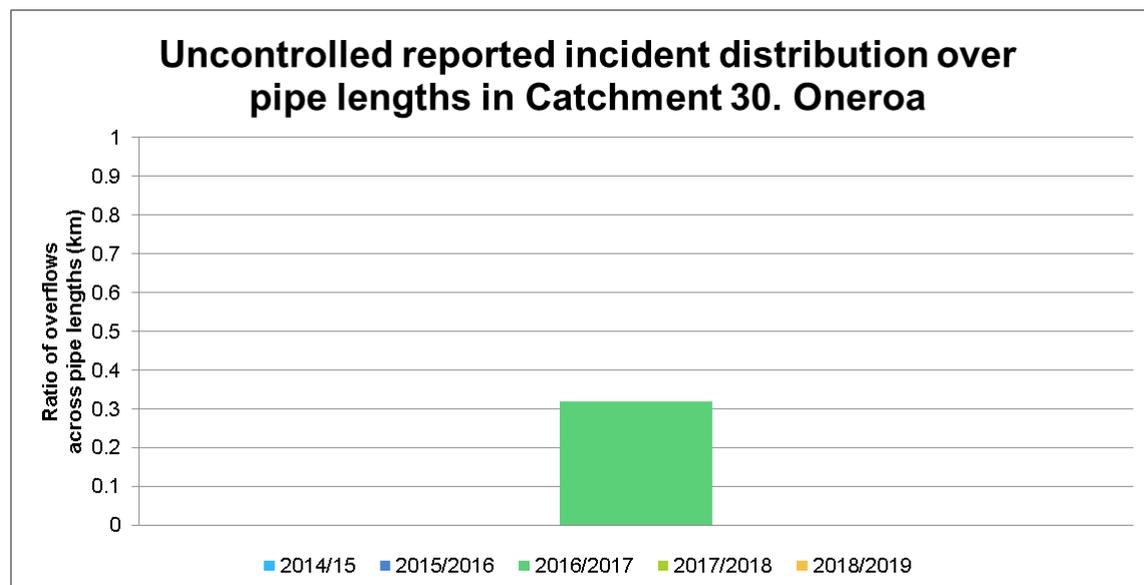
### 2.34.3 Trend analysis of reported incidents

There were 0 reported incidents in the Oneroa catchment.
