## **Section 2**

# **Annual Performance Report Strategic Management Areas & Geographical Catchments**

**1 July 2018 to 30 June 2019**

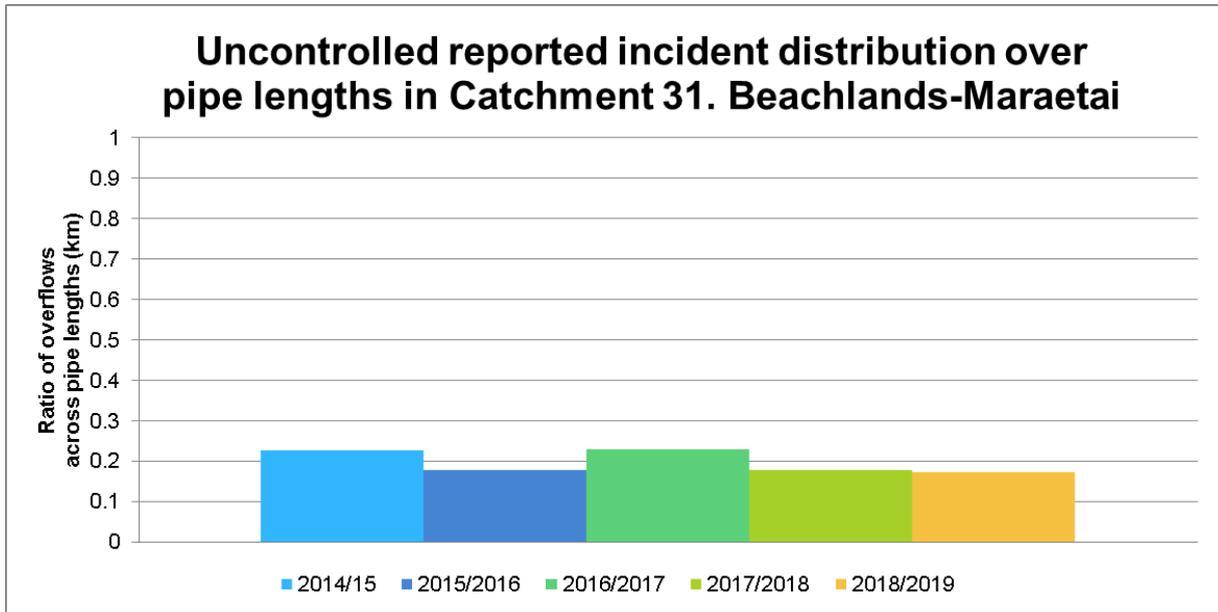
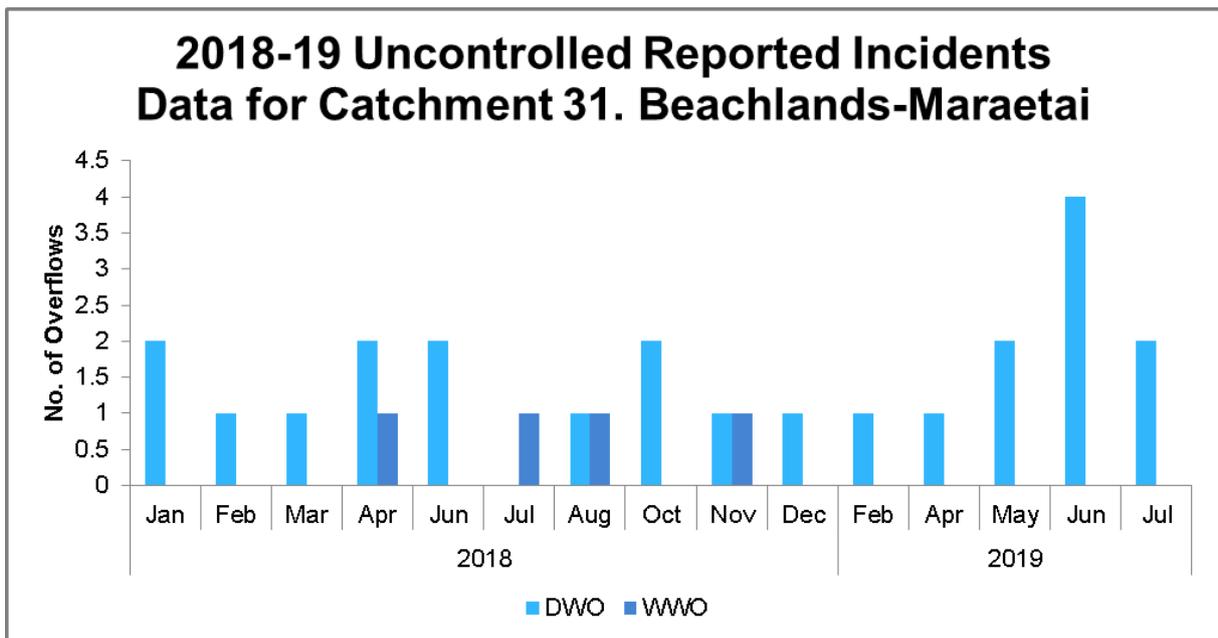
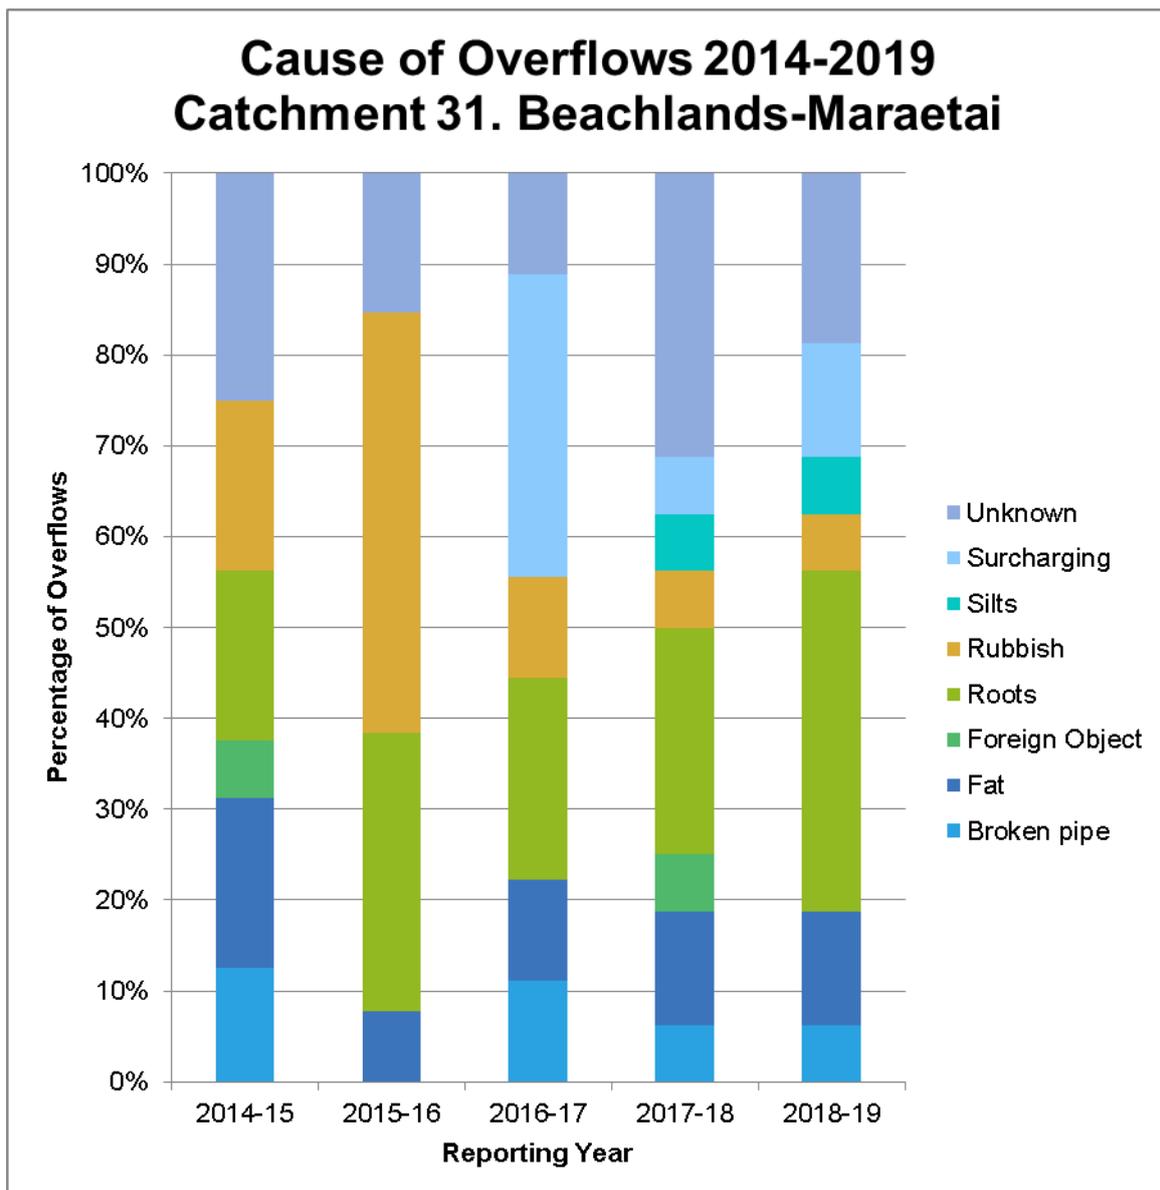
### 2.35.4 Trend analysis of reported incidents

The graphs overleaf reflect the trends distributed along pipe lengths, annual trends, and overflow cause proportions. Trends are displayed over months where overflows occurred.

Trend analysis has been carried out where the cause has been identified.

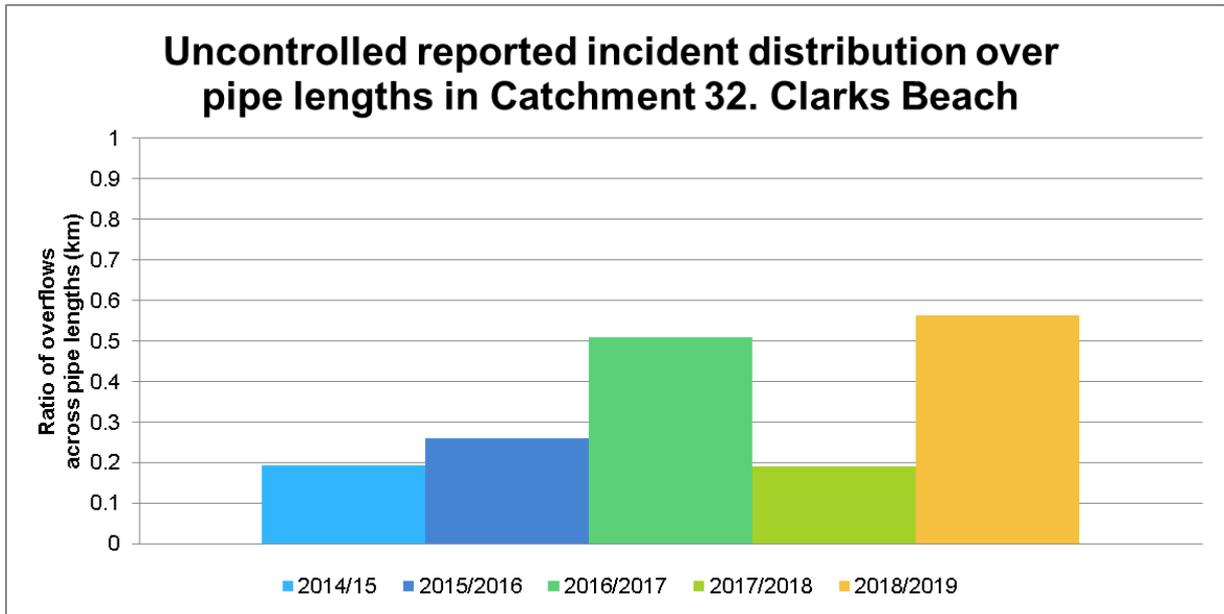
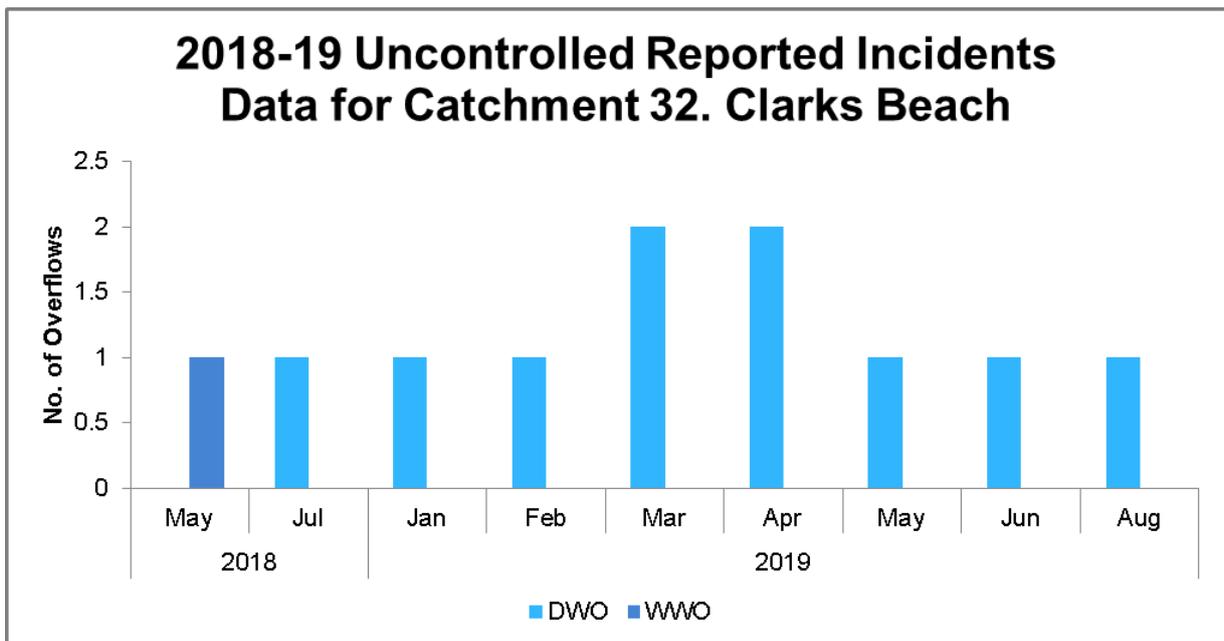
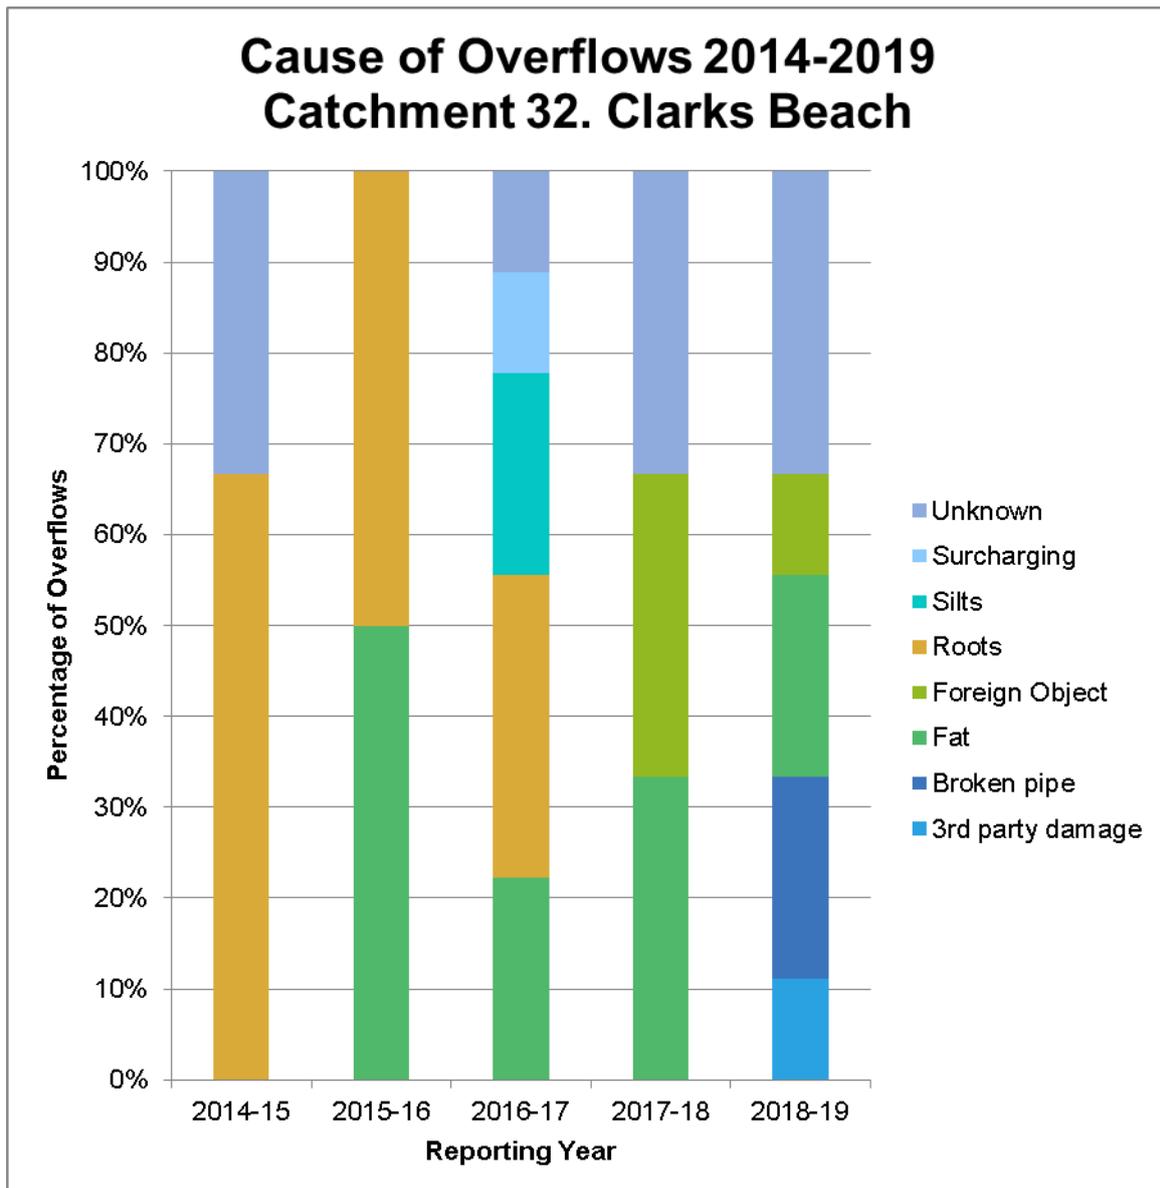
### 2.36.1 Trend analysis of reported incidents

The below overleaf reflect the trends distributed along pipe lengths, annual trends, and overflow cause proportions. Trends are displayed over months where overflows occurred.

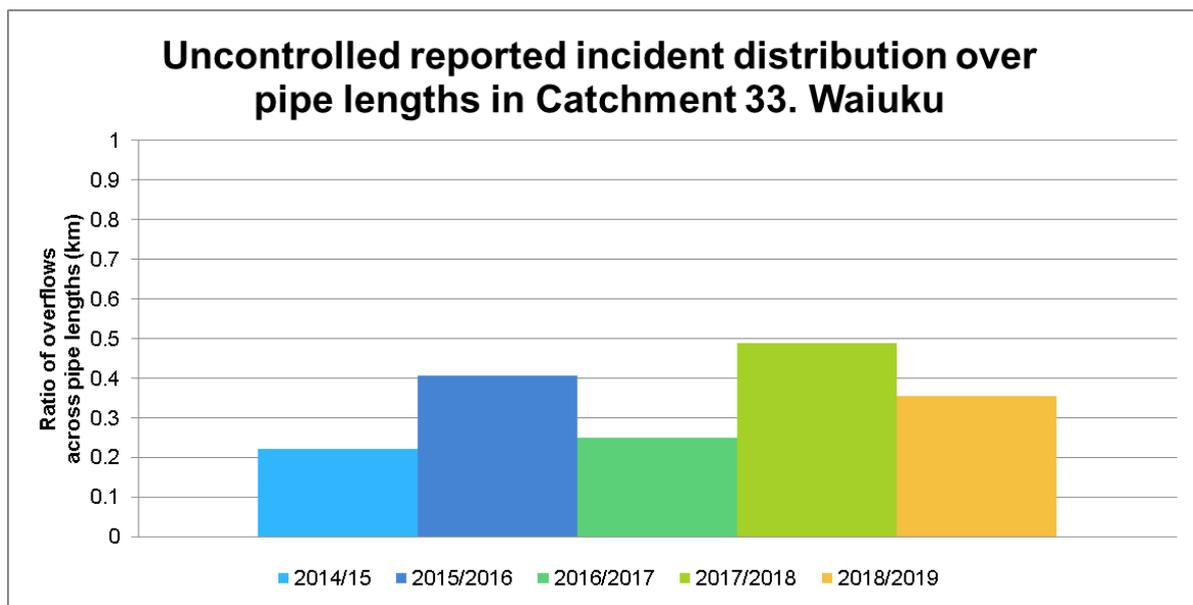
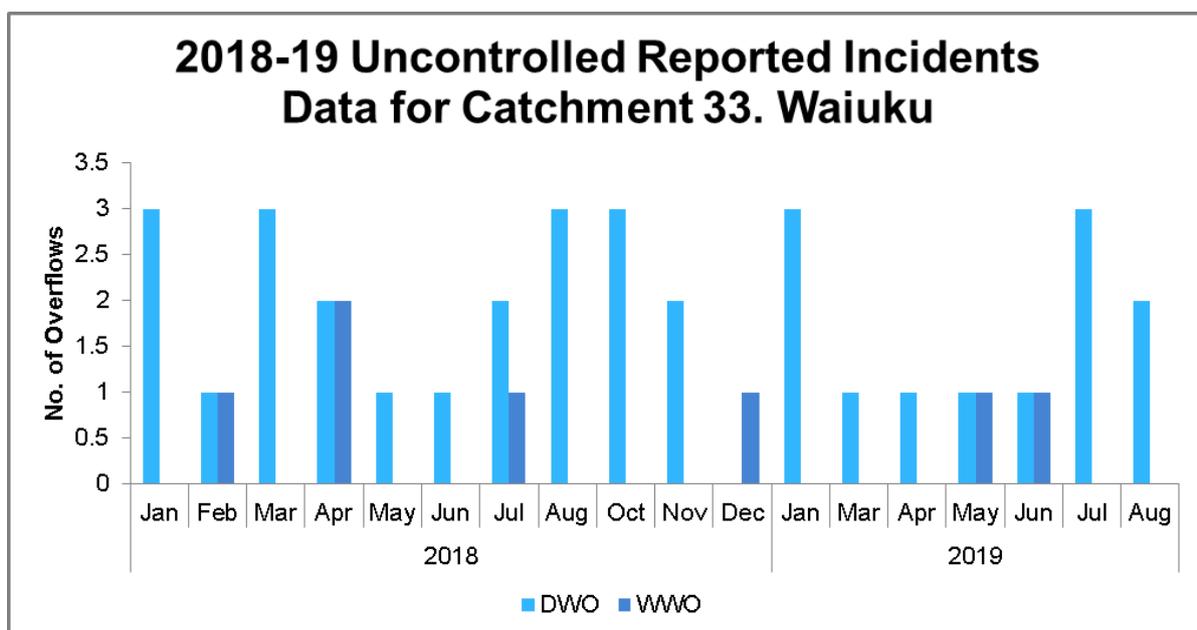
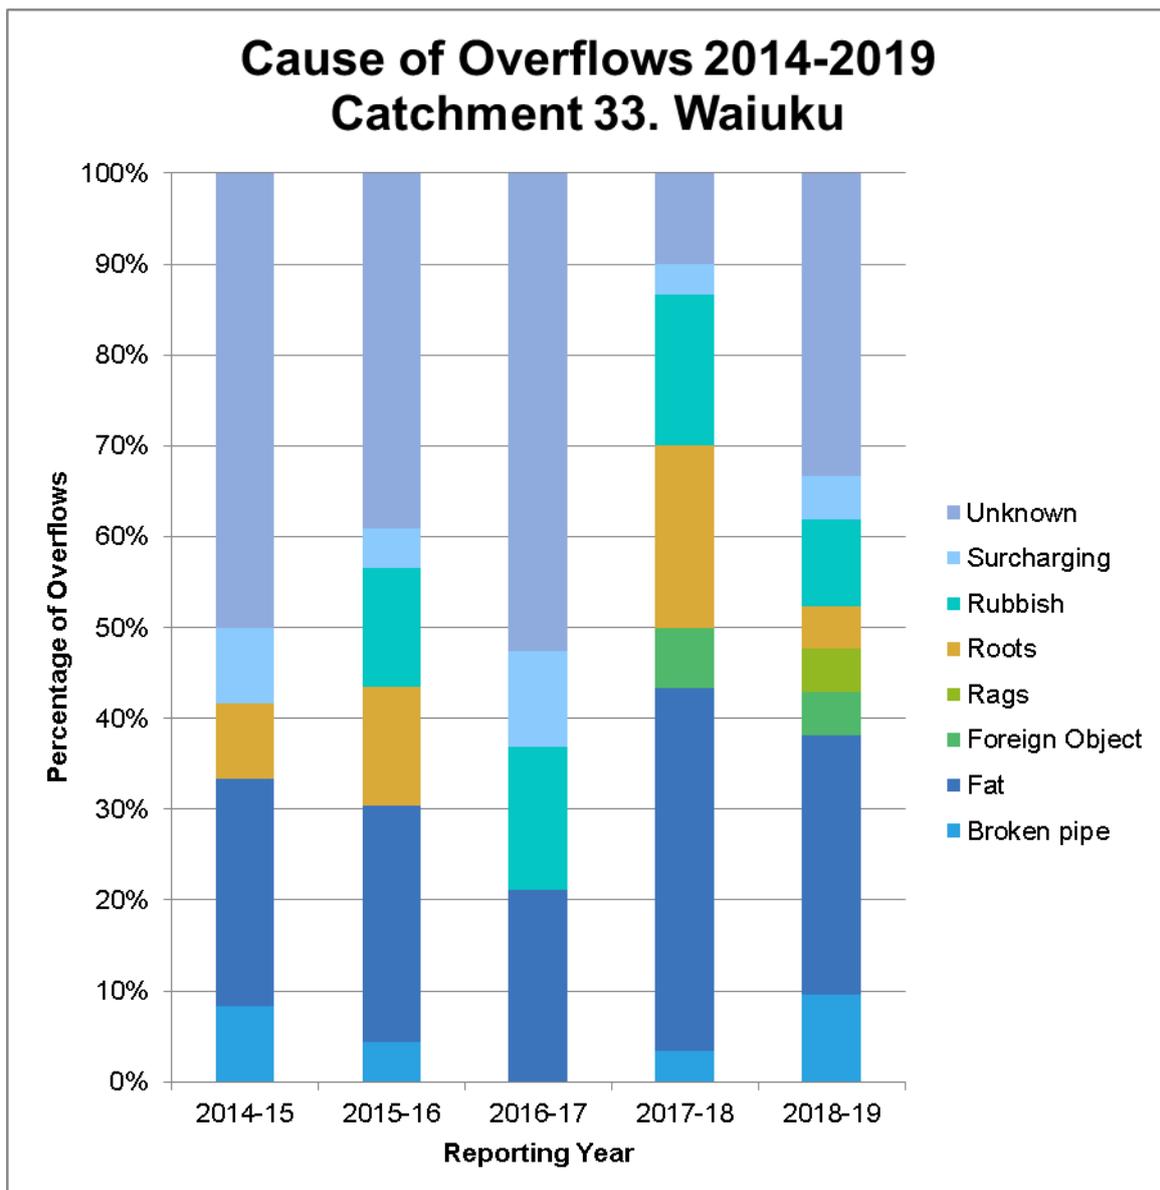
### 2.37.3 Trend analysis of reported incidents

The below graphs reflect the trends distributed along pipe lengths, annual trends, and overflow cause proportions. Trends are displayed over months where overflows occurred.

Trend analysis has been carried out where the cause has been identified.

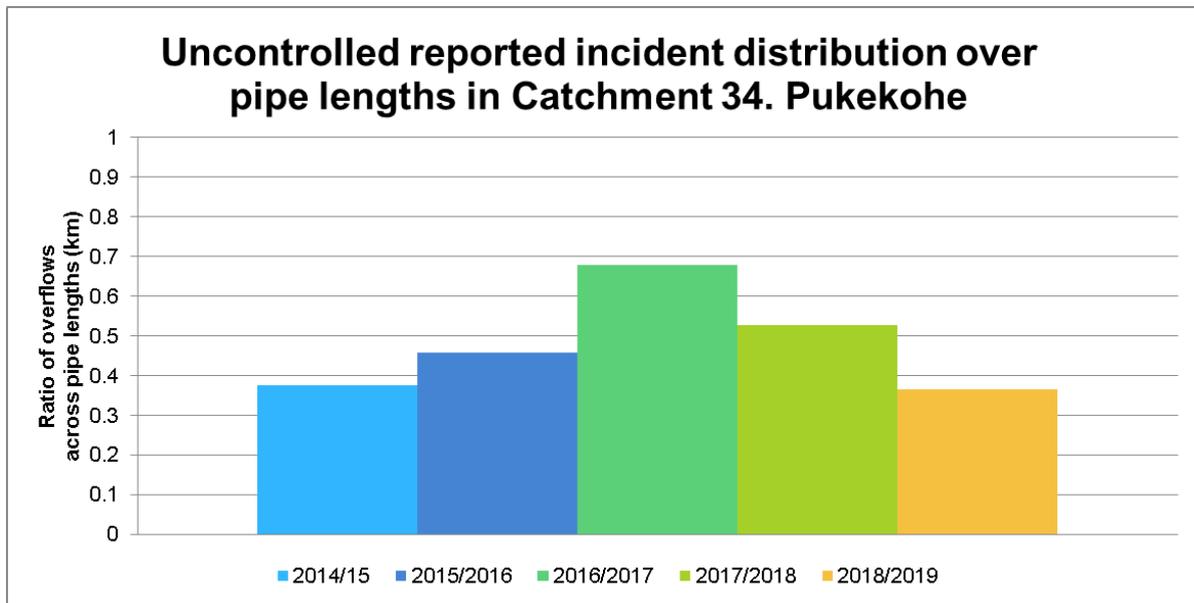
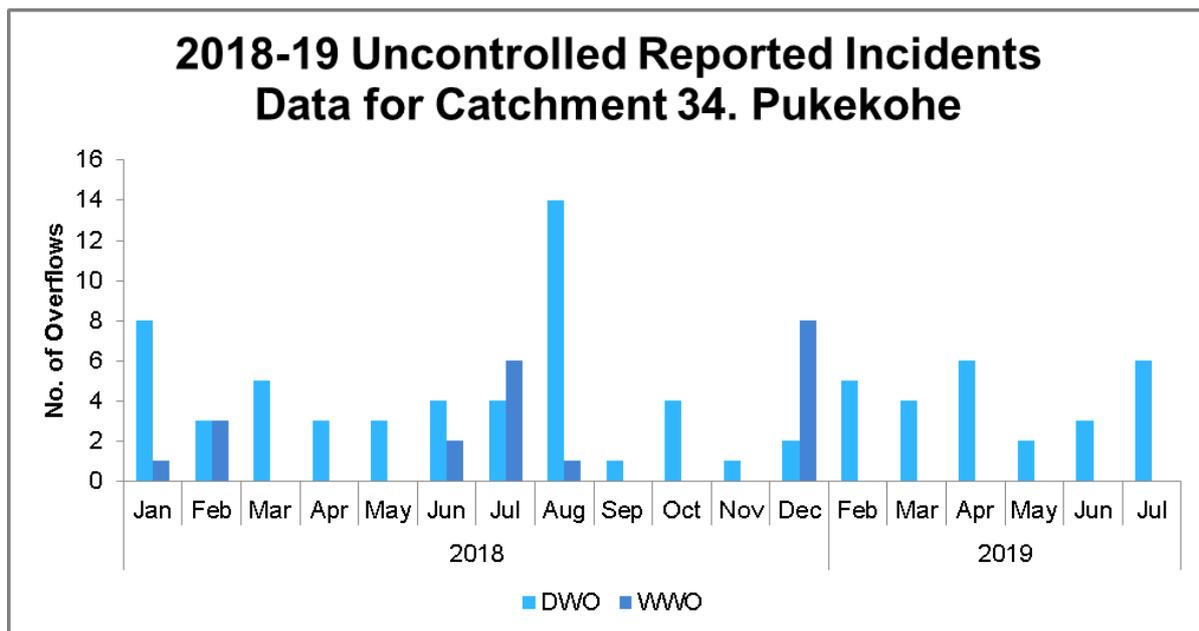
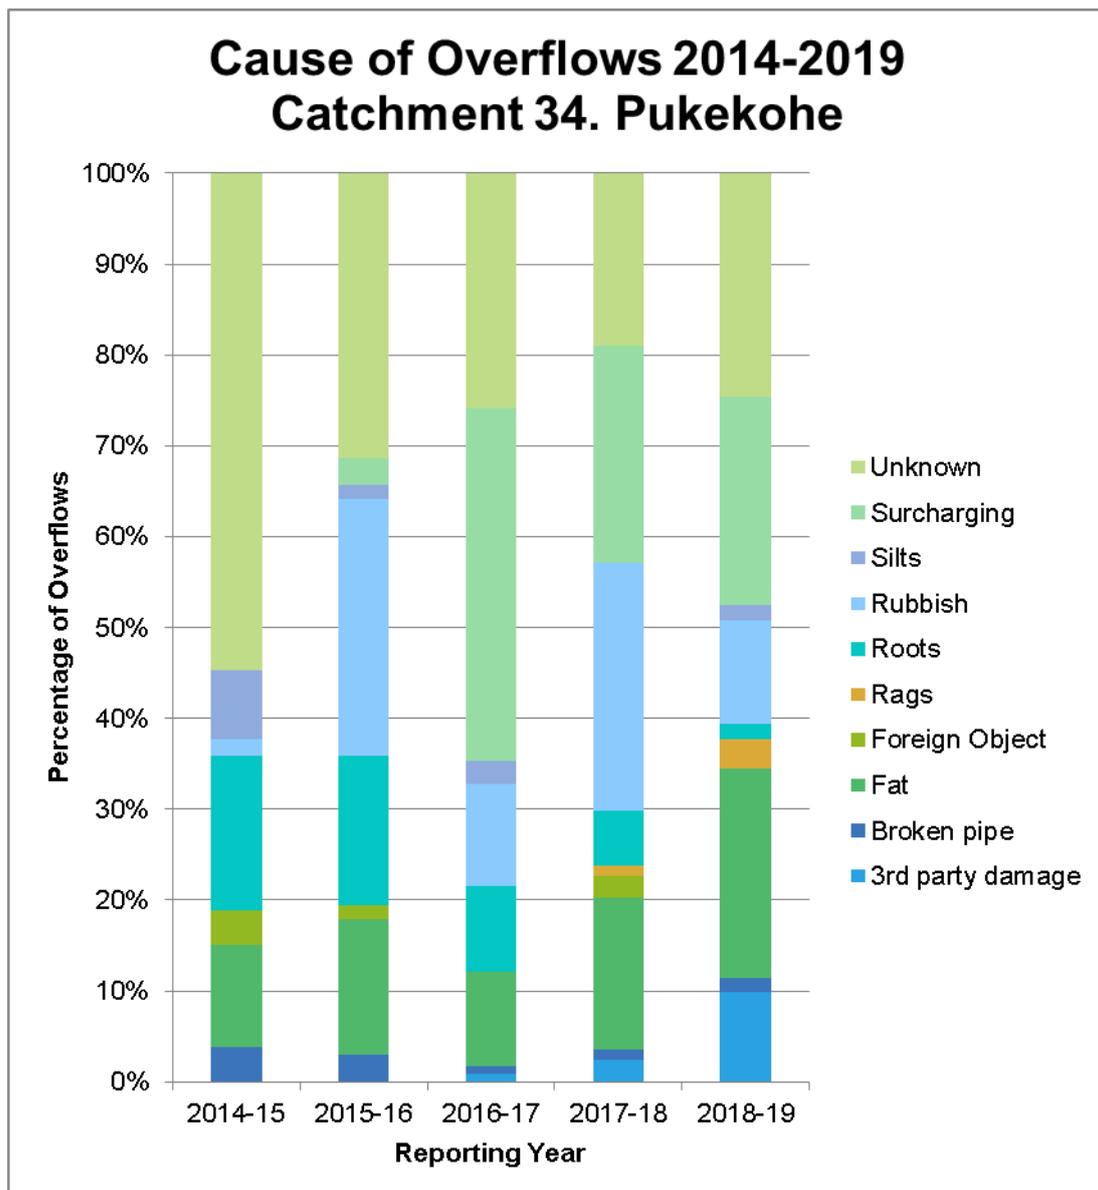
### 2.38.3 Trend analysis of reported incidents

The below graphs reflect the trends distributed along pipe lengths, annual trends, and overflow cause proportions. Trends are displayed over months where overflows occurred.

Trend analysis has been carried out where the cause has been identified.
